the **play** inspection company

Annual Inspection

Pointon Parish Council

Pointon Playing Field

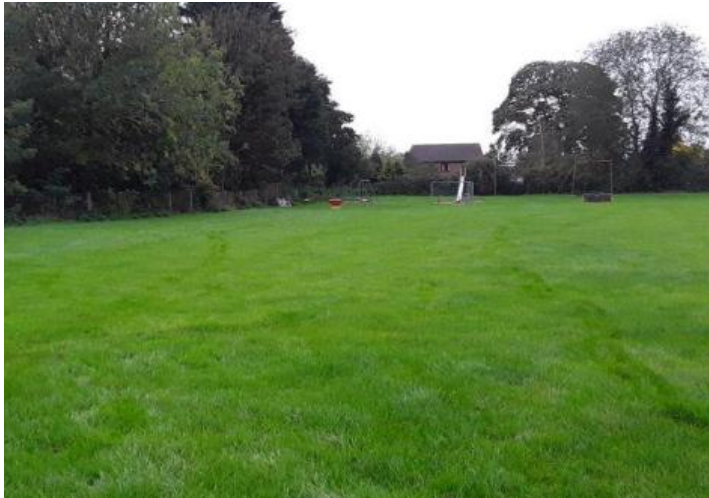
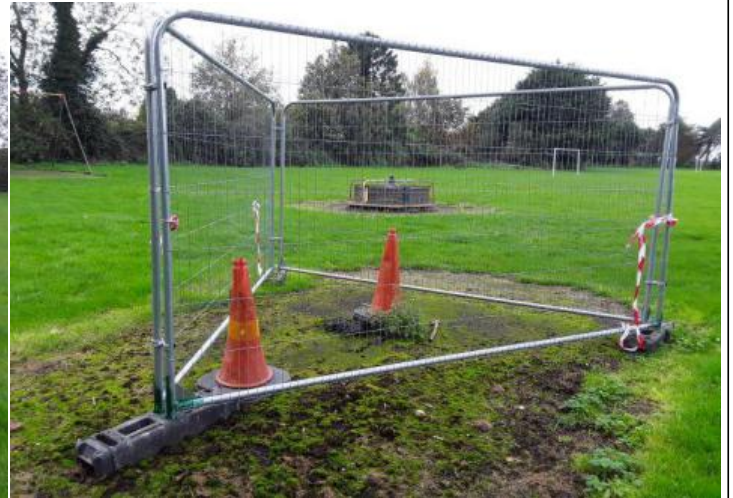
Finding: Access to this area has been restricted by the owner / operator

Action: Complete repairs or removal of affected elements

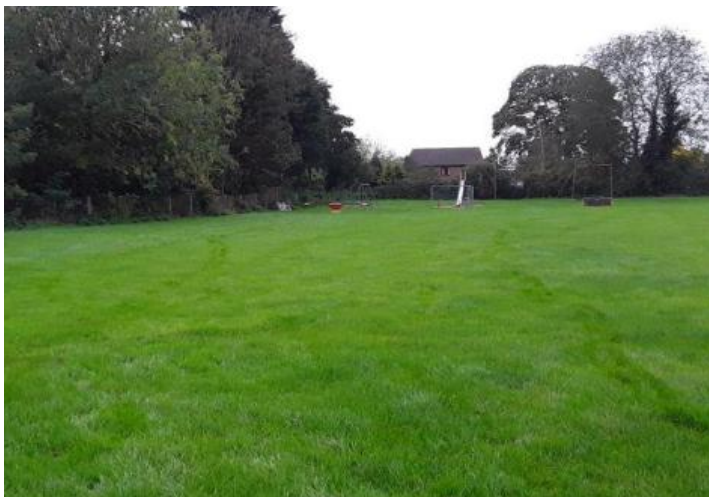
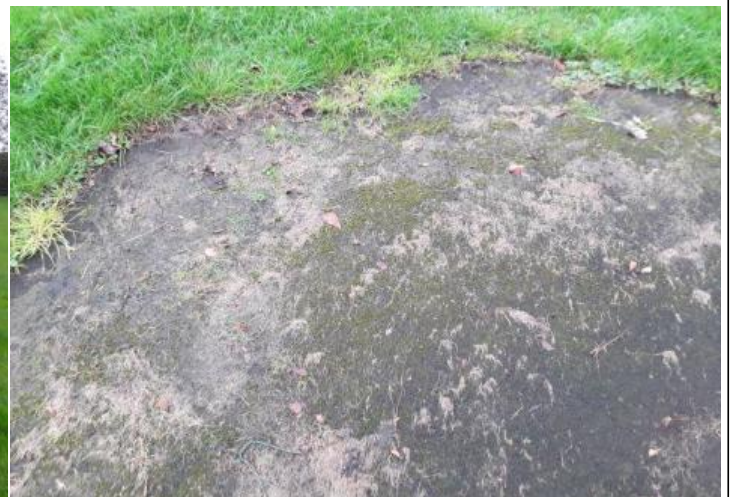
Finding: There is algae, silt or moss growth on the surface resulting in slippery conditions

Action: Clean and treat appropriately

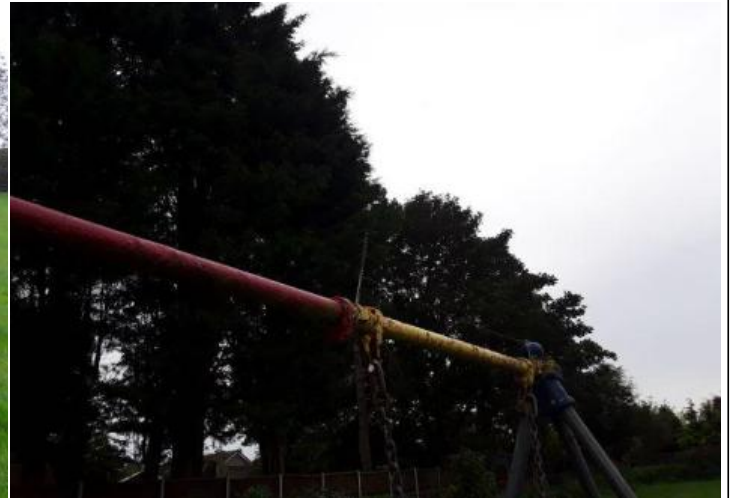
Finding: The use of hard or sharp elements as bird deterrents is not recommended

Action: Remove the affected elements

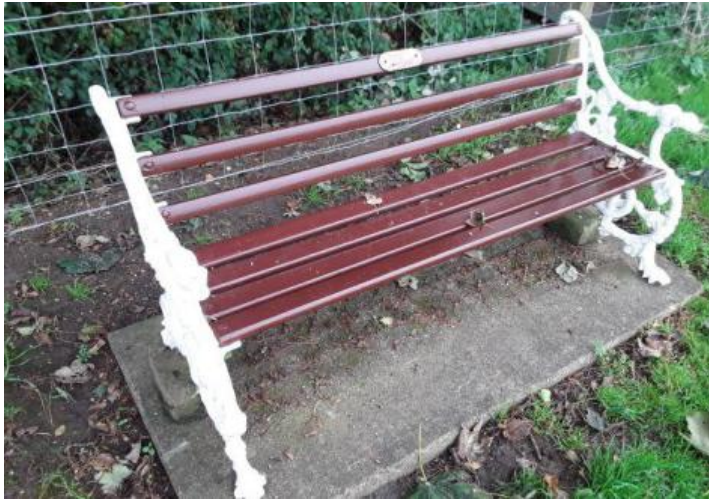
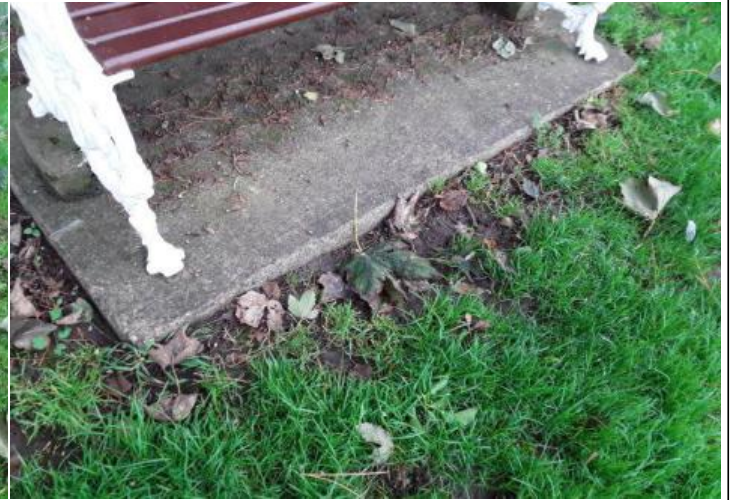
Finding: There are trip hazards at the edges of the surface

Action: Reinstate surrounding surface levels to remove the trip points

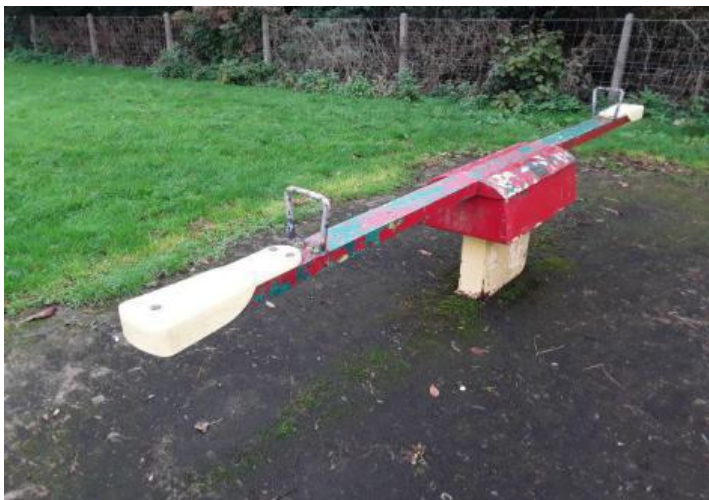
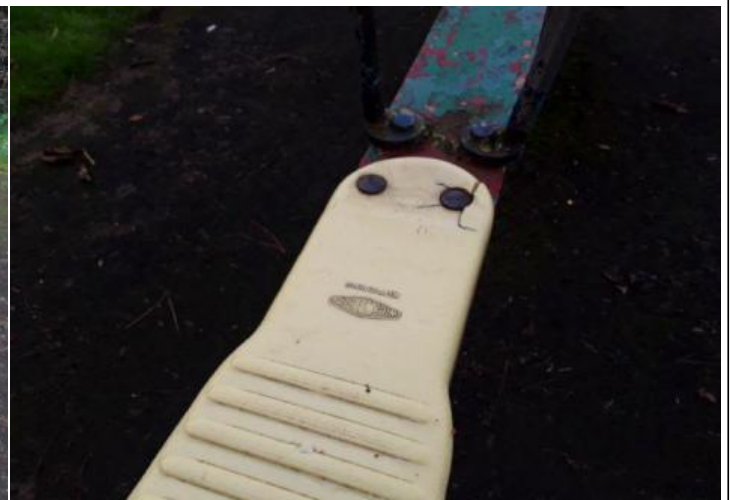
Finding: The seat has been damaged

Action: Replace the seat

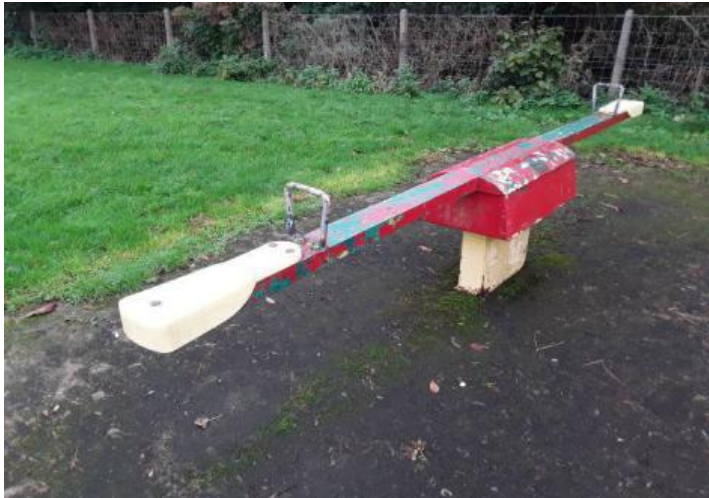
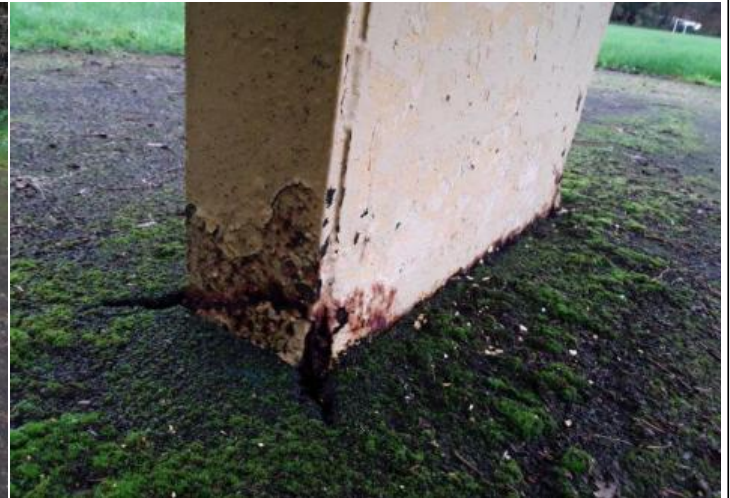
Finding: The paintwork on this item has been damaged or worn exposing the metal underneath which is rusting / corroding

Action: Treat affected areas and repaint

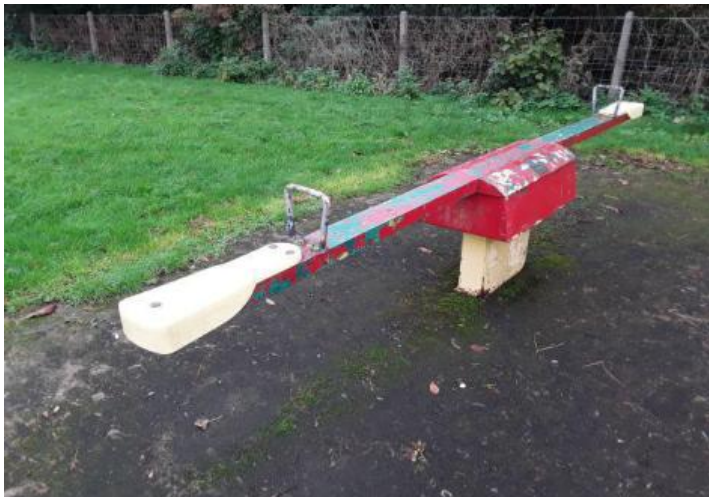
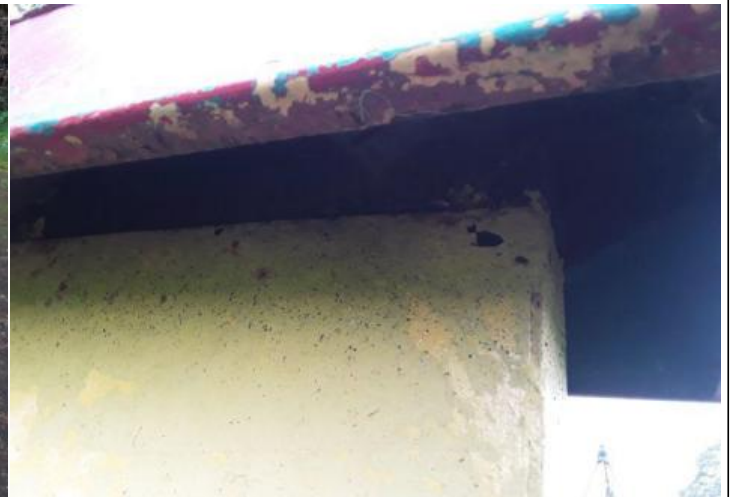
Finding: There is no gaiter protection for accessible moving parts (possible shear trap) as recommended in BS EN 1176 Part 1; 4.2.6 Moving Parts

Action: Monitor - No remedial work recommended

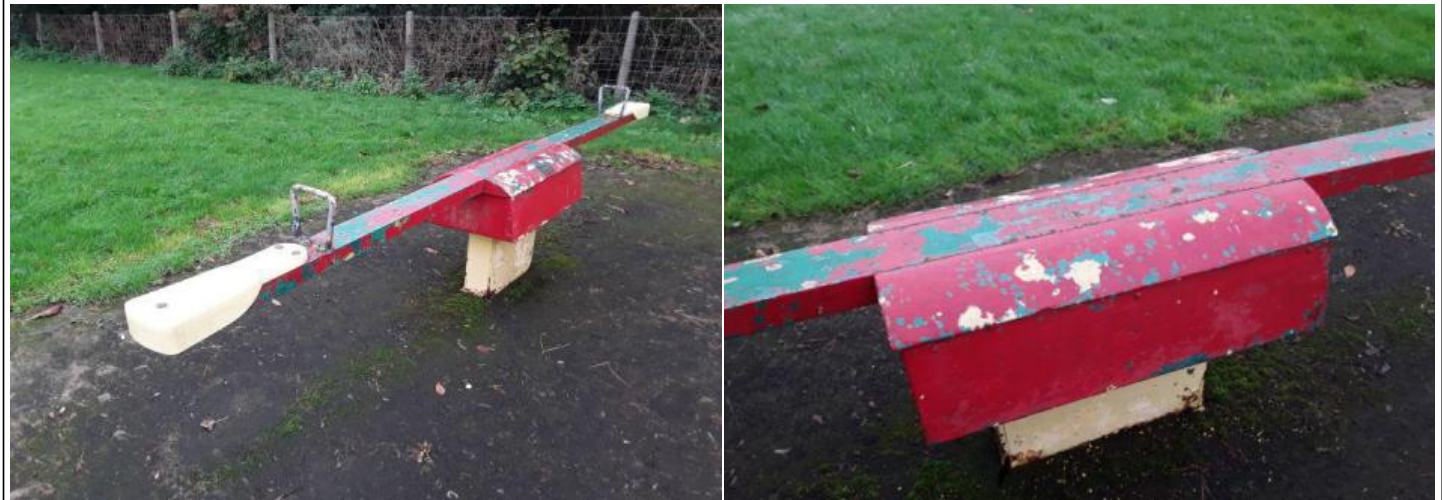
Finding: The pivot mechanism is showing signs of wear	Action: Monitor for any further deterioration and replace as required
--	--

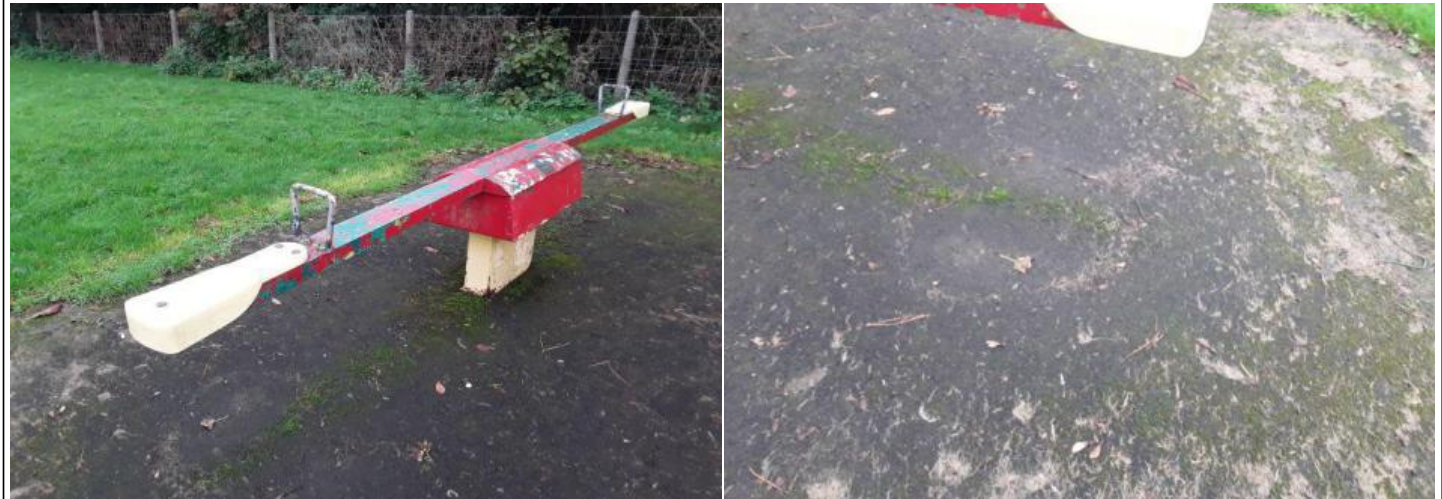
Finding: The surface has subsided in some areas	Action: Monitor for any further deterioration and repair as required
--	---

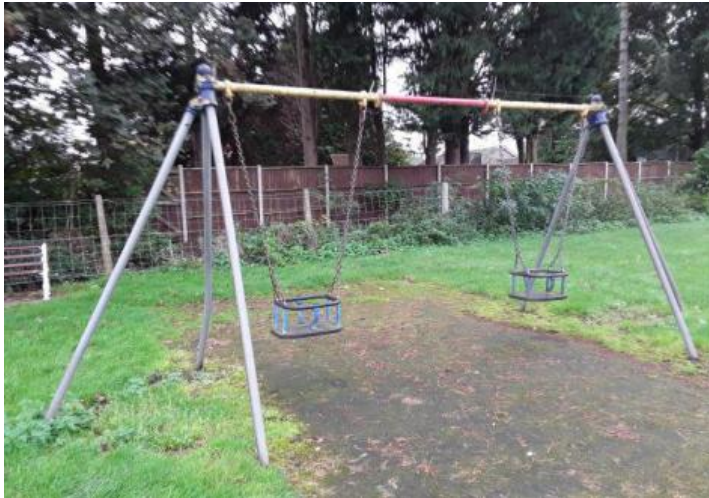
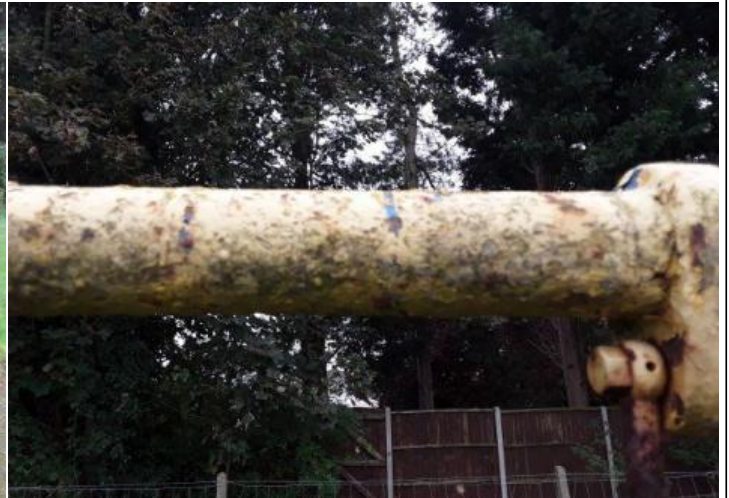
Finding: The paintwork on this item has been damaged or worn exposing the metal underneath which is rusting / corroding

Action: Treat affected areas and repaint

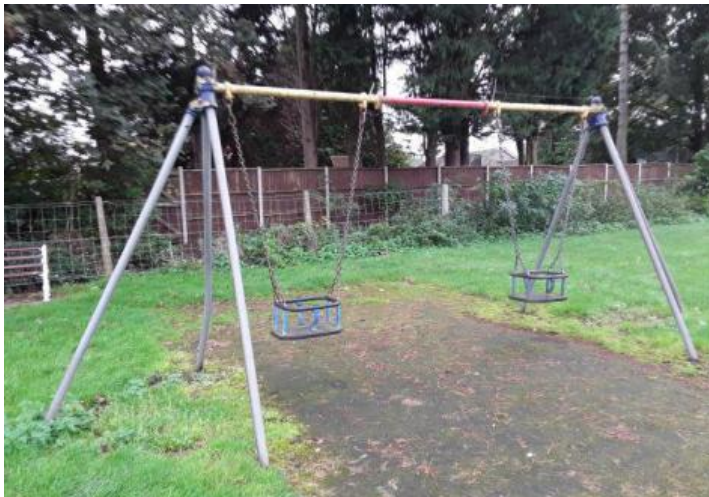
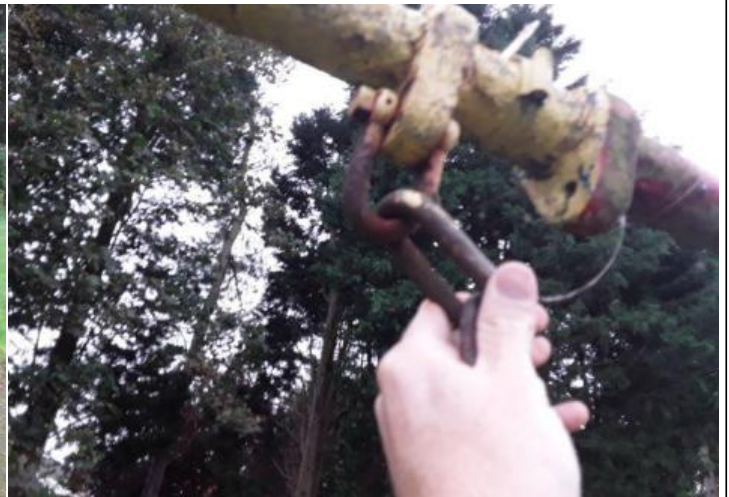
Finding: There is some wear to the shackles.

Action: Monitor for any further deterioration and replace when 40% worn

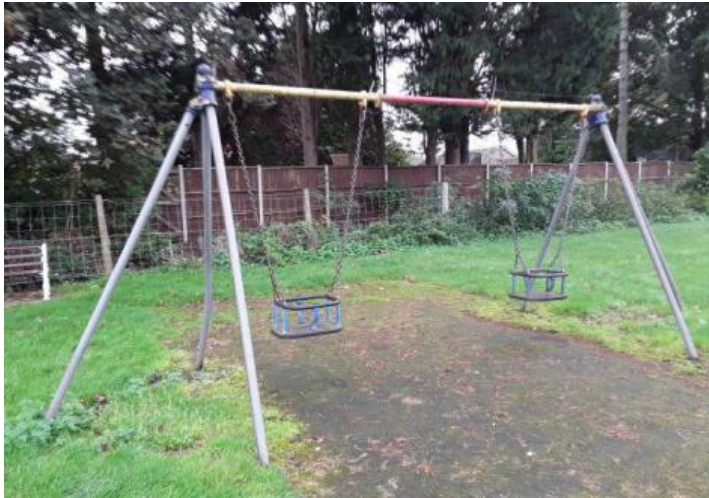
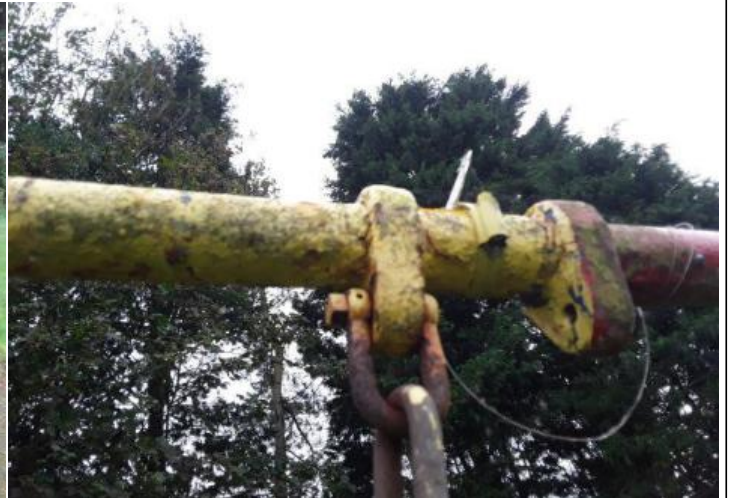
Finding: The split pins are missing from the shackles

Action: Insert split pins to secure the shackles

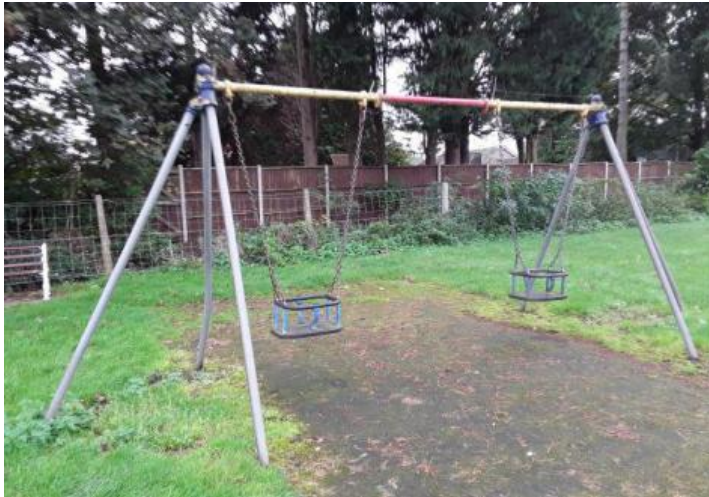
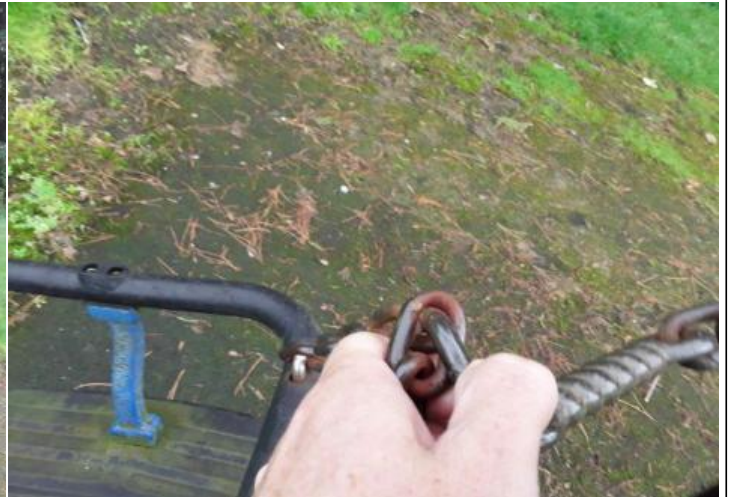
Finding: The chain links are worn in excess of 40% and require renewing

Action: Replace worn chains

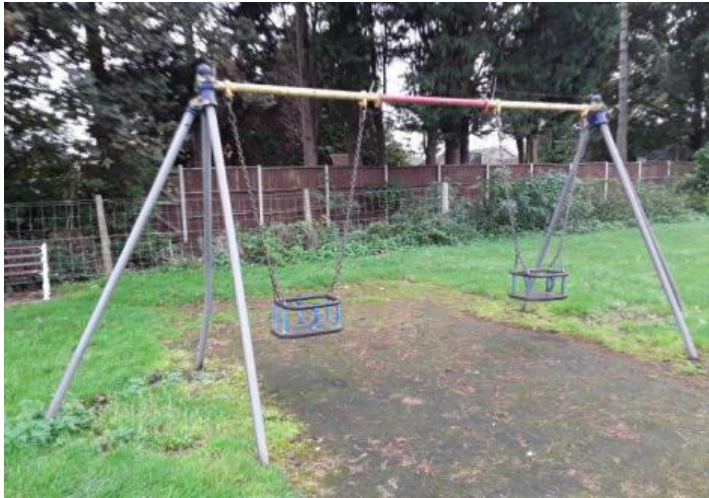
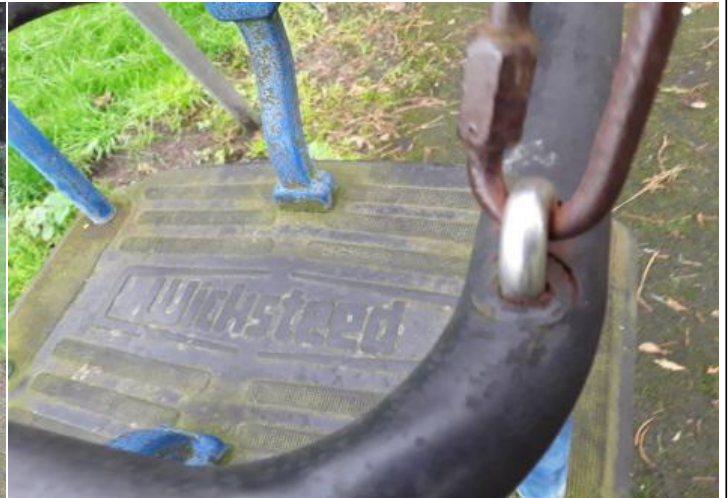
Finding: The swing seat frames are corroding

Action: Monitor for any further deterioration and replace as required

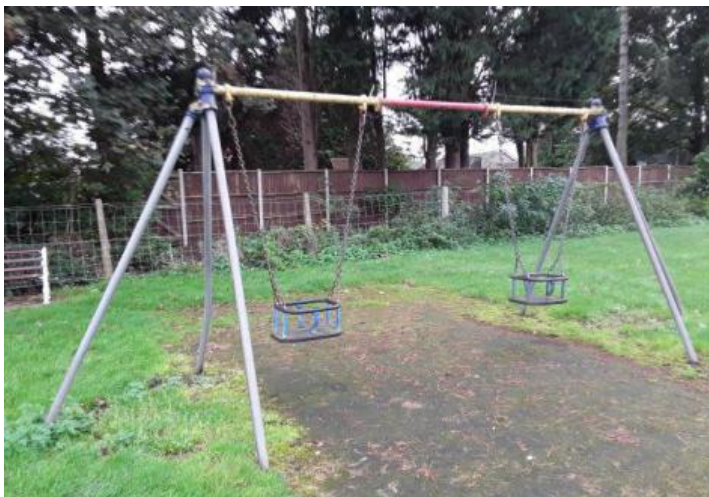
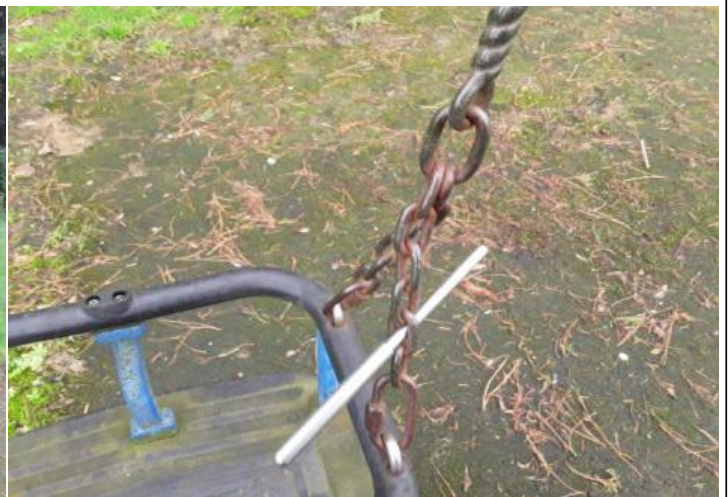
Finding: The chain openings are in excess of the 8.6mm as recommended by BS EN 1176

Action: Monitor - No remedial work recommended

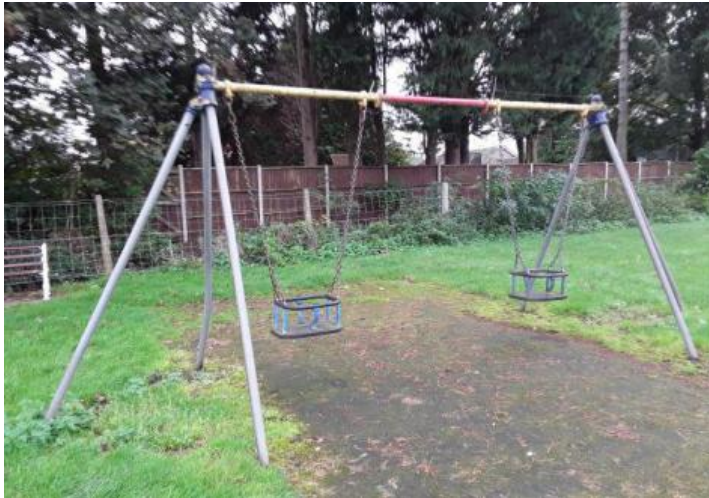
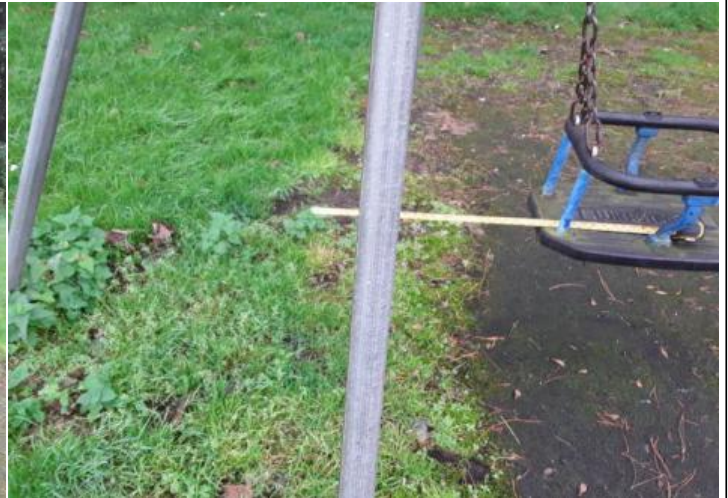
Finding: The seats are too close to the frame as defined in BS EN 1176 Part 2; this is a low risk failure and no remedial action is required

Action: Monitor - No remedial work recommended

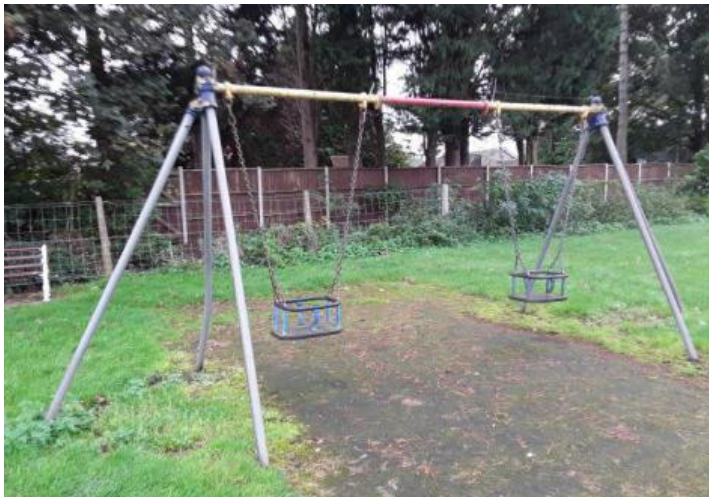
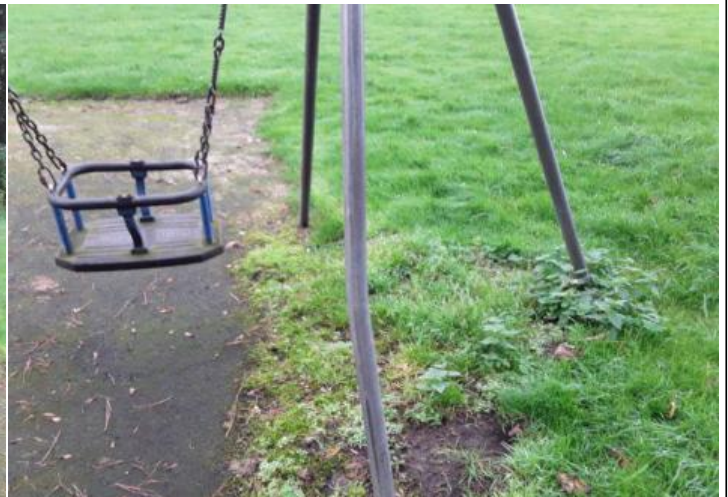
Finding: The frame has been damaged

Action: Monitor for any further deterioration and replace as required

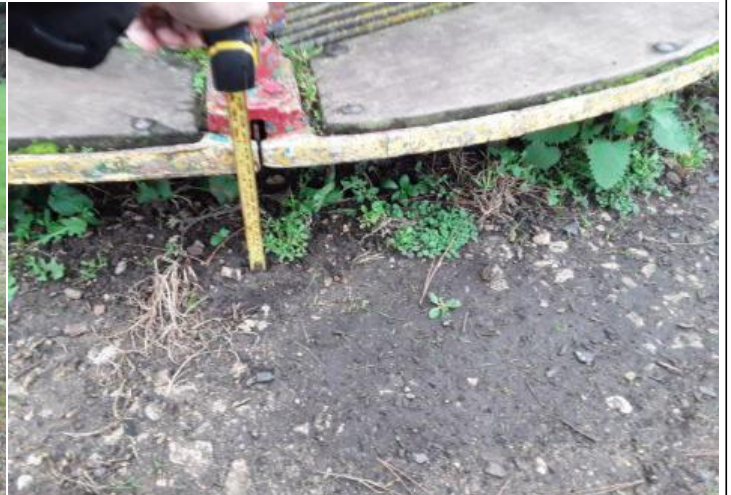
Finding: The distance between the underside of the roundabout platform and the playing surface is in excess of 110mm and contravenes the requirements of BS EN 1176 Part 5 which requires that the distance be maintained between 60mm-110mm - for the entire circumference of the roundabout

Action: Replace the missing surface

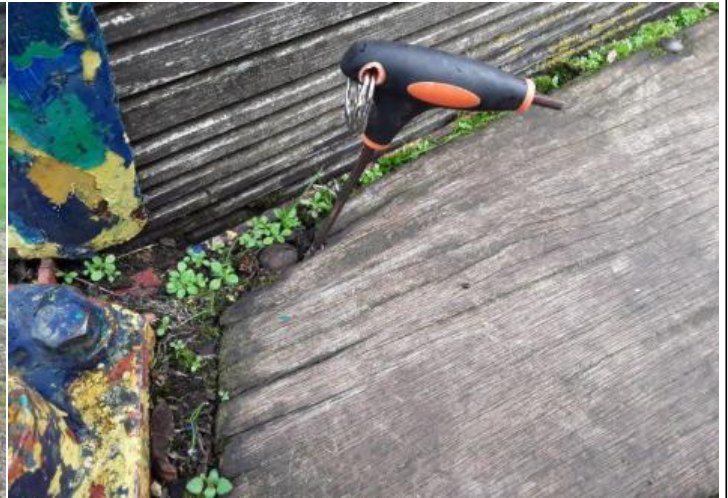
Finding: There are areas or parts of the timber on the structure that have rotted around fixing points

Action: Replace all affected timbers

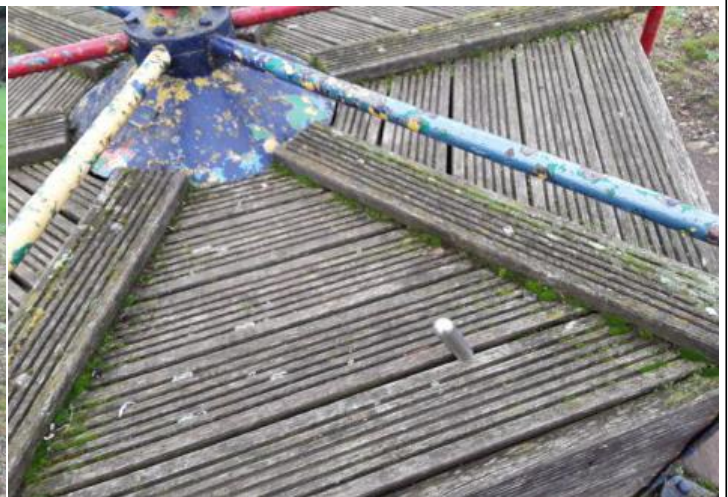
Finding: There is/are finger entrapment/s in the structure and the item fails to meet the requirements of BS EN 1176 Part 1 4.2.7.6 Entrapment of fingers

Action: Infill to remove the entrapments

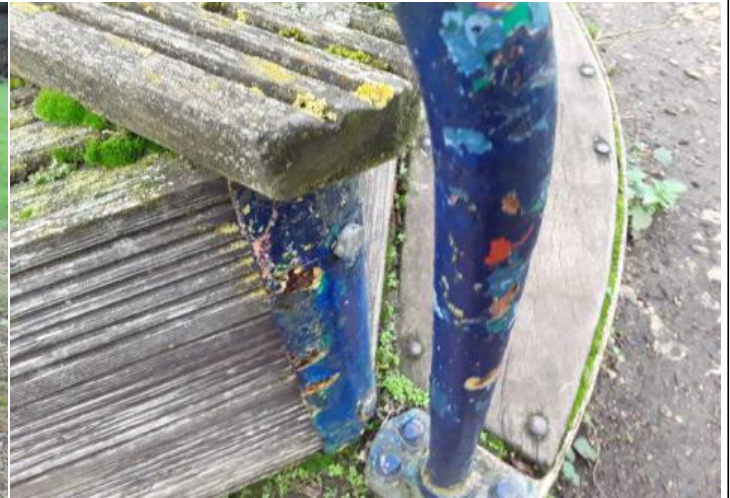
Finding: The paintwork on this item has been damaged or worn exposing the metal underneath which is rusting / corroding

Action: Treat affected areas and repaint

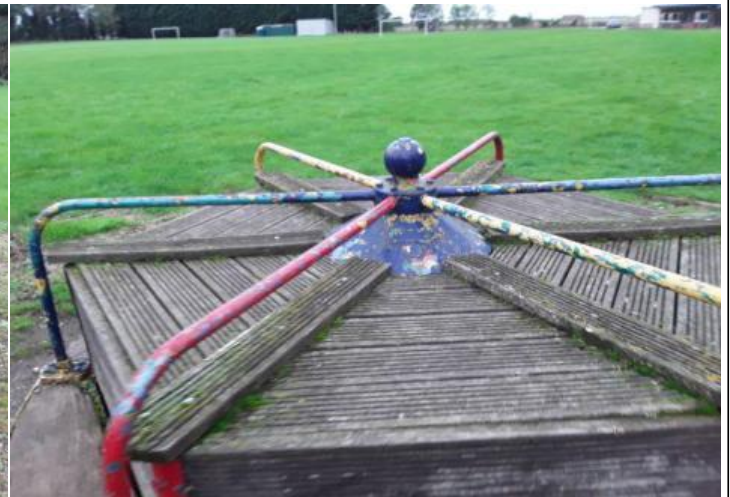
Finding: The bearing is showing signs of wear

Action: Monitor for any further deterioration and replace as required

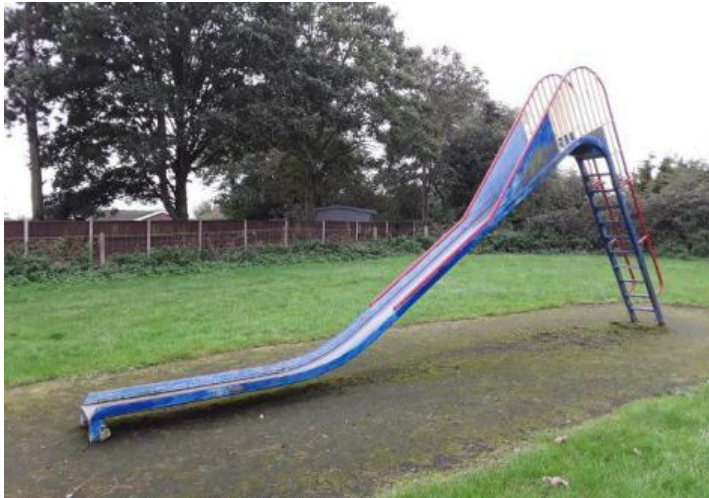
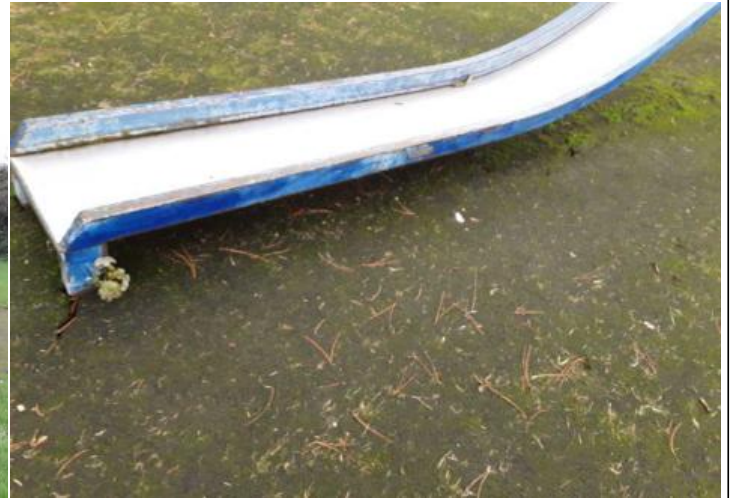
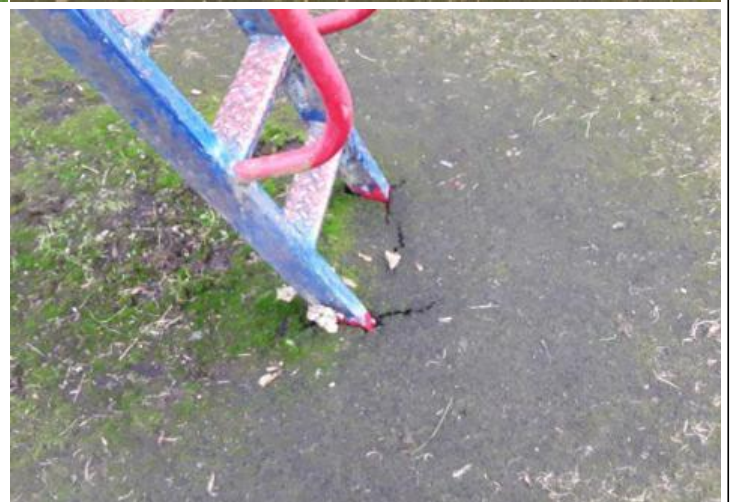
Finding: There is some minor damage to the surface

Action: Monitor for any further deterioration and repair as required

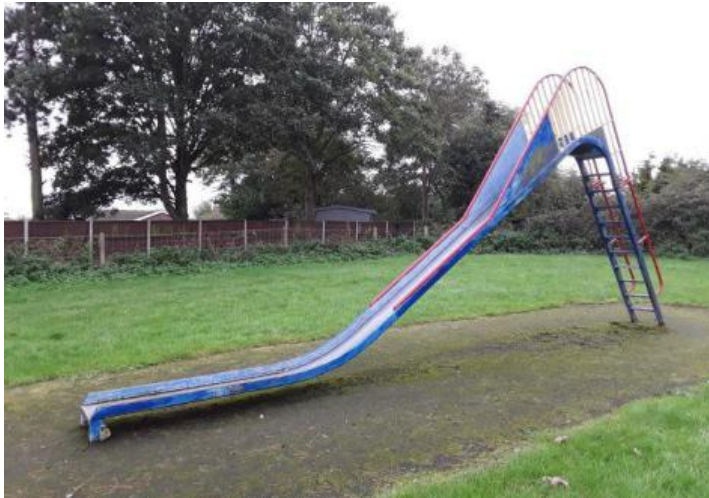
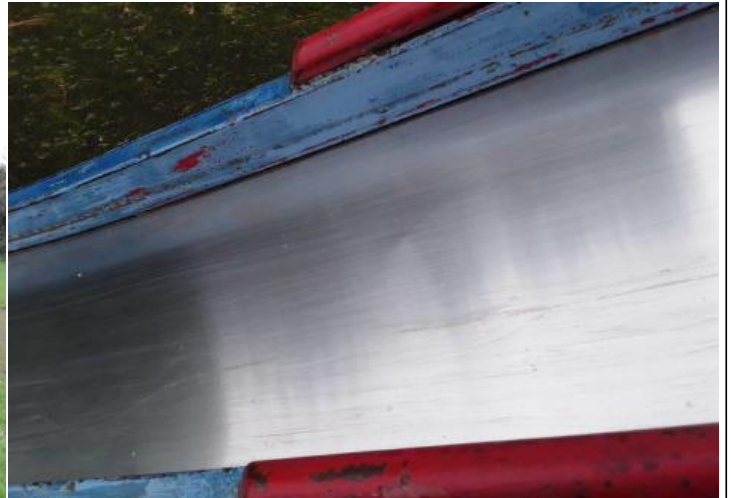
Finding: There are a number of dents in the slide surface

Action: Monitor for any further deterioration and repair as required

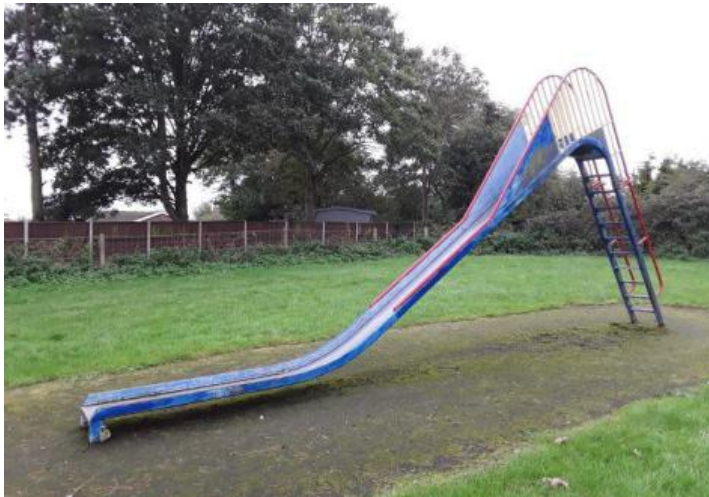
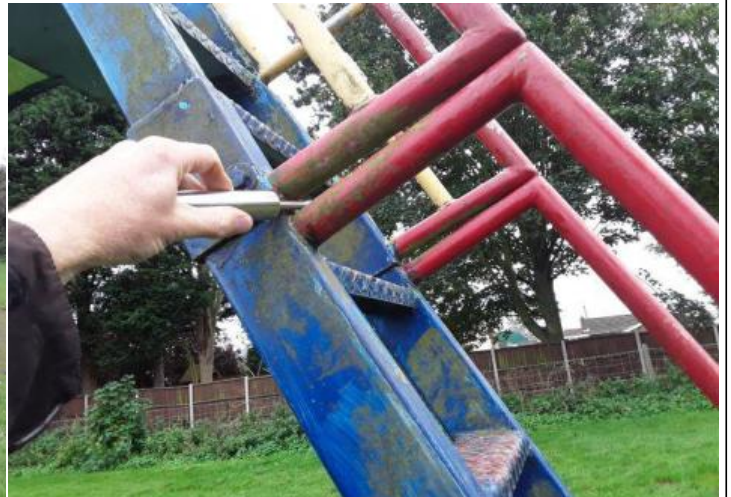
Finding: There is/are finger entrapment/s in the framework and the item fails to meet the requirements of BS EN 1176 Part 1 4.2.7.6 Entrapment of fingers

Action: Monitor - No remedial work recommended

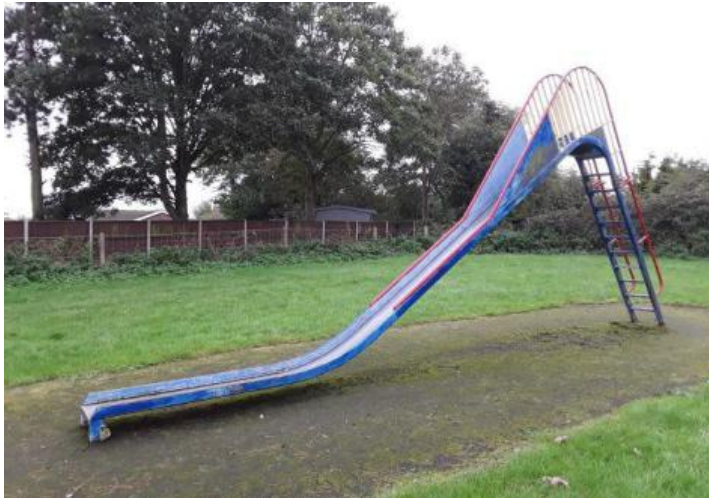
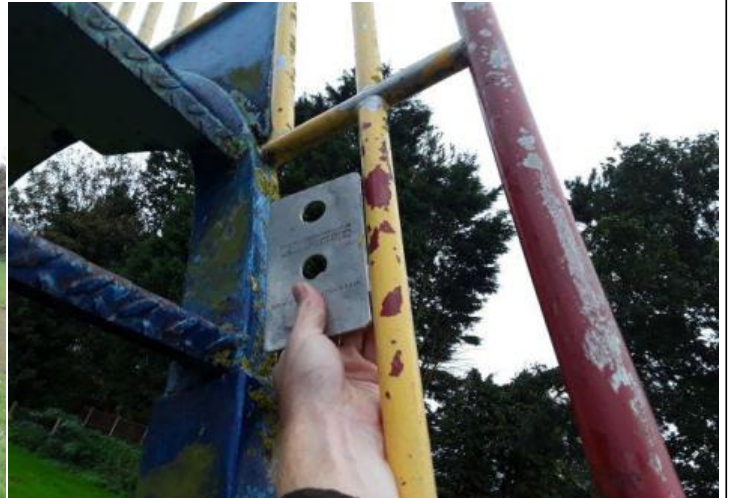
Finding: The item fails to meet the requirements of BS EN 1176 Part 1 4.2.7.2 head and neck entrapment in the barriers and/or steps

Action: Monitor - No remedial work recommended

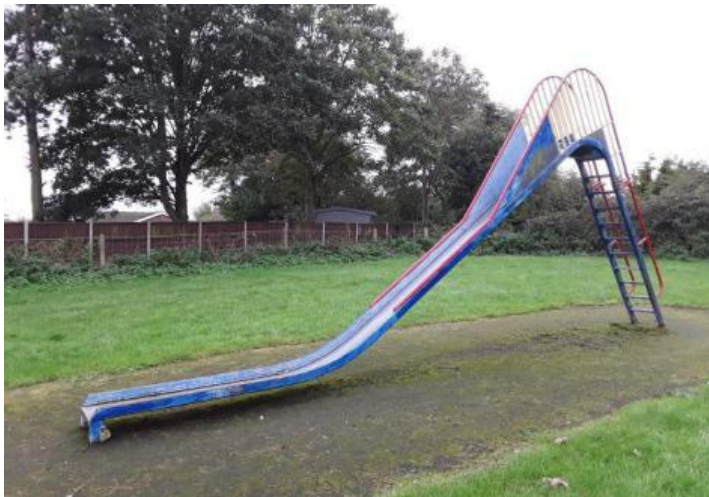
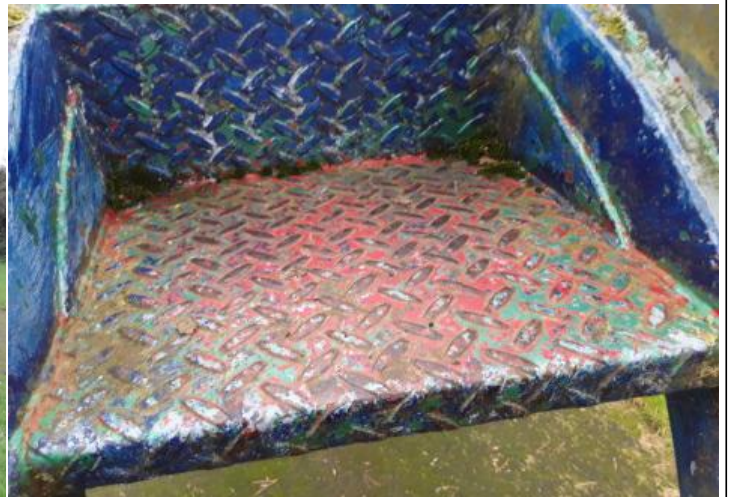
Finding: The paintwork on this item has been damaged or worn exposing the metal underneath which is rusting / corroding

Action: Treat affected areas and repaint

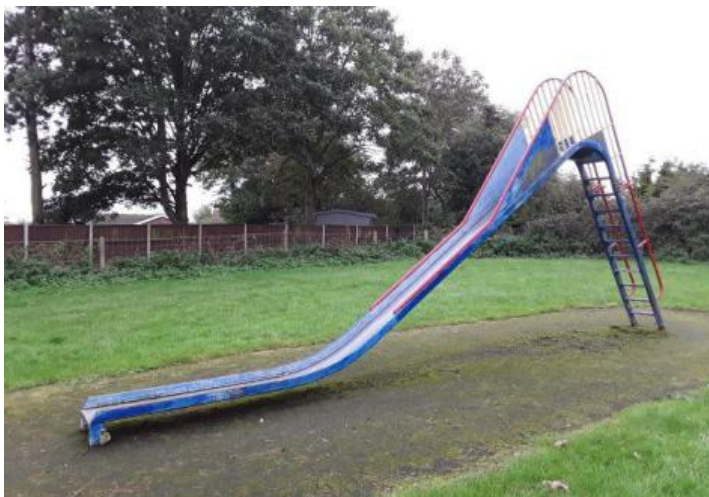
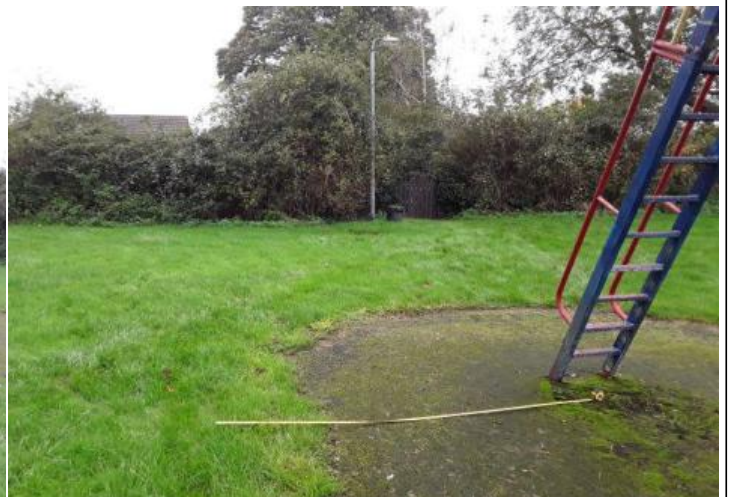
Finding: The surfacing dimensions are short and do not meet with the requirements of the current applicable standard

Action: Monitor - no remedial action recommended

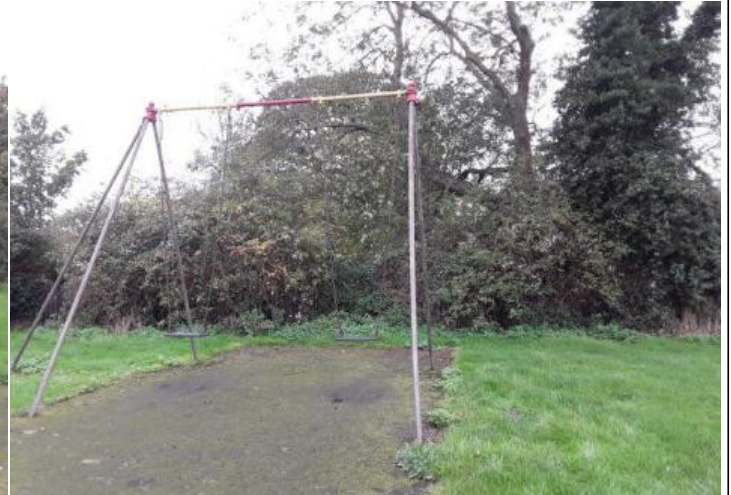
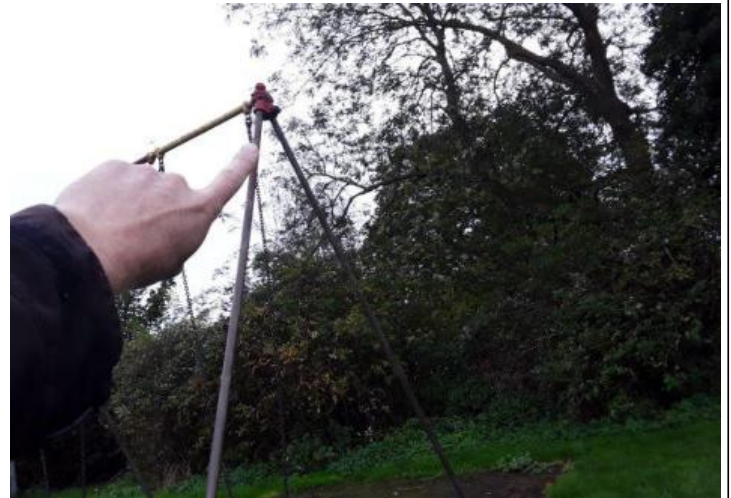
Finding: One of the lateral frame stabilisers is missing

Action: Replace the missing structural components

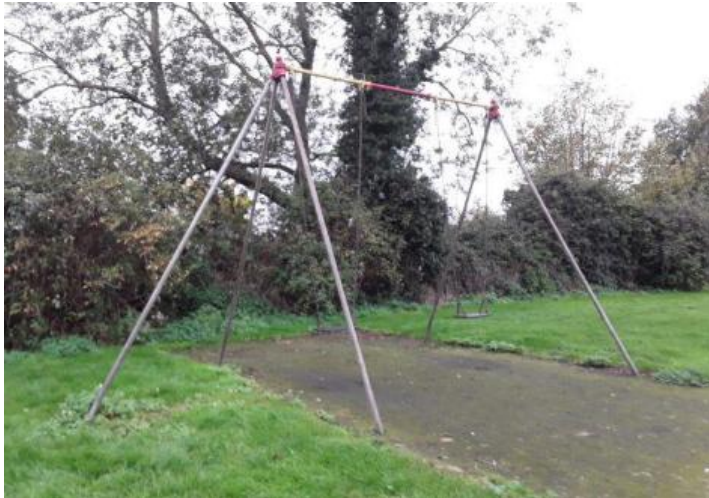
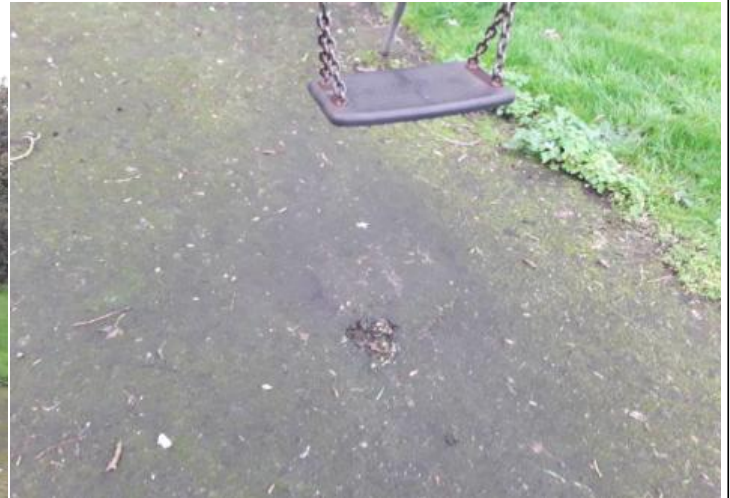
Finding: There is moderate damage to the surface

Action: Repair the damaged areas of surfacing

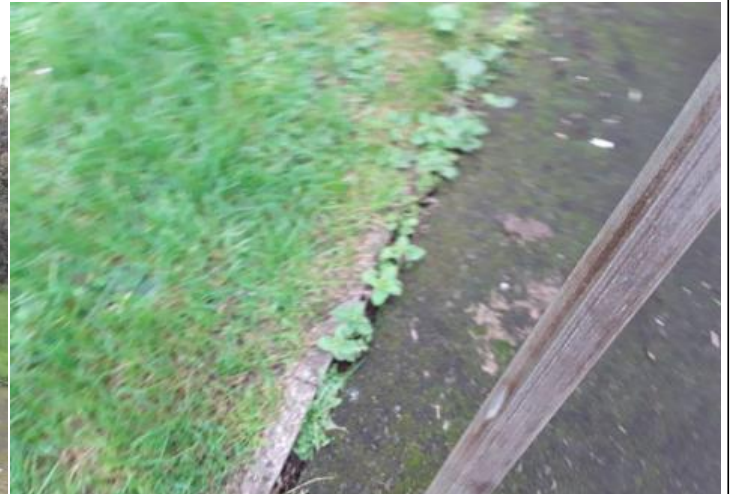
Finding: There are significant gaps (over 30mm) between the surface and the edging or between the joints in the surface; these are large enough for a small foot to enter

Action: Repair surfacing

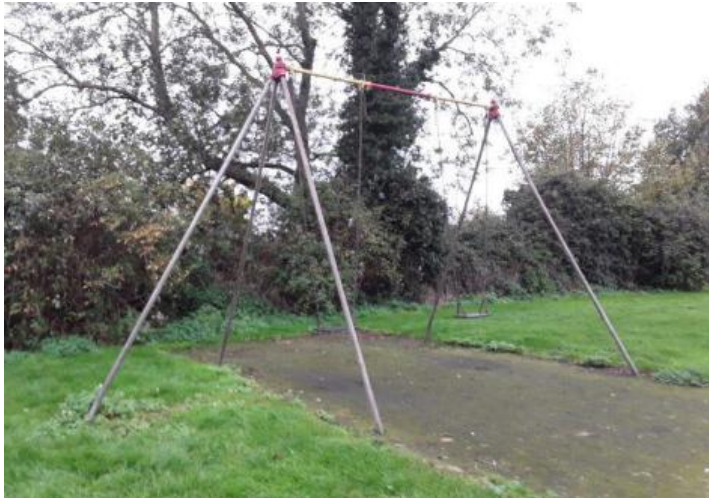
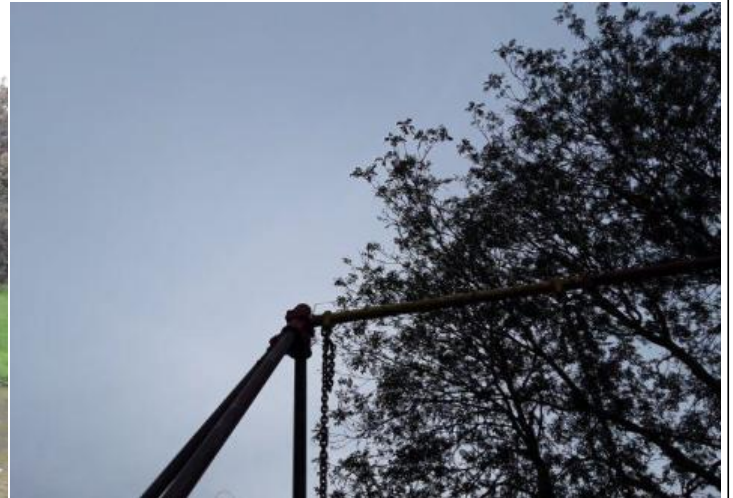
Finding: The fixings or components for this item were in excess of 2.5m above the standing surface and could not be fully accessed by the inspector. We have completed a visual inspection of the fixings from ground level but a maintenance inspection should be undertaken to assess the condition, security and wear of the components at intervals in accordance with the manufacturers recommendations.

Action: Inspect in accordance with the manufacturers recommendations

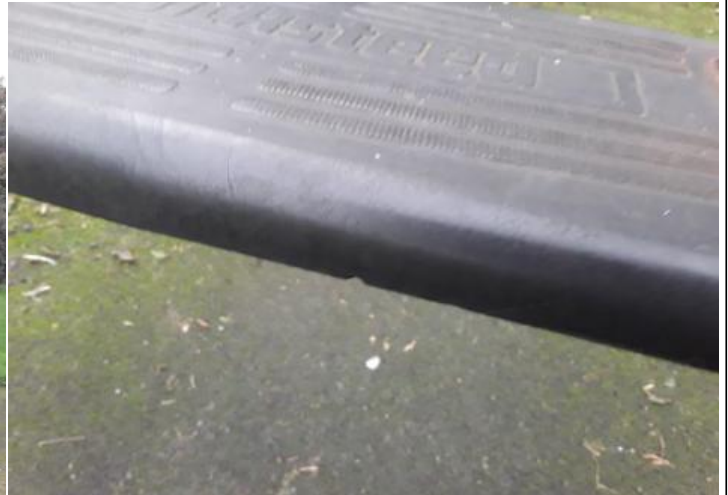
Finding: The seat has minor damage or wear

Action: Monitor for any further deterioration and replace as required
