the **play** inspection company

Annual Inspection

Pointon Parish Council

Pointon Playing Field

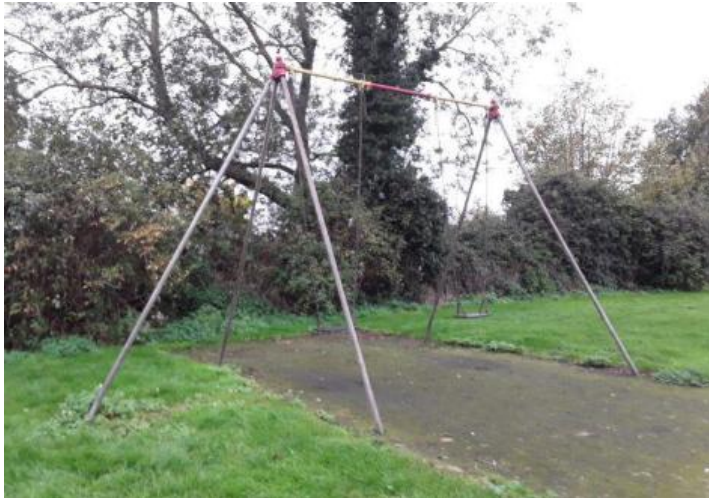
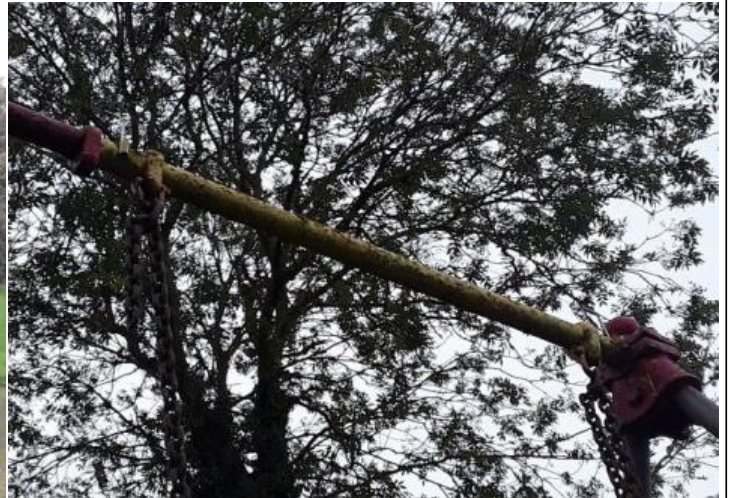
Finding: There is some wear to the shackles.

Action: Monitor for any further deterioration and replace when 40% worn

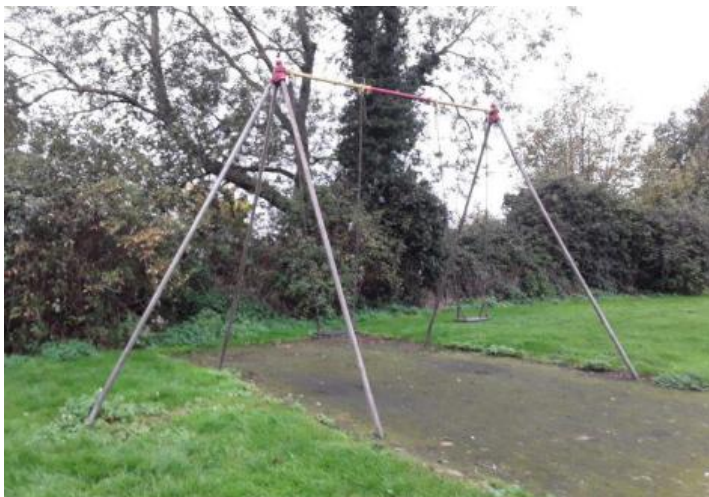
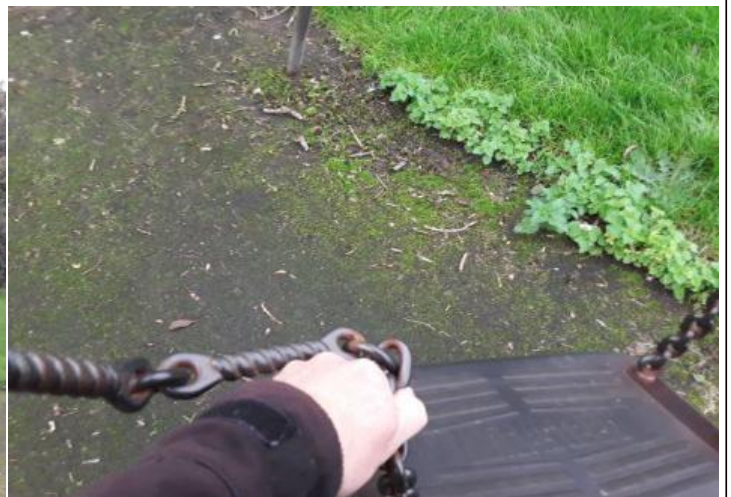
Finding: There is some notable evidence of chain wear

Action: Monitor for any further deterioration and replace when 40% worn

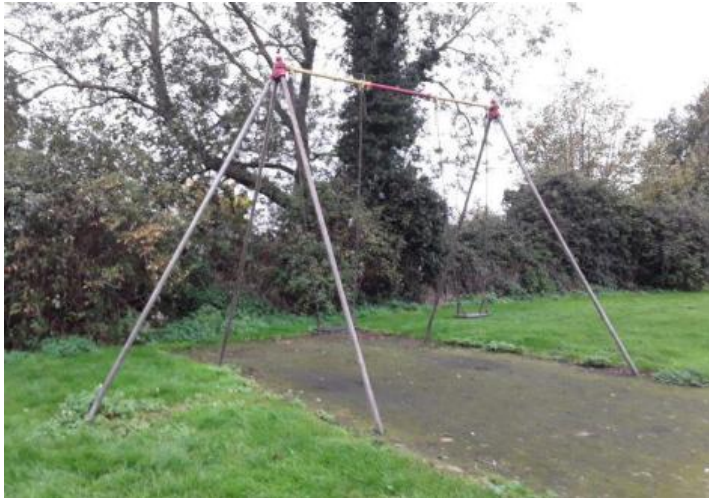
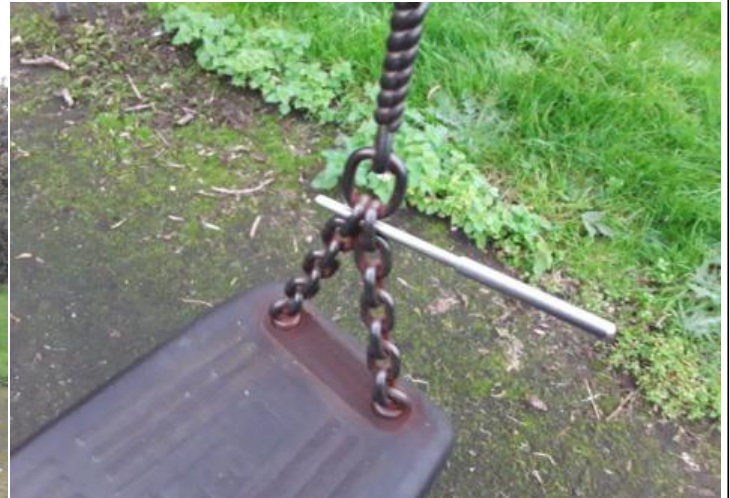
Finding: The chain openings are in excess of the 8.6mm as recommended by BS EN 1176
Action: Monitor - No remedial work recommended

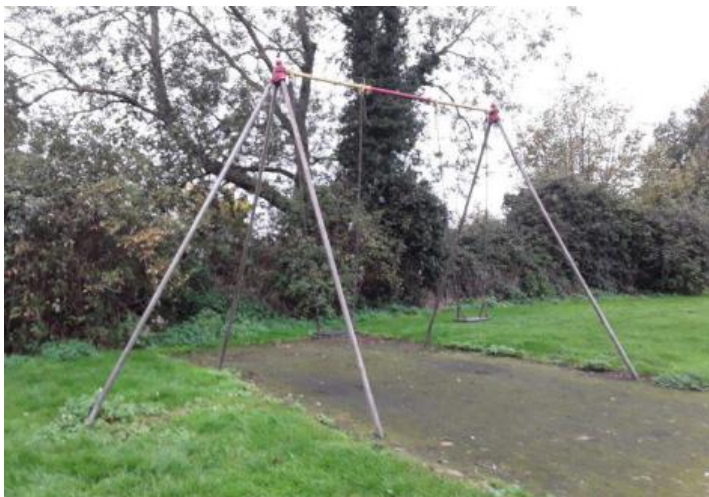
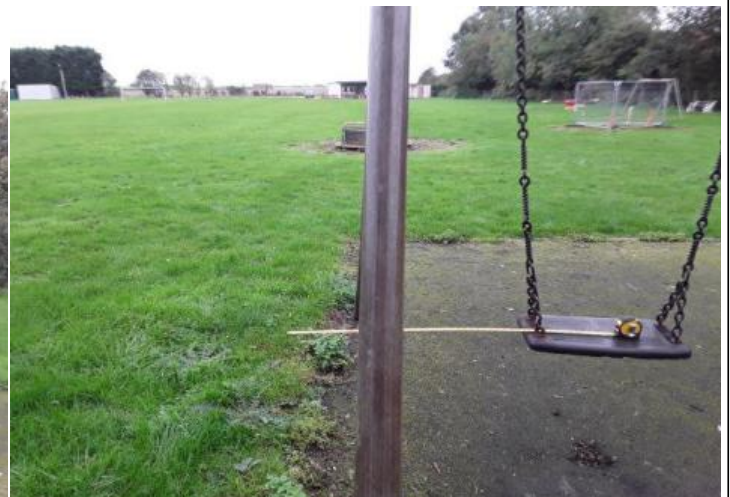
Finding: The seats are too close to the frame as defined in BS EN 1176 Part 2; this is a low risk failure and no remedial action is required
Action: Monitor - No remedial work recommended

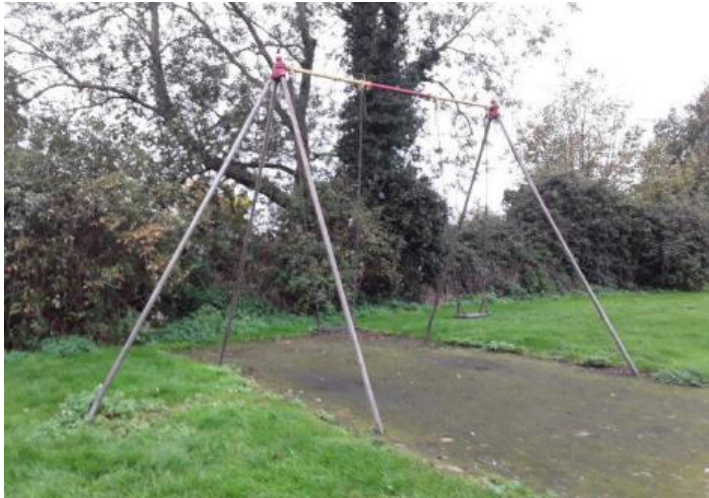
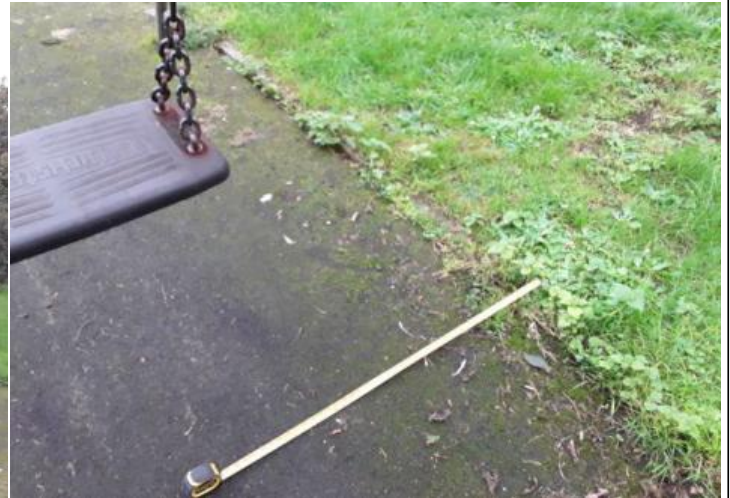
Finding: The surfacing width under the seat/s is / are less than 875mm when measured from the centre of the seat outwards, and fails the requirements of BS EN 1176 Part 2

Action: Monitor - No remedial work recommended

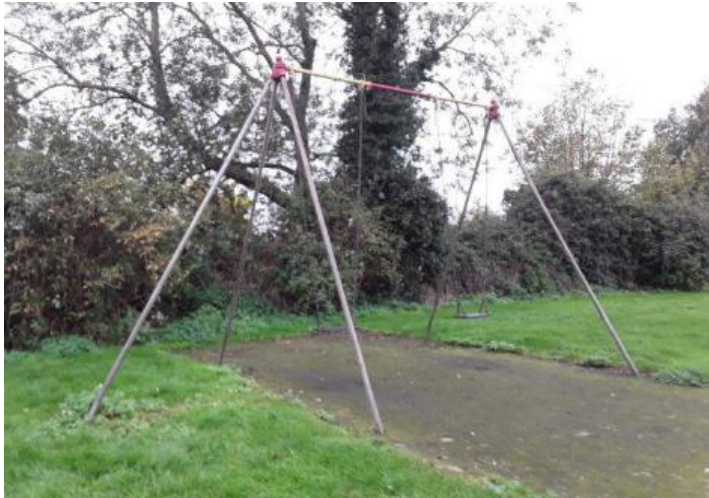
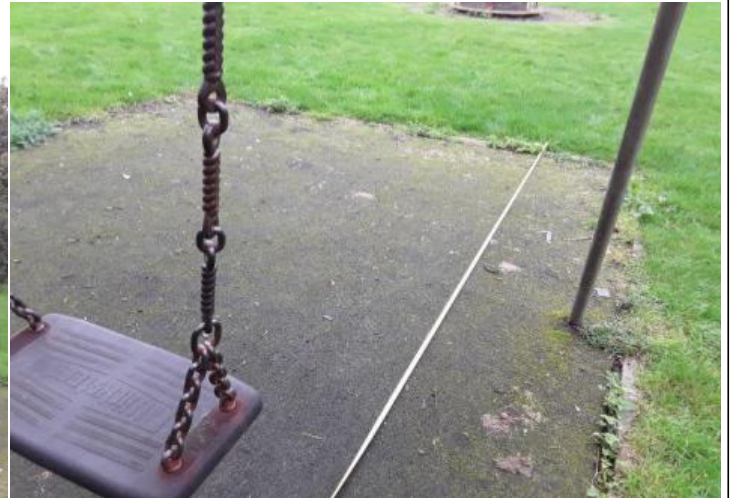
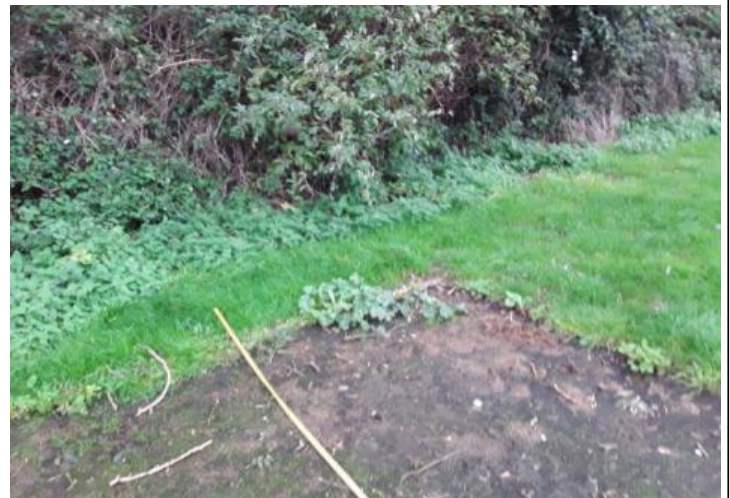
Finding: The surfacing dimensions are short and do not meet with the requirements of the current applicable standard

Action: Monitor - no remedial action recommended
