Pointon Playing Field & Social Club

Asbestos Management Survey Report

Job No: DUA - 1662

Survey Date: 31st March 2021

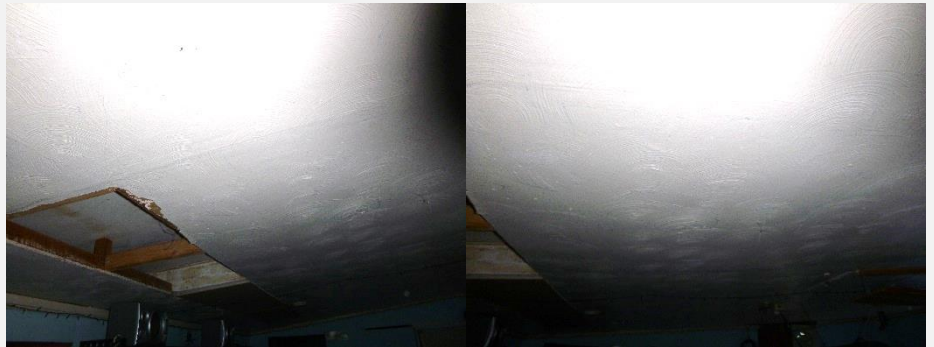
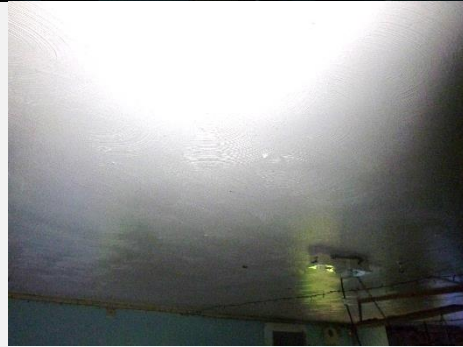
Building:	Main Building
Floor:	Ground
Room/Area:	Bar Area – G 01

NO ASBESTOS DETECTED IN SAMPLE

Item/Location:	Textured coating to plasterboard ceiling
----------------	--

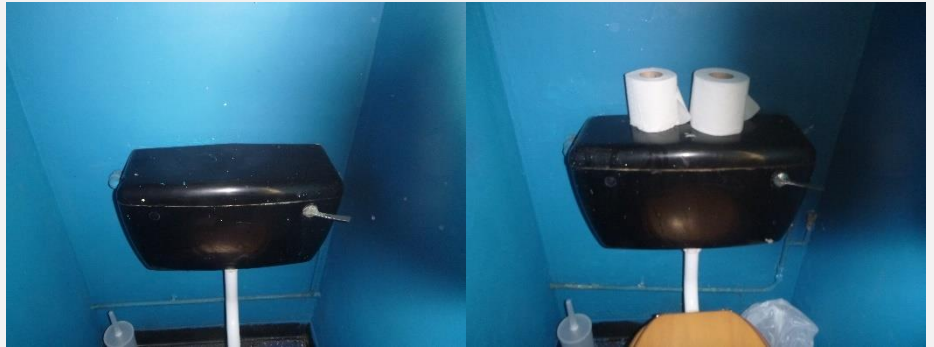
All these items identified above are located within **W.C. – G 07** and are of low damage.

Building:	Main Building
Floor:	Ground
Room/Area:	W/C – G 07
ASBESTOS DETECTED IN SAMPLE	
Level of ID	Identified
Bulk Cert No.	SCO/21/5461
Non- Licensed Material	Yes
Extent	2 Items
Accessibility	Easy

Item/Location:	Shires toilet cistern
----------------	-----------------------

Priority Assessment		Material Assessment		
Normal Occupancy / Activity	1	Product Type	Reinforced plastic	1
Likelihood of Disturbance	2	Condition	Low damage	1
Human Exposure Potential	2	Surface Treatment	Composite	0
Maintenance Activity	0	Asbestos Type	Amosite	2
Priority Assessment Total	5	Material Assessment Total		4

- Asbestos warning signs should be placed on items, where practical.
- Works on these materials would be non-licensed or notifiable non-licensed and should only be undertaken by qualified, trained, and competent persons.
- Re-inspections of condition should be undertaken by competent persons, on a 12-monthly basis.
- All records of re-inspections kept, and asbestos register/asbestos management plan updated.

Recommendation: **Label and Manage**

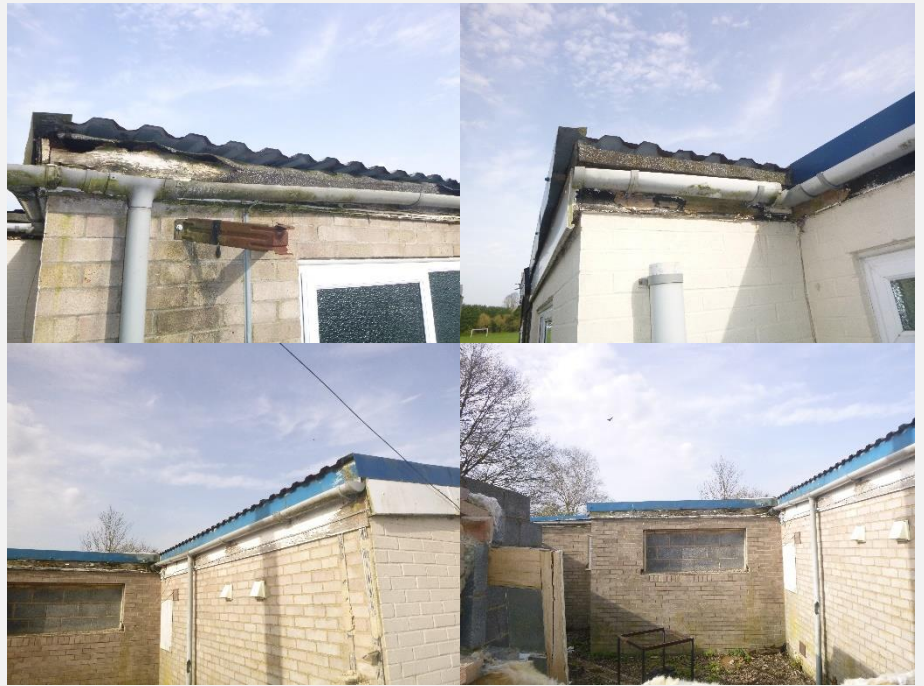
Building:	Main Building
Floor:	Roof
Room/Area:	Roof # 01
NO ASBESTOS DETECTED IN SAMPLE	
Level of ID	Identified
Bulk Cert No.	SCO/21/5461
Non- Licensed Material	-
Extent	160 sq. m
Accessibility	-

Item/Location:	Felt beneath corrugated metal
----------------	-------------------------------
