**JOB No. 24-1080**

**MAR 2024**

**VISUAL INSPECTION REPORT**

**POINTON FOOTBALL CLUB  
POINTON**

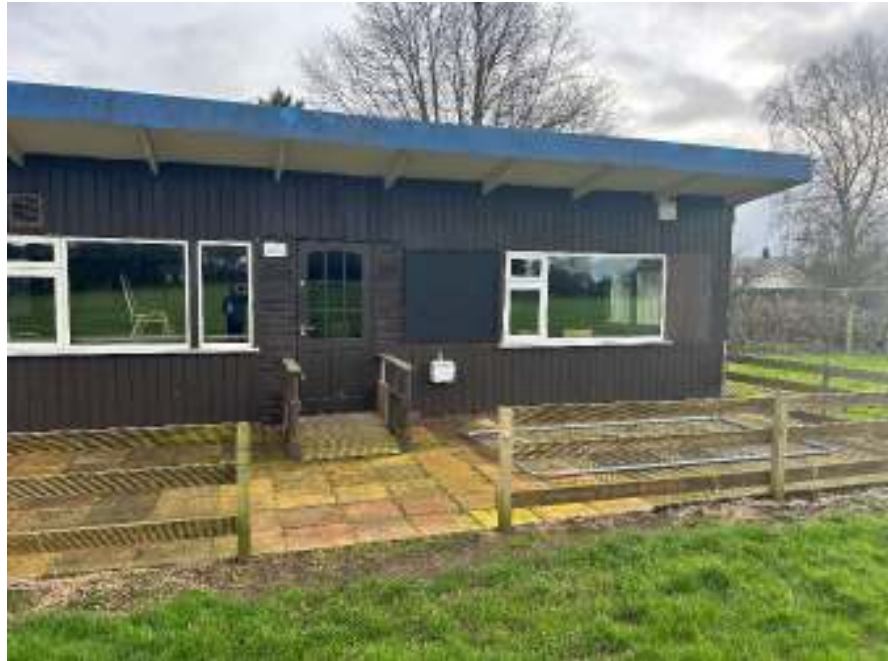
Photo 1

- 3.1 The cladding to the front, north elevation is weathered and starting to show signs of rot
- 3.2 The decking out the front of the building is soft underfoot and shows significant signs of rot as does the timber boards to the handrailing.
- 3.3 There is damage to the brickwork at low level in the southwest corner which has been caused over time due to leaking of the gutters.
- 3.4 The UPVC gutter and associated downpipes are in poor condition with failed joints and missing sections. The fascia boards behind the gutters show significant signs of rot.

Front north  
elevation.

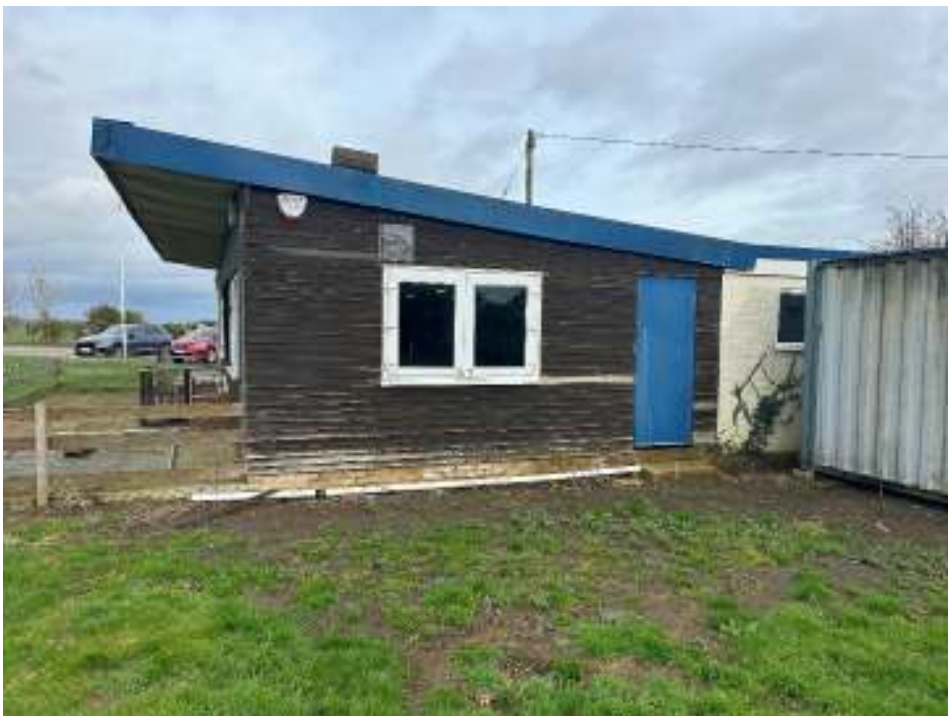
Photo 2

Side, west elevation.

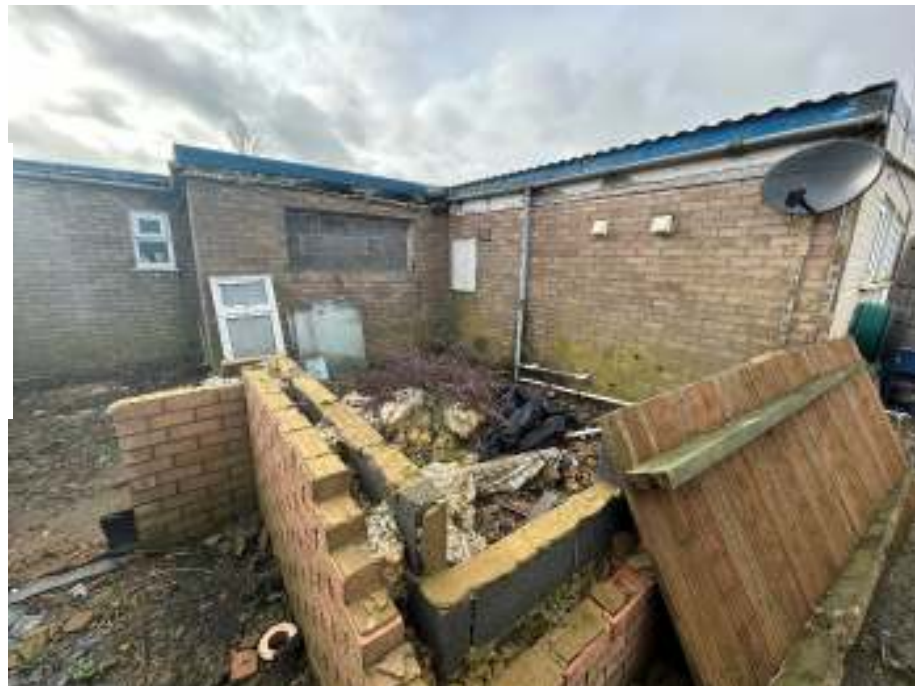
Photo 3

- 3.5 To the east there is a partially built extension with a cavity wall construction which has been left open to the elements. As a result, the insulation within the cavity has been compromised.
- 3.6 The original felt roof has been over sheeted using a profiled metal sheet which doesn't appear to be firmly fixed down. An area of the felt around the edges that is visible is in poor condition. There is an area where the timber boards are exposed and show significant signs of rot.

Rear east elevation.

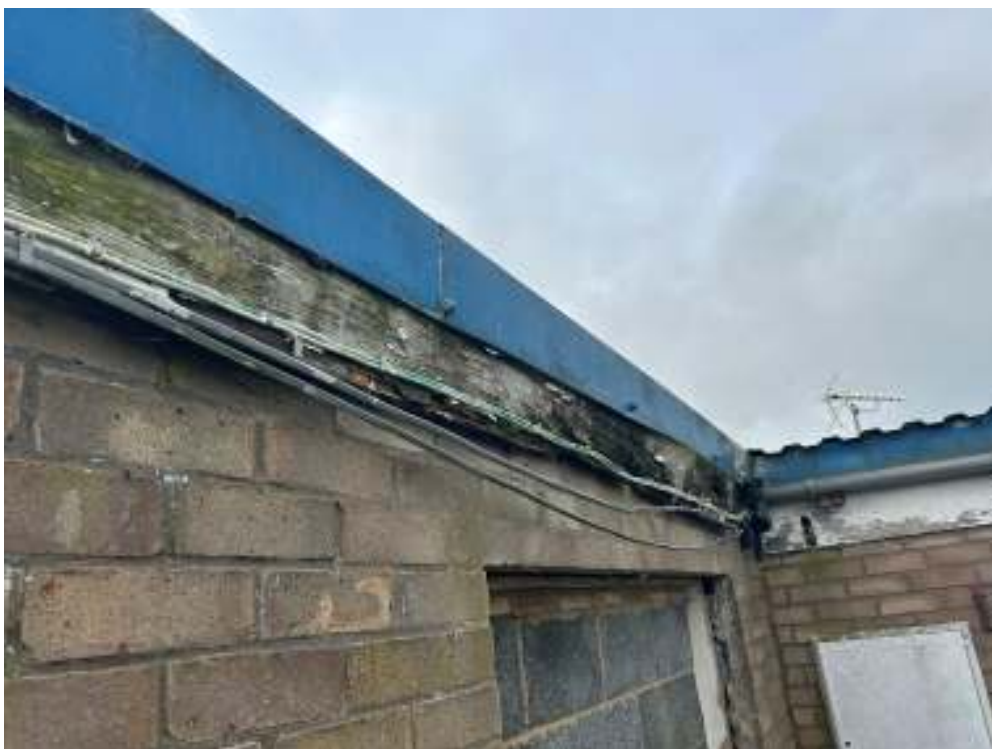
Photo 4

Rotten fascia boards.

- 5.5 All rainwater goods and fascia boards require replacing. Discharge of rainwater should go into the local system, or a suitable soakaway positioned a minimum 5m from any structure.

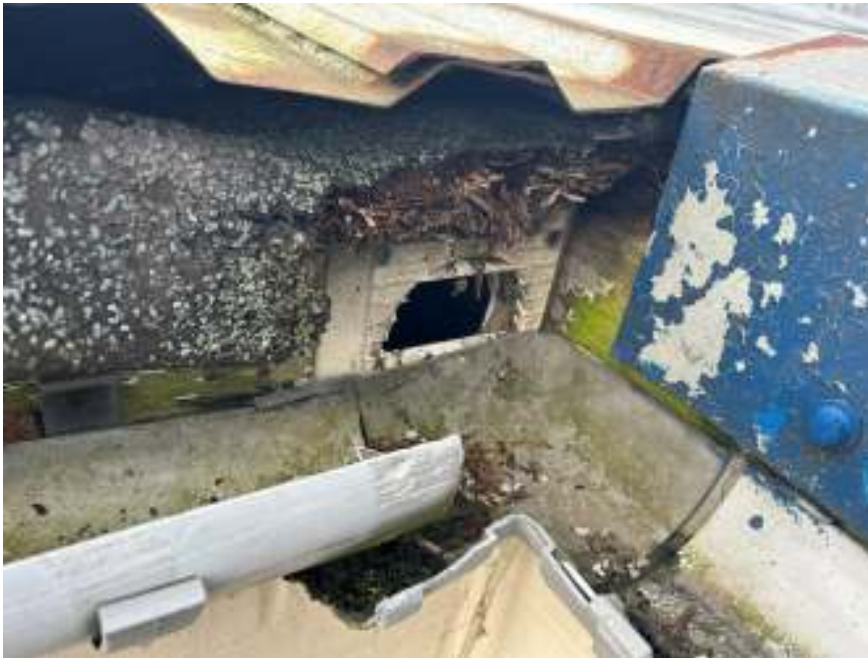
Photo 5

Guttering in poor condition. Roof generally in poor condition

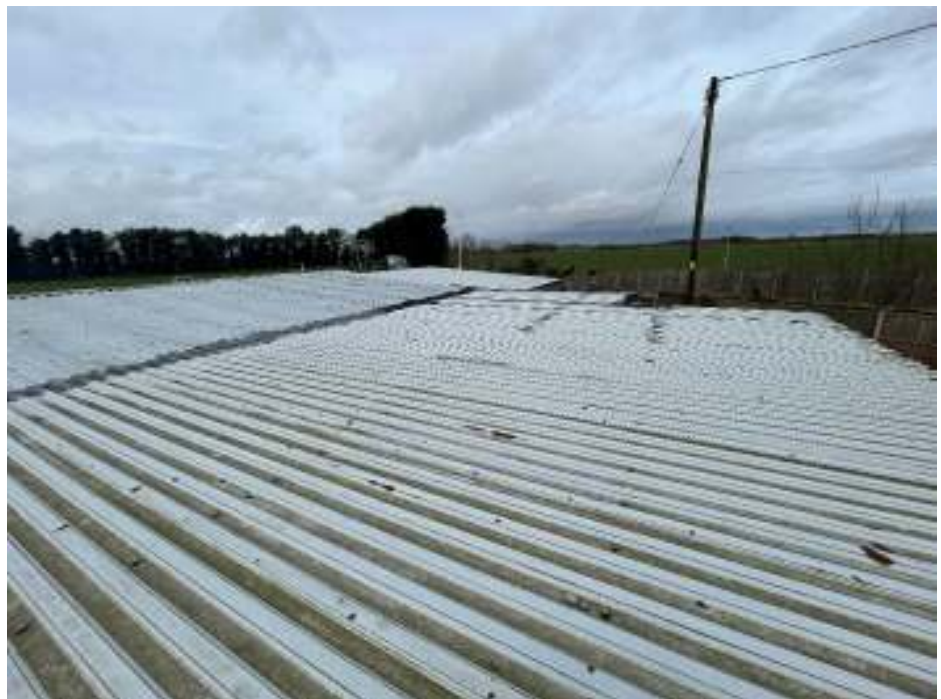
Photo 6

Over sheeted roof panels.

- 5.1 It is clear that there are a number of structural issues as pointed out above. The roof structure has failed in areas, and it is highly likely that other areas of the roof which can't be seen are affected due to water ingress. Should the building be brought back into use then allowance should be made to strip and replace the entire roof.

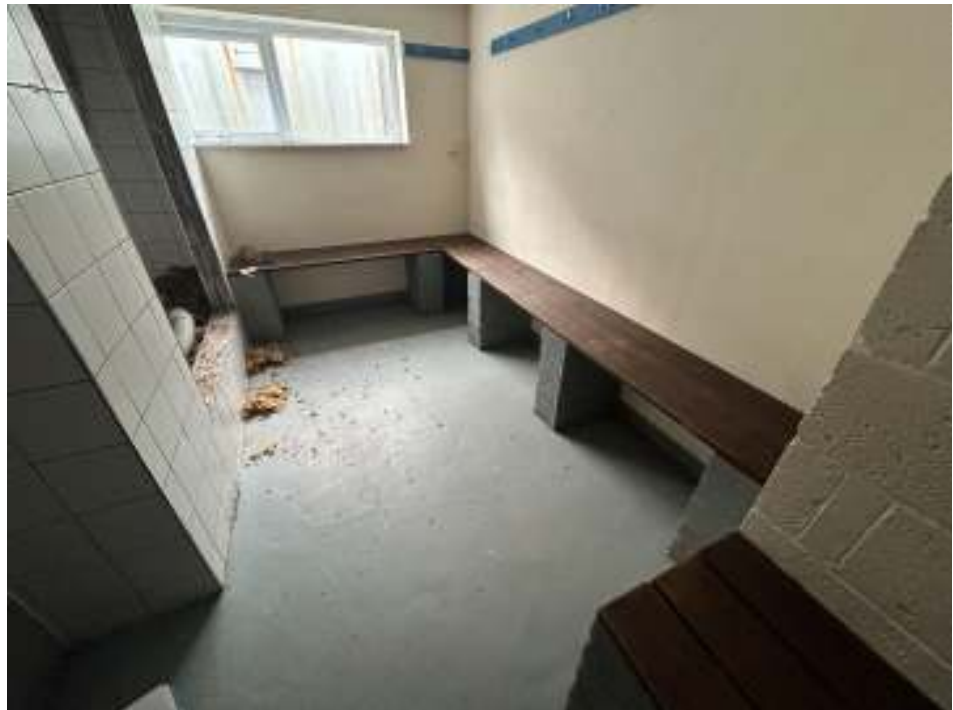
Photo 7

- 4.2 A door leads through to the rear of the premises which houses changing rooms and toilets. Each changing room measures approximately 4.3m x 2.95m including the shower room. In each of the changing rooms there are areas of ceiling that have been damaged by water ingress and the plasterboard ceiling has collapsed revealing the timber roof joists which show considerable signs of rot as does the boards above. It was noted that in the left-hand changing room some parts of the ceiling had been removed to aid inspection but the bulk of it collapsed by itself.

Inside changing room.

- 5.7 Given the current condition of the roof to the changing rooms and toilets we recommend that these areas are taken out of commission and not used for safety reasons.
- 5.8 Generally the property is in poor condition, and it is our opinion that the structure is no longer fit for purpose. Notwithstanding the structural issues, the changing rooms are extremely small 3m x 4.3m 12.9m<sup>2</sup> approx. including the showers, falling short of the current minimum recommendations of 18m<sup>2</sup>.
- 5.9 In addition, we do not consider it to be financially viable to carry out the extensive list of repairs that is required. It is our opinion that consideration should be given to demolition of the property and a purpose-built new facility be constructed subject to the necessary planning permissions.

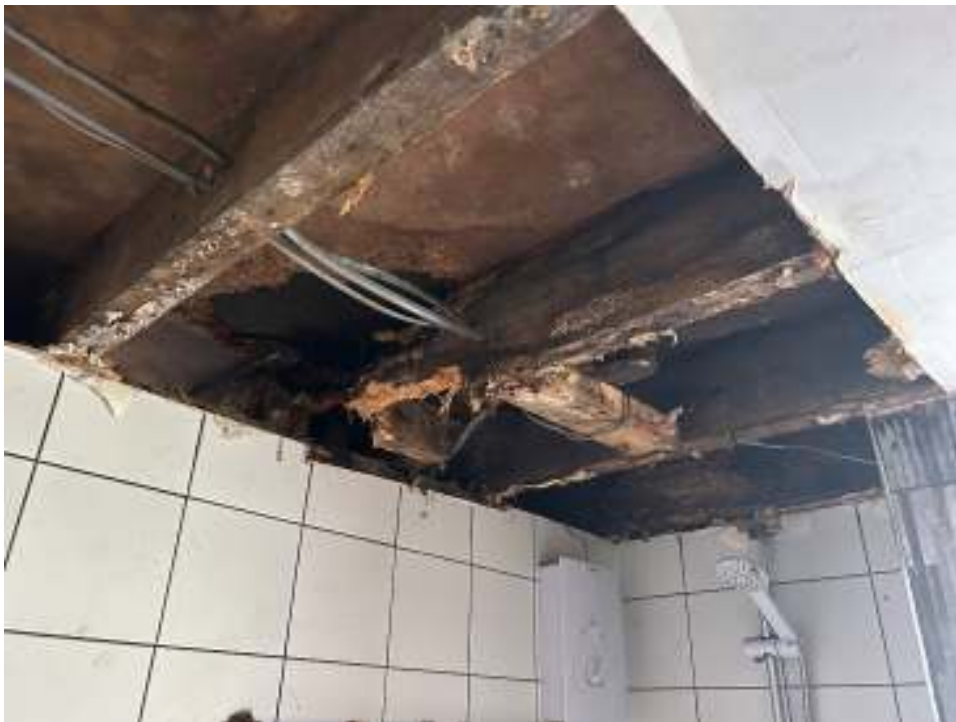
Photo 8

Rotten timber roof members caused by water ingress.

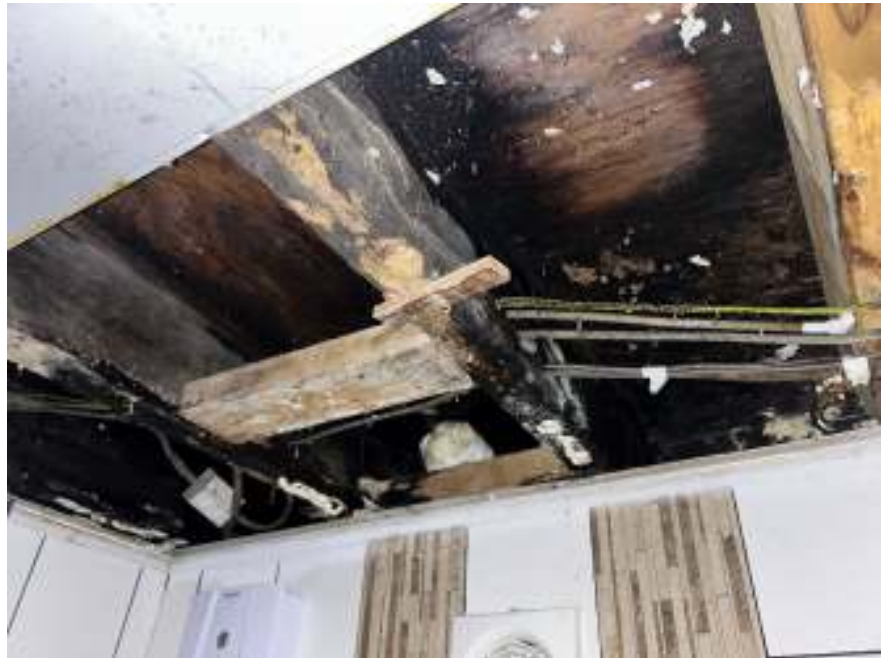
Photo 9

Rotten timber roof members caused by water ingress.

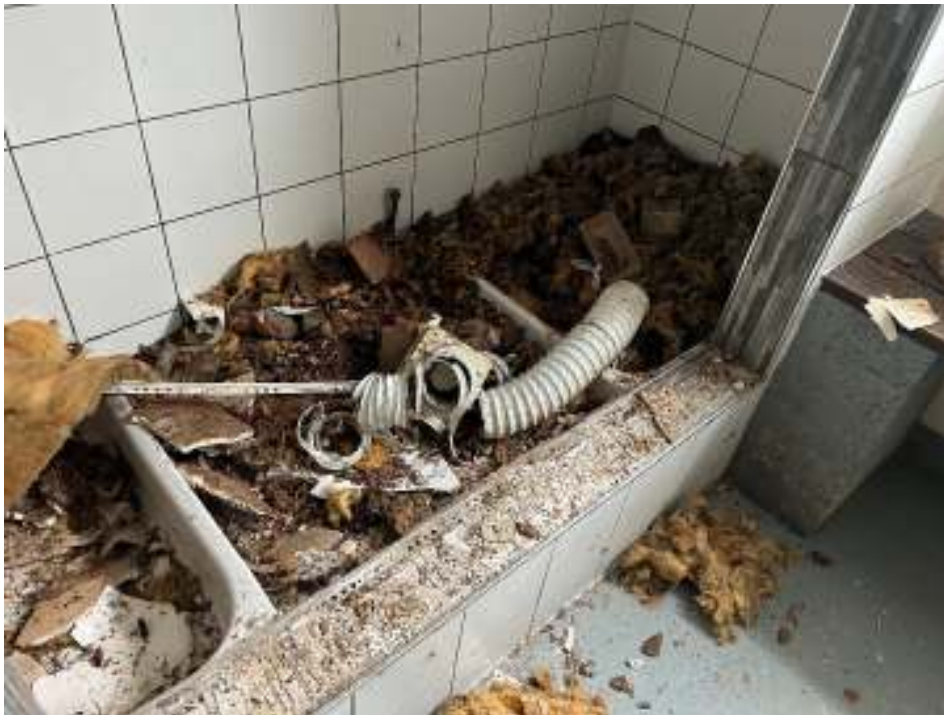
Photo 10

Debris from roof fallen into shower base.

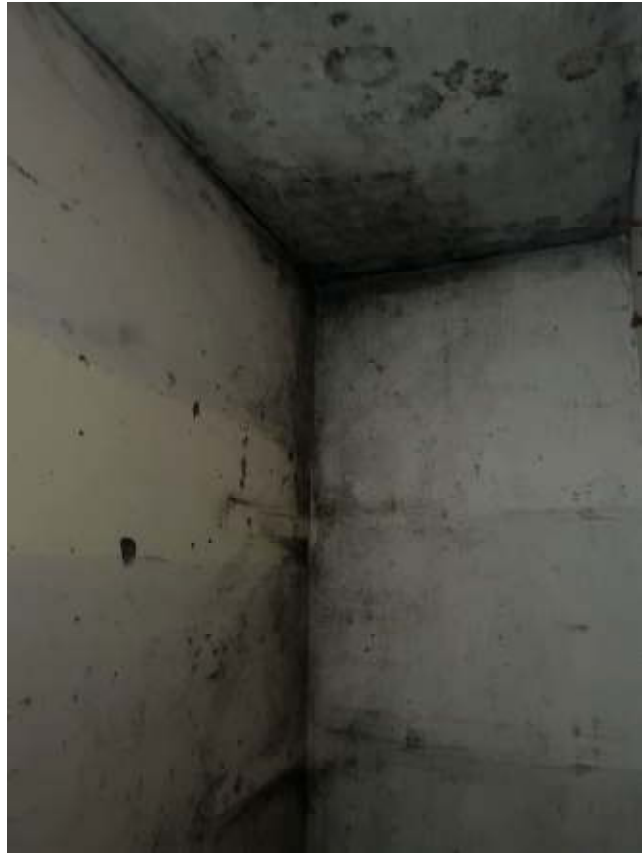
Photo 11

- 4.3 There are numerous areas that house black mould spores on walls and ceiling due to lack of ventilation.

Black mould spores present.

- 5.3 Consideration should be given to introducing suitable ventilation.
- 5.4 We were informed that an asbestos survey had been undertaken in 2001 and it was found that the toilet cistern was found to contain asbestos, but this was the only thing found. Recommendations made in the report for safe removal should be followed if it removed.

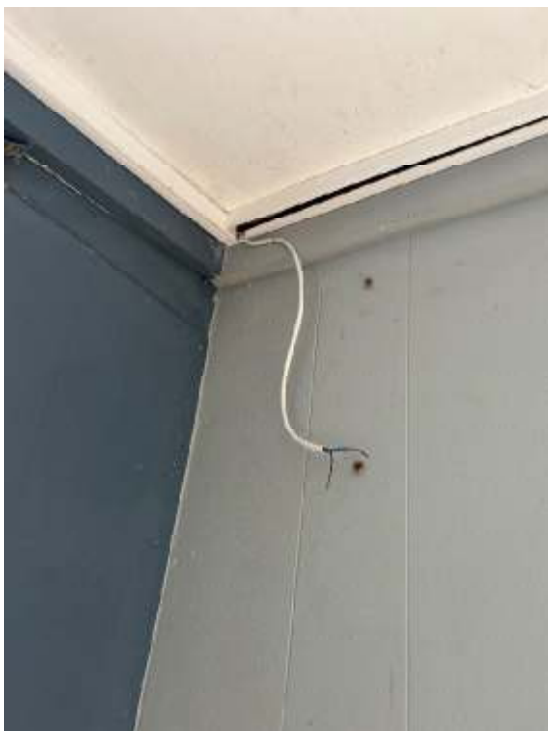
Photo 12

- 4.0 A door in the front, north elevation leads into the main function room with a bar to the east and a kitchen area behind the bar. There are several loose and exposed wires. The flooring in the bar area and kitchen to the rear is in poor condition.

Bare wires exposed.

- 5.2 We recommend that the electrics are tested by a competent qualified electrician before being used as it was mentioned that it has not been wired for commercial use.

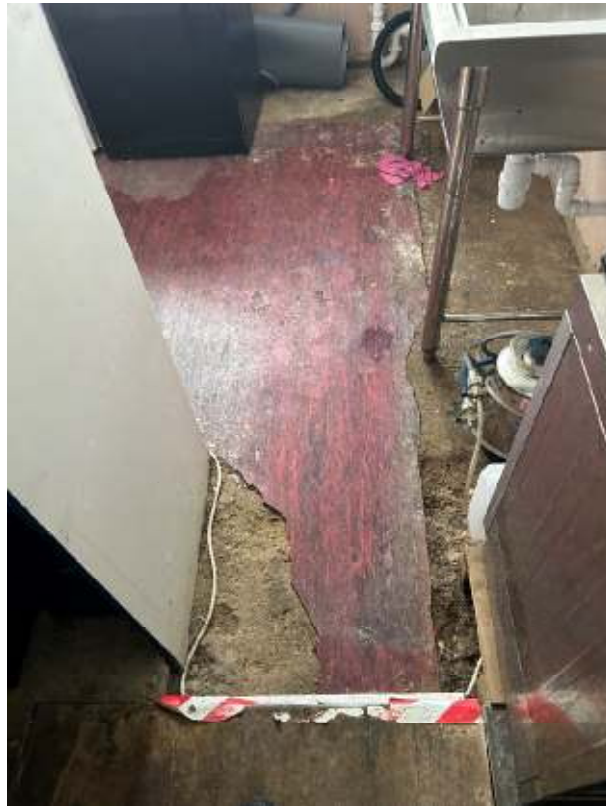
Photo 11

Flooring to kitchen area in poor condition.

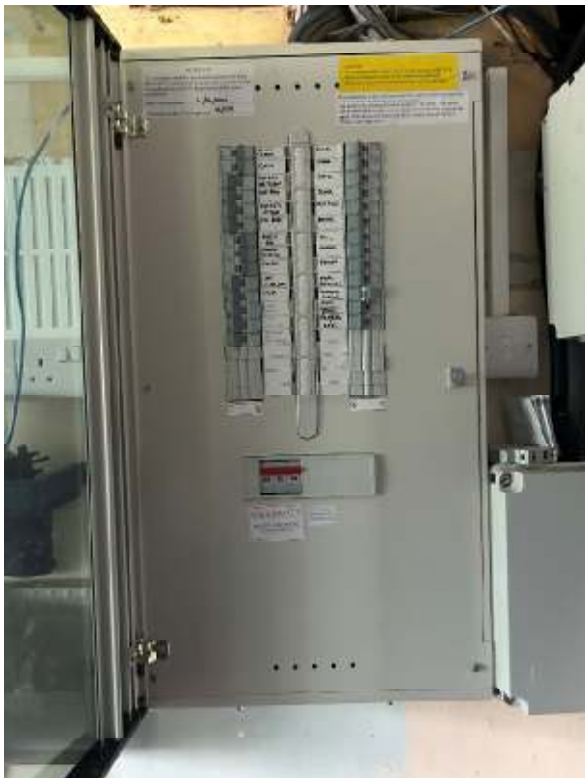
Photo 12

- 4.1 We were informed a qualified electrician has looked at the fuse board and said that it had been wired as a residential property and not for commercial use and for that reason would not pass inspection.

Fuse cupboard wired for residential use not commercial.
