Annual Inspection

Pointon Parish Council

Pointon Playing Field

Fen Road, Pointon, NG34 0LZ

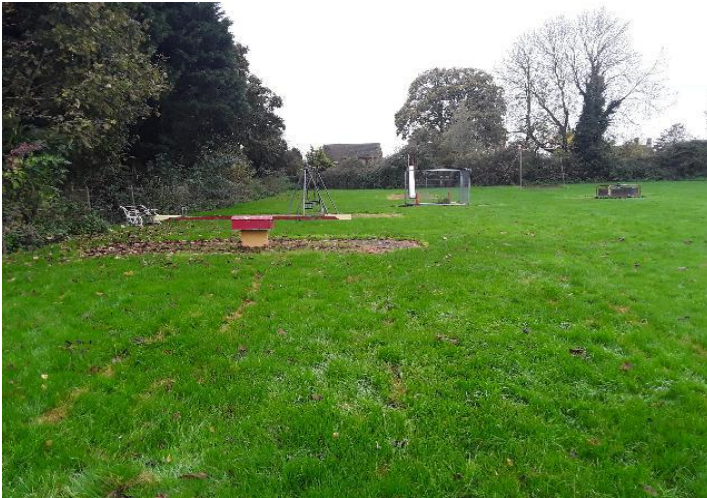
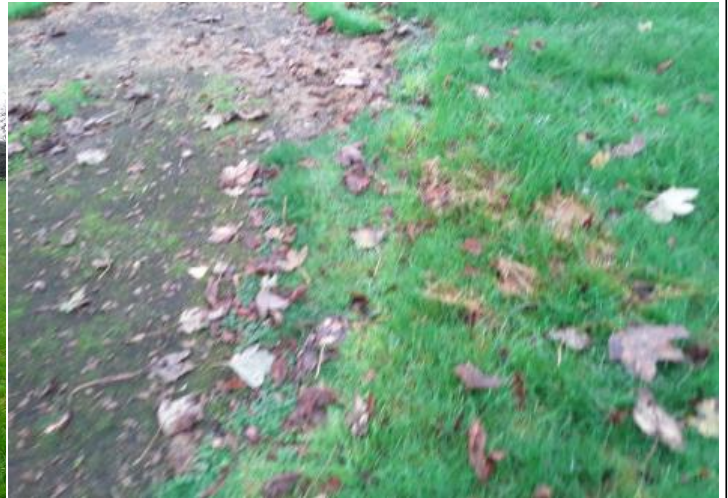
Finding: There is algae, silt or moss growth on the surface resulting in slippery conditions

Action: Clean and treat appropriately

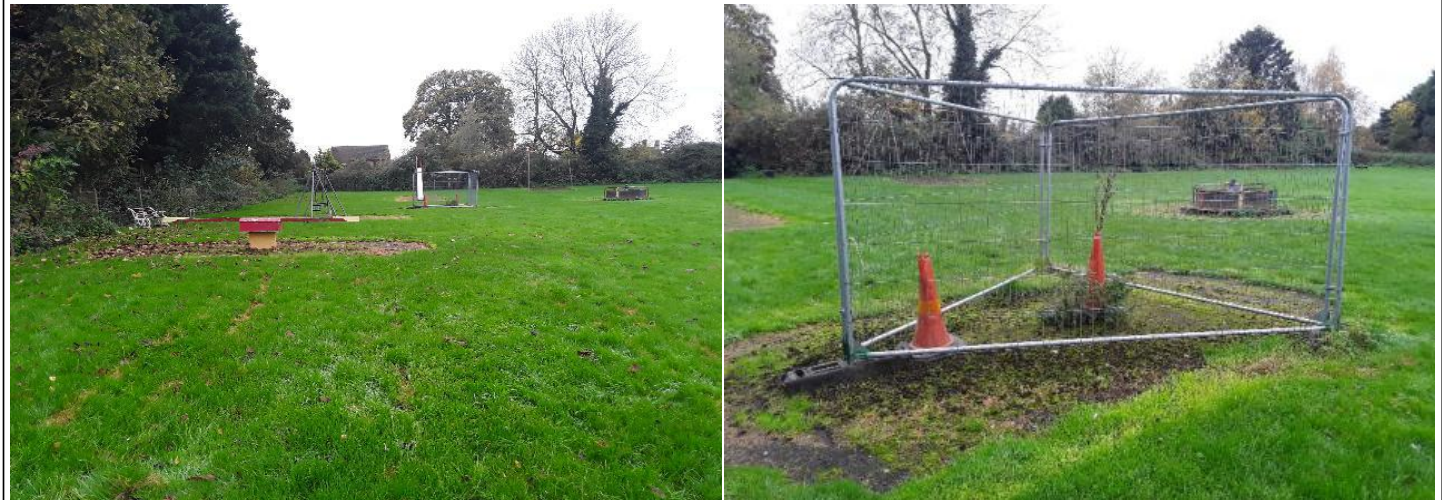
i 6 - Low Risk (Finding 4)

Finding: A redundant damaged area of wet pour has been fenced off preventing access
Action: Consider reinstating the area to grass

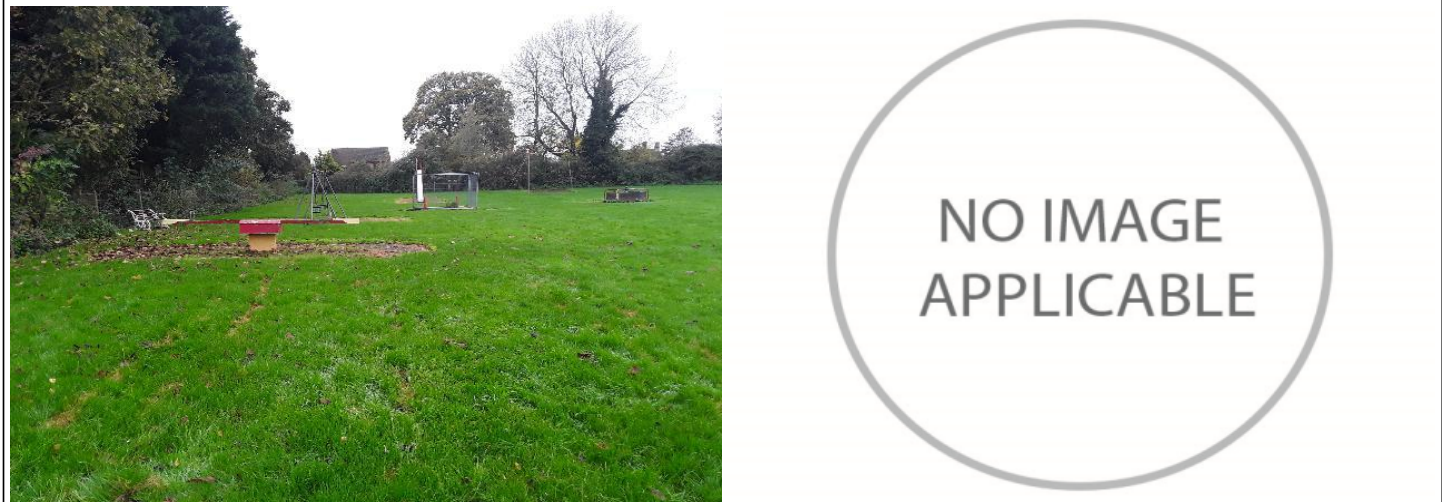
i 5 - Very Low Risk (Finding 1)

Finding: It is recommended that signage, with information including the site address, contact information for maintenance issues and emergency contact details are provided for the facility
Action: Provide in accordance with the recommendations

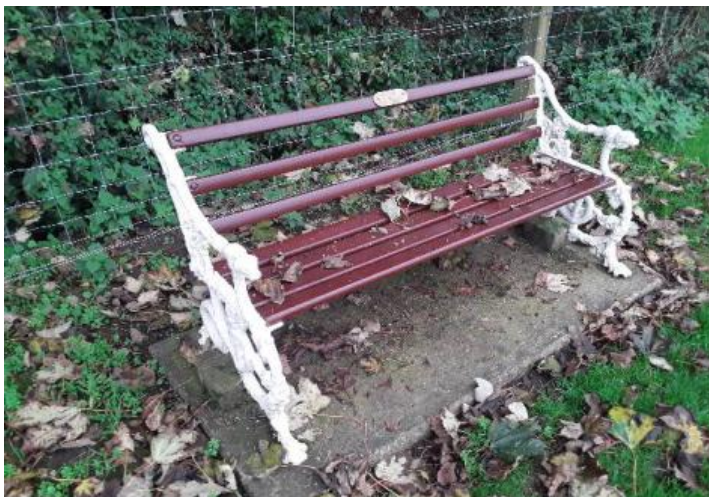
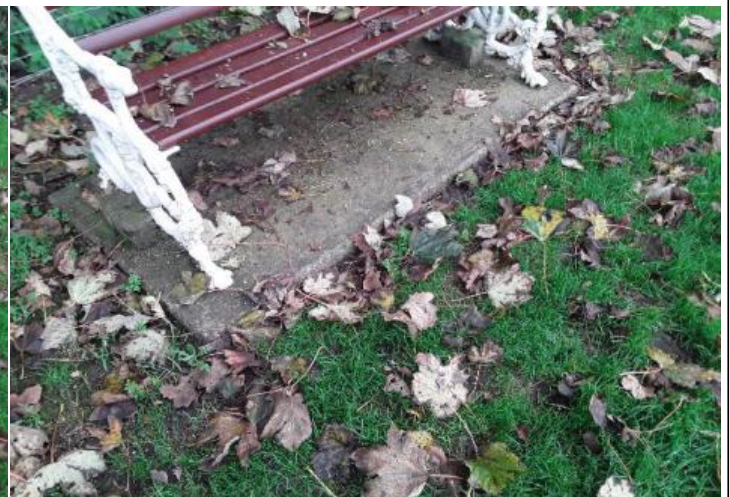
Finding: There are trip hazards present over the concrete base

Action: Remove trip hazard

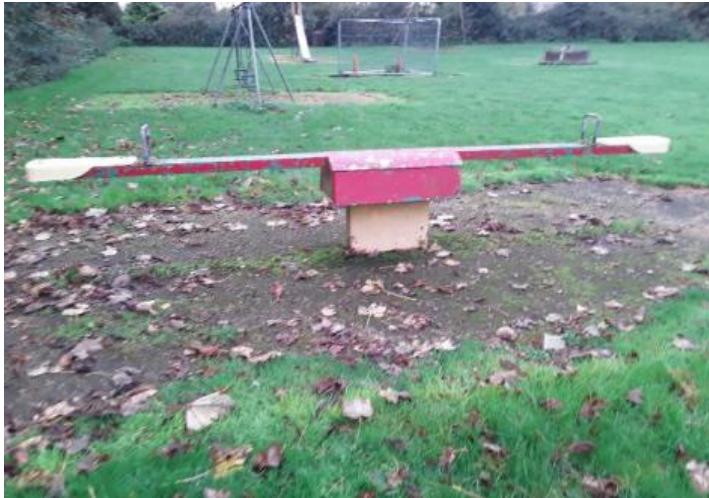
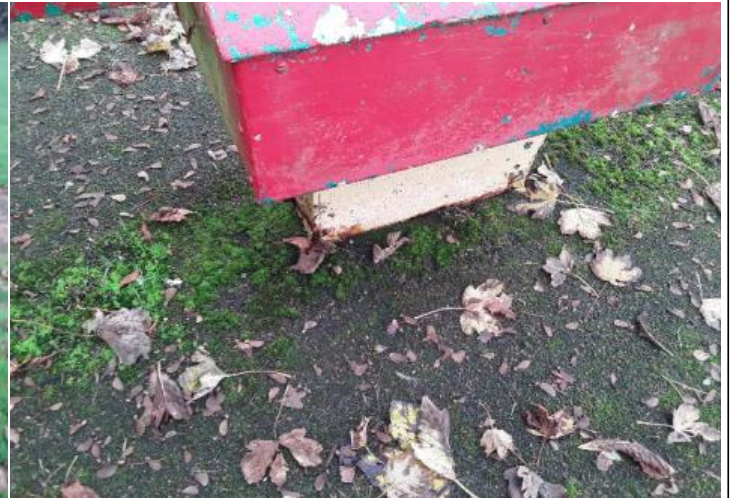
Finding: There is no gaiter protection for accessible moving parts (possible shear trap) as recommended in BS EN 1176 Part 1; 4.2.6 Moving Parts
Action: Monitor - No remedial work recommended

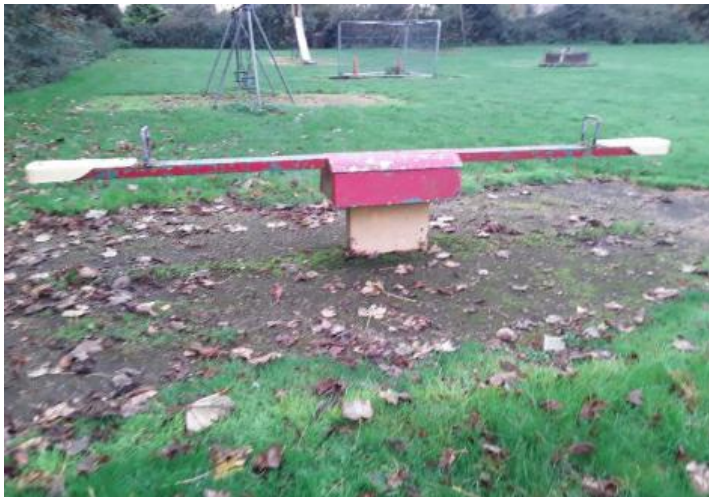
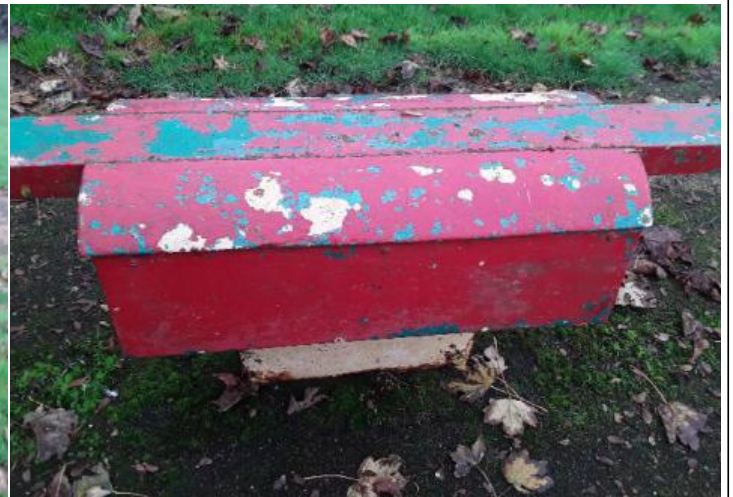
Finding: There is wear damage to the dampening mechanism
Action: Monitor and replace if required

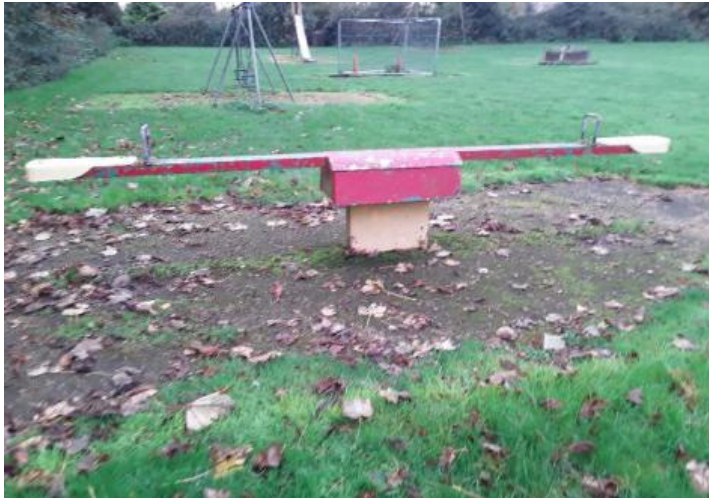
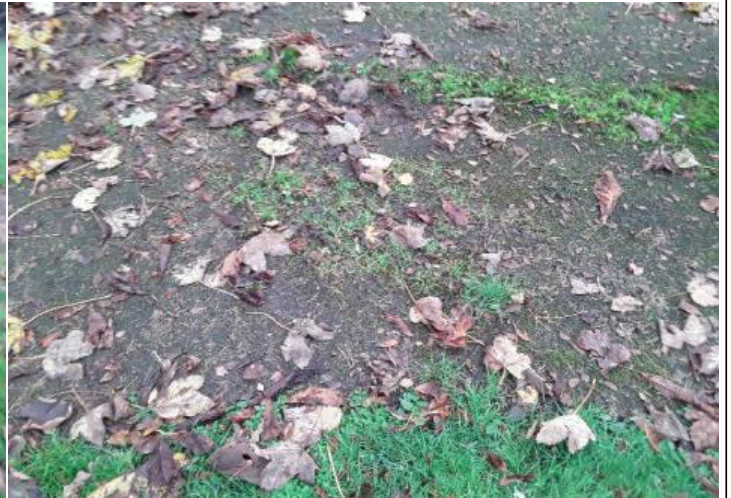
Finding: There is damage to the surface

Action: Repair the damaged areas of surfacing

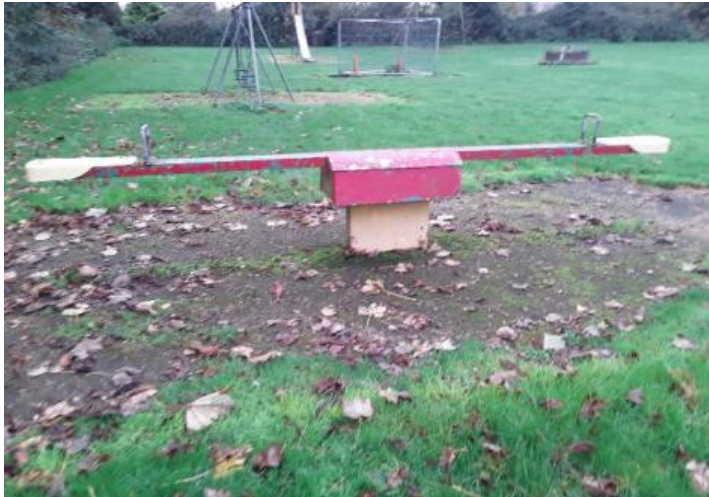
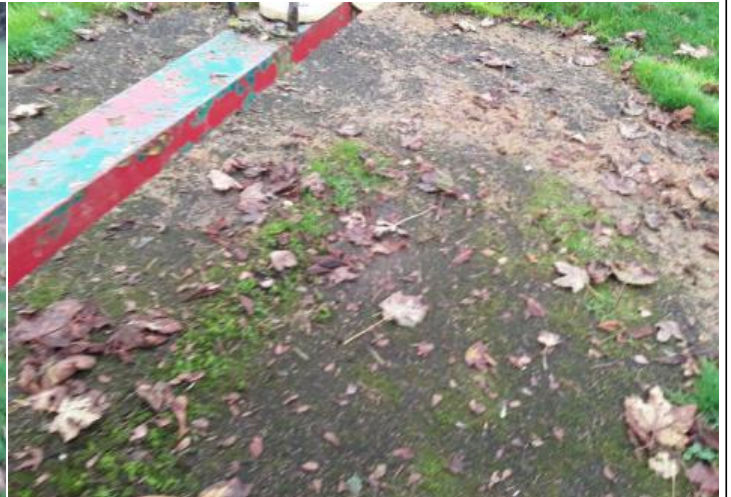
Finding: The surface has subsided in some areas

Action: Monitor for any further deterioration and repair as required

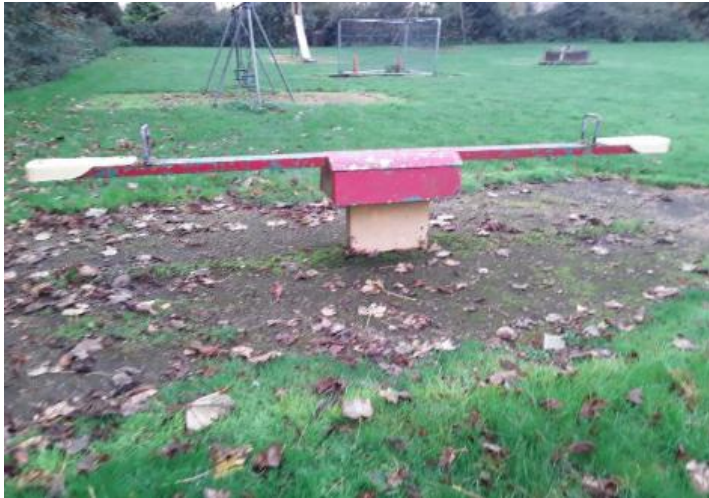
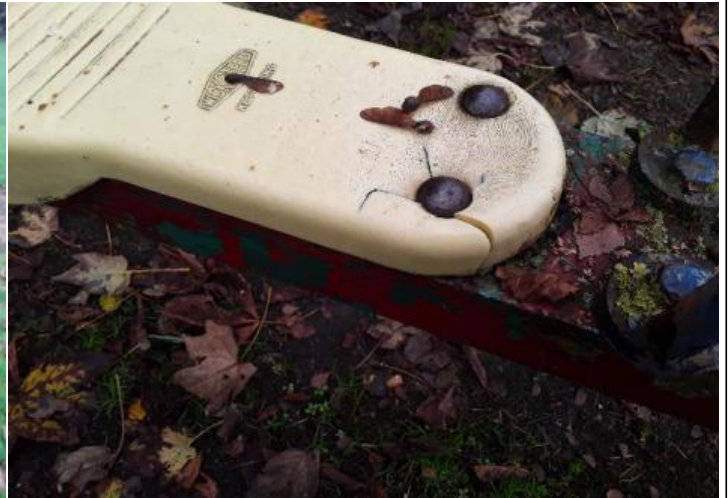
Finding: The seat has minor damage or wear

Action: Monitor for any further deterioration and replace as required

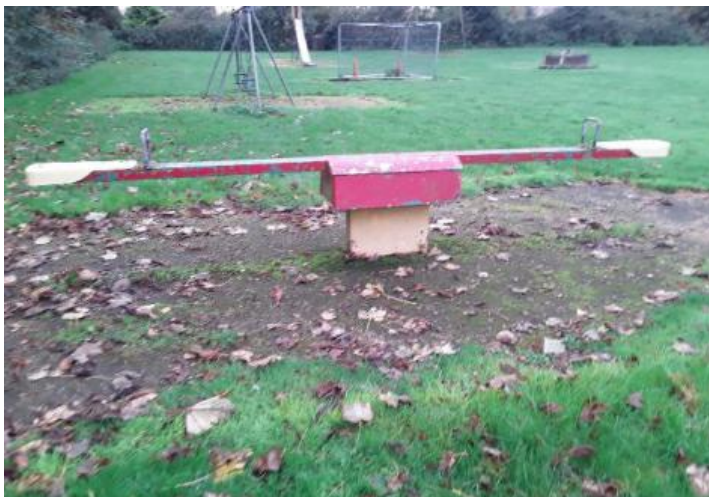
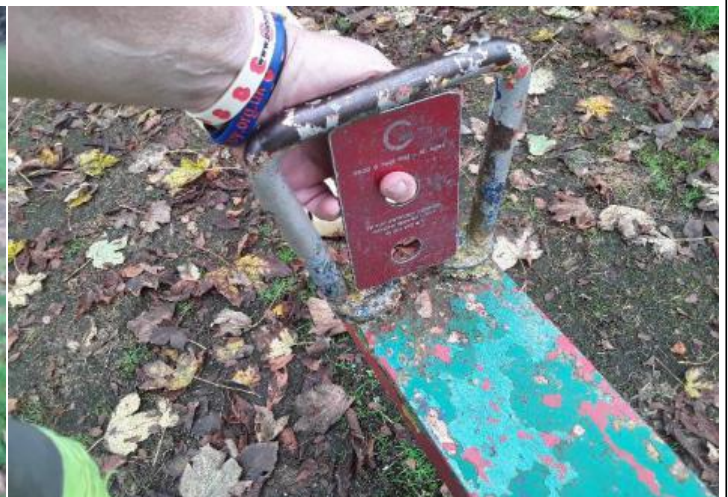
Finding: The item fails to meet the requirements of BS EN 1176 Part 1 4.2.7.2 for head and neck entrapment in the handgrip openings

Action: Monitor - No remedial work recommended

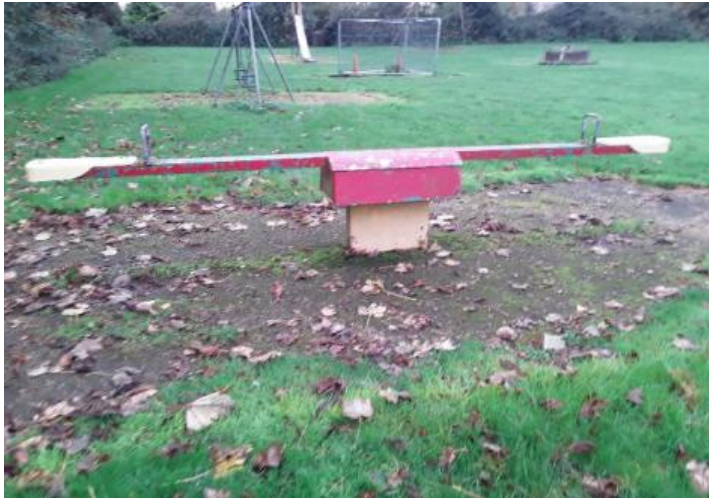
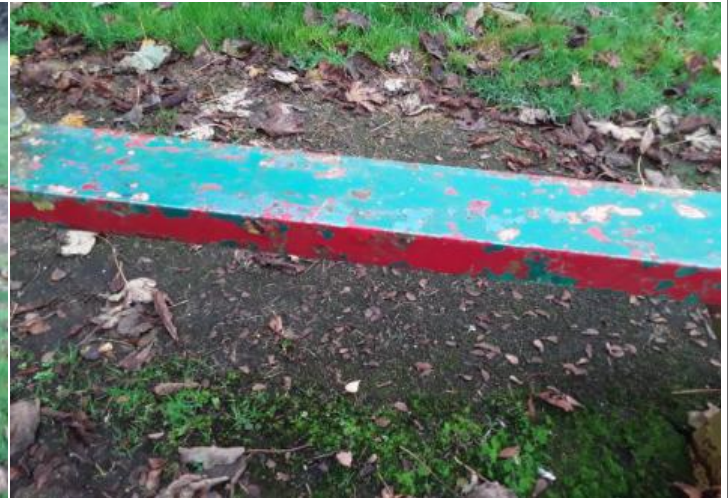
Finding: There is surface corrosion / rust present on the item	Action: Consider treating the item
---	---

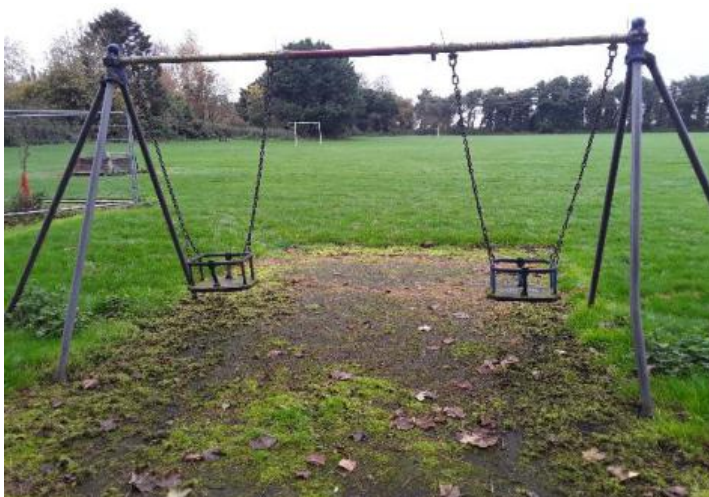
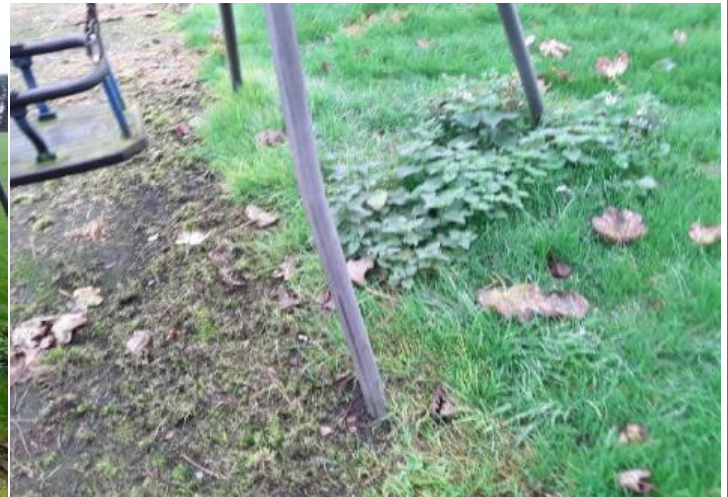
Finding: There is minor distortion damage to the leg	Action: Monitor and repair if required
---	---

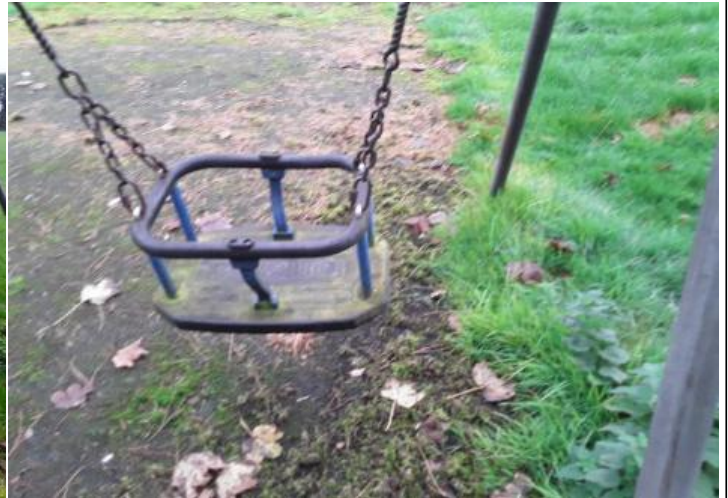
Finding: The seats are too close to the frame as defined in BS EN 1176 Part 2; this is a low risk failure and no remedial action is required

Action: Monitor - No remedial work recommended

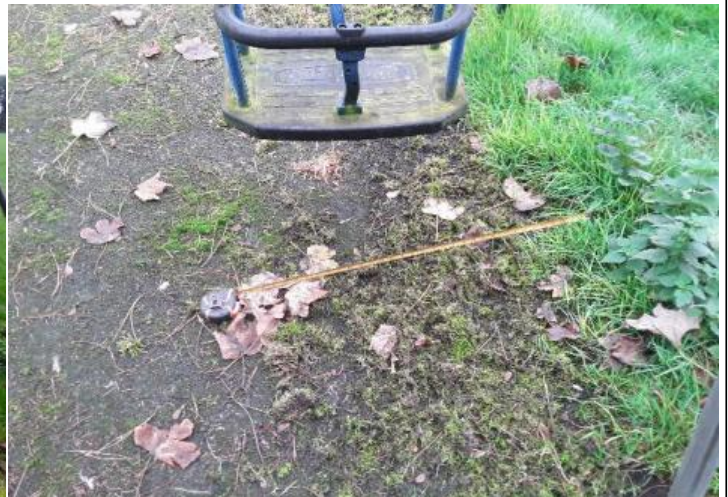
Finding: The surfacing width under the seat/s is / are less than 875mm when measured from the centre of the seat outwards, and fails the requirements of BS EN 1176 Part 2

Action: Monitor - No remedial work recommended

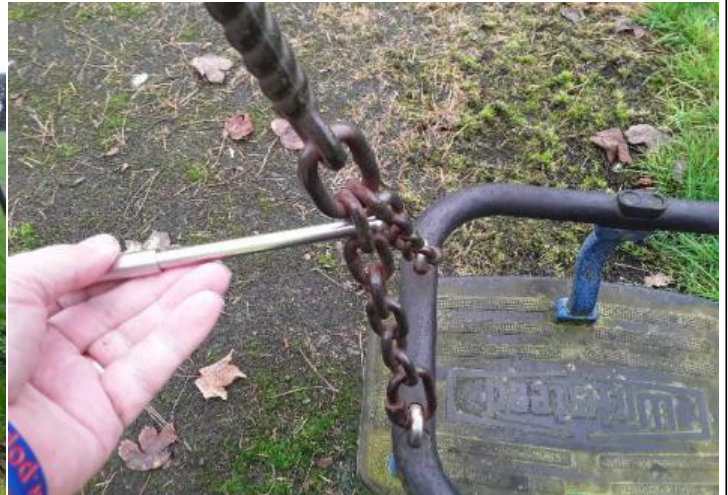
Finding: The chain openings are in excess of the 8.6mm as recommended by BS EN 1176 **Action:** Monitor - No remedial work recommended

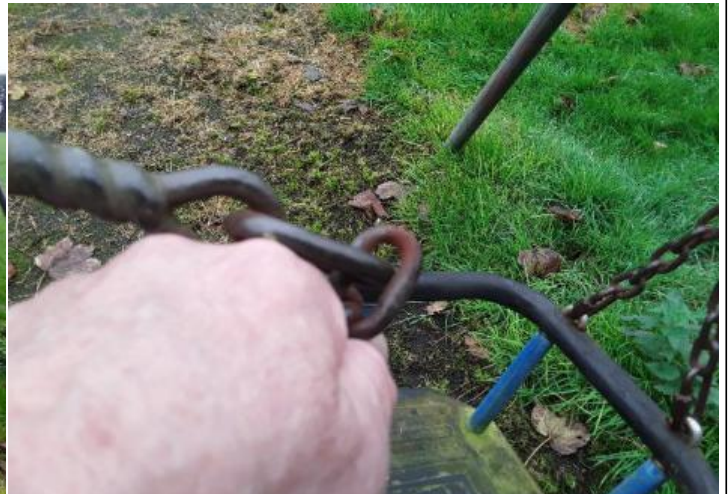
Finding: There is some notable evidence of chain wear **Action:** Monitor for any further deterioration and replace when 40% worn

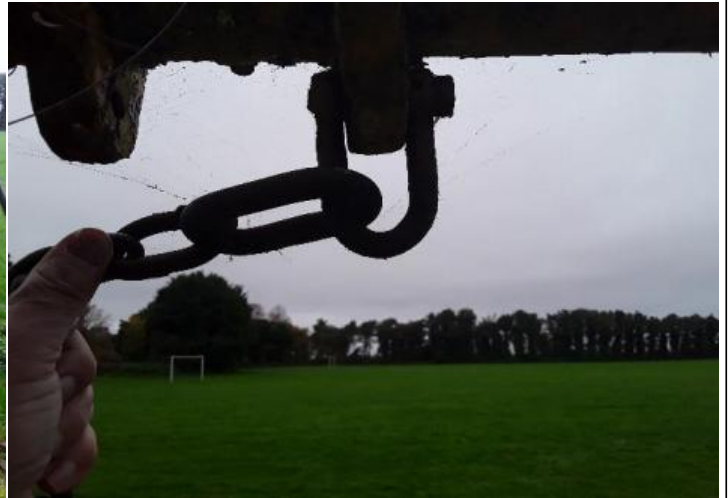
Finding: There is some wear to the shackles.

Action: Monitor for any further deterioration and replace when 40% worn

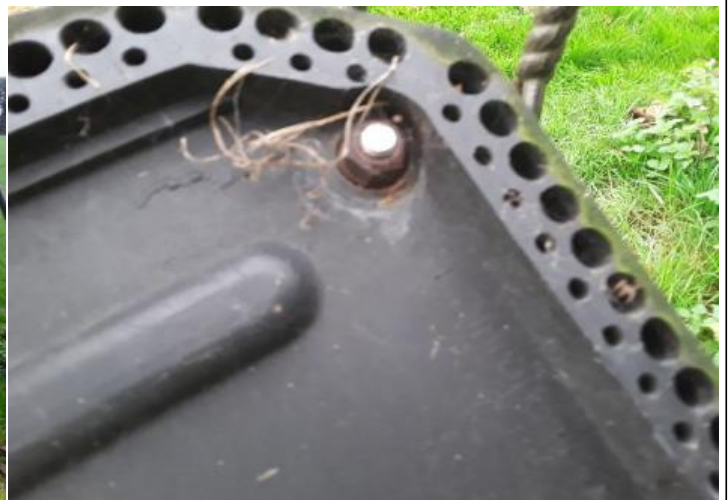
Finding: The fixings have corroded

Action: Replace all corroded fixings

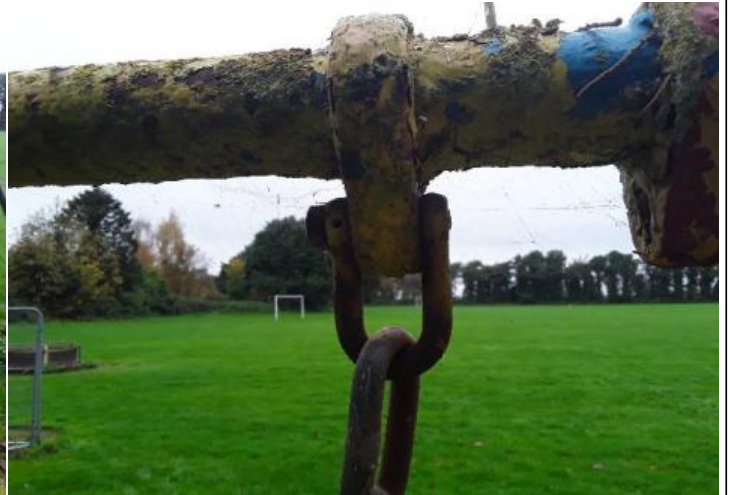
Finding: The split pins are missing from the shackles

Action: Insert split pins to secure the shackles

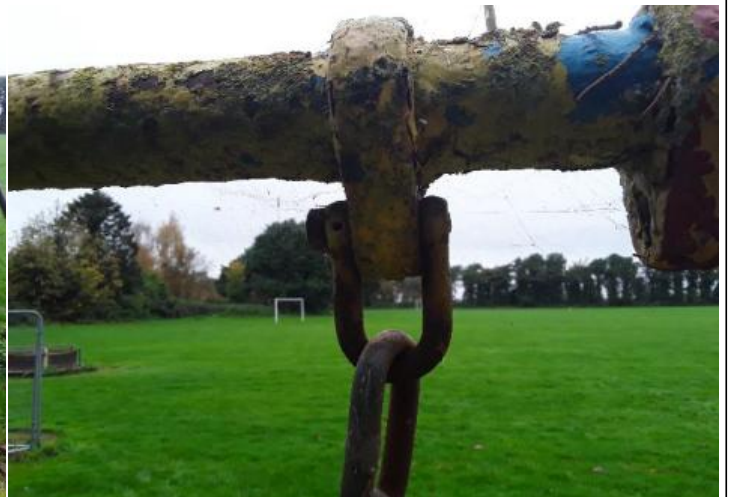
Finding: There is surface corrosion / rust present on the item

Action: Consider treating the item

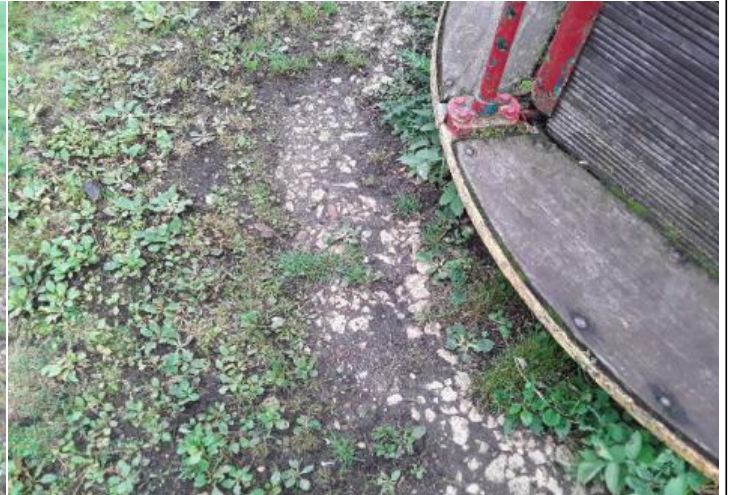
Finding: The safety surface has degraded / reduced and the concrete foundations are exposed

Action: Replace the missing safety surface

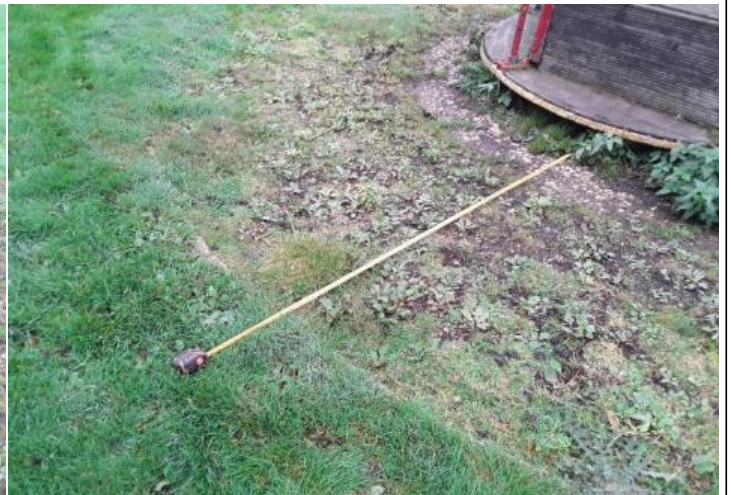
Finding: The surfacing dimensions are short and do not meet with the requirements of the current applicable standard

Action: Monitor - no remedial action recommended

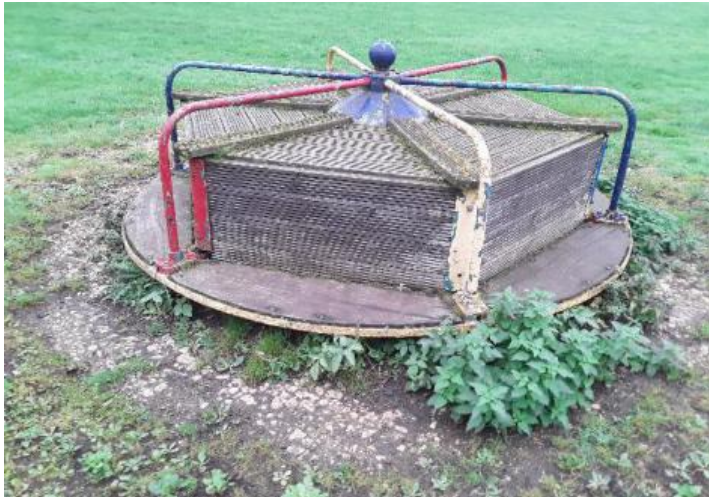
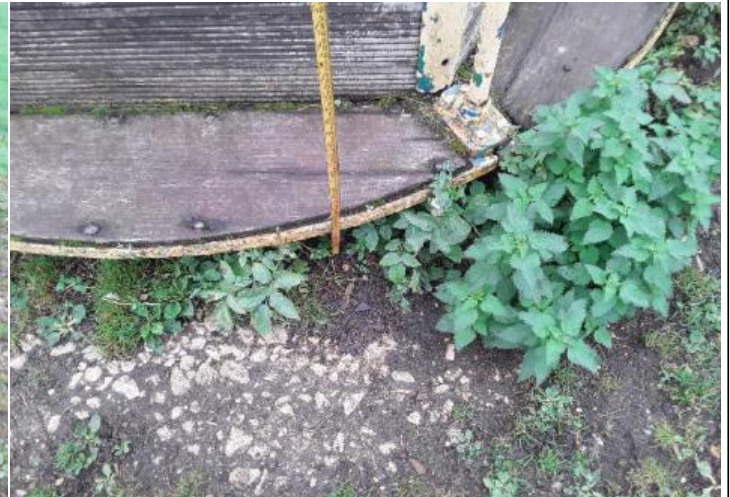
Finding: The distance between the underside of the roundabout platform and the playing surface is in excess of 110mm and contravenes the requirements of BS EN 1176 Part 5 which requires that the distance be maintained between 60mm-110mm - for the entire circumference of the roundabout

Action: Replace the safety surface

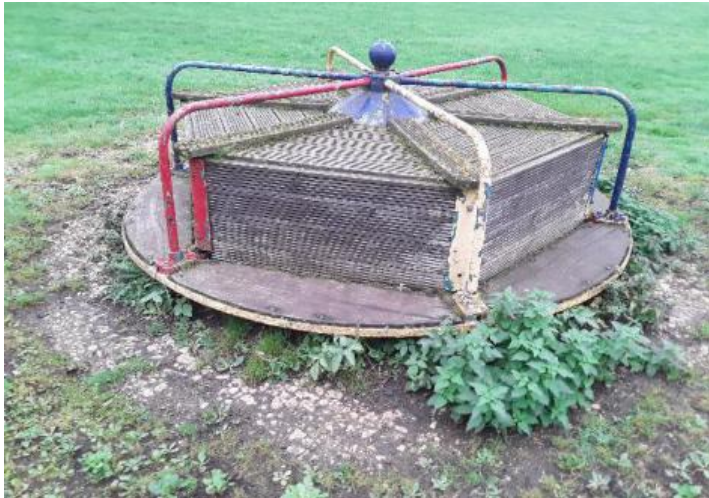
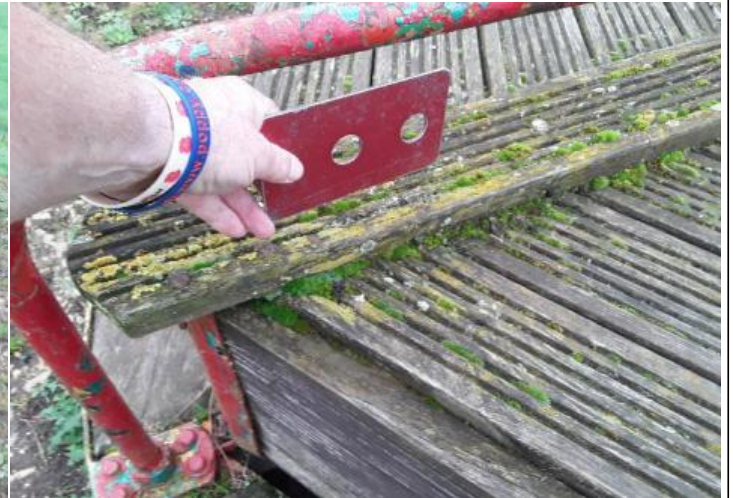
Finding: The item fails to meet the requirements of BS EN 1176 Part 1 4.2.7.2 for head and neck entrapment in the handgrip openings

Action: Monitor - No remedial work recommended

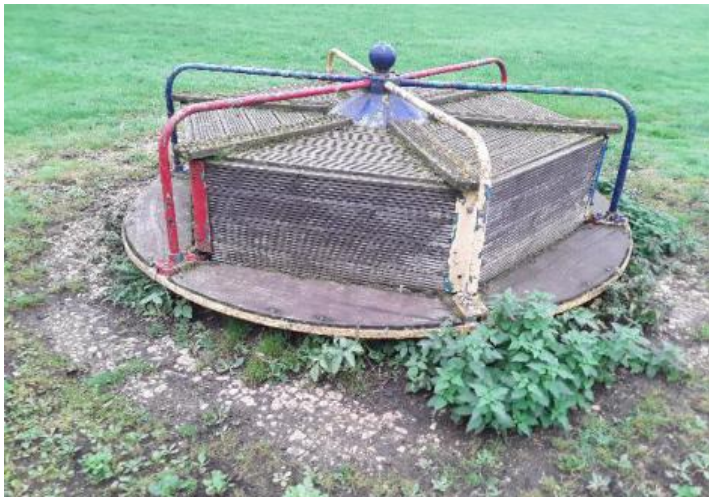
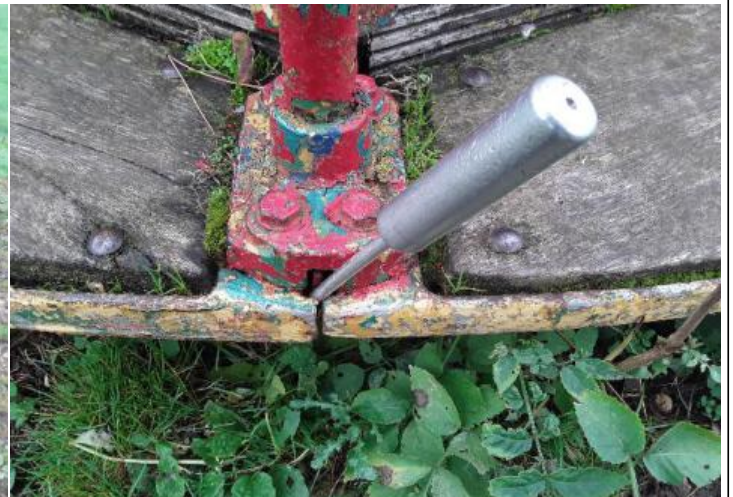
Finding: There is/are finger entrapment/s in the structure and the item fails to meet the requirements of BS EN 1176 Part 1 4.2.7.6 Entrapment of fingers

Action: Monitor - No remedial work recommended

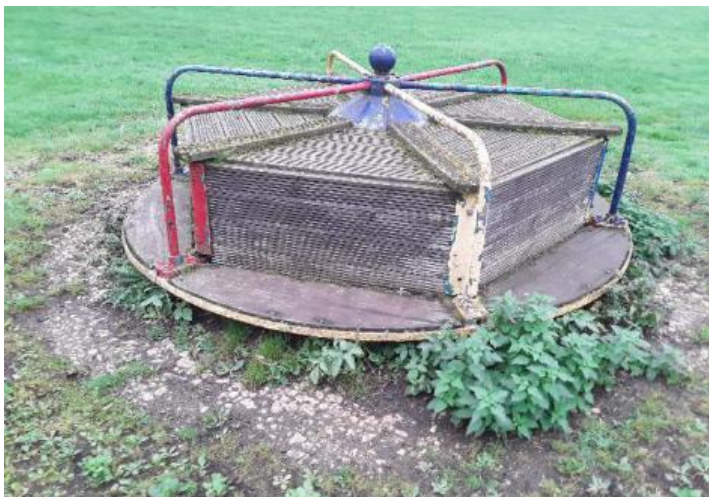
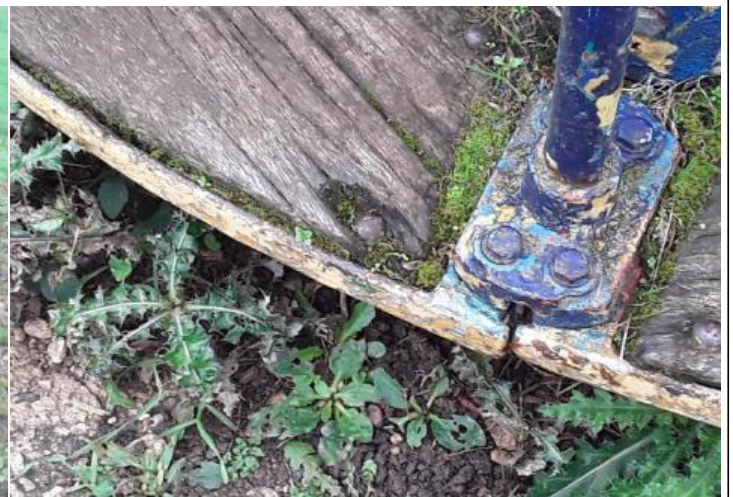
Finding: There are parts of the timber around the fixing points that have rotted

Action: Replace all affected timbers

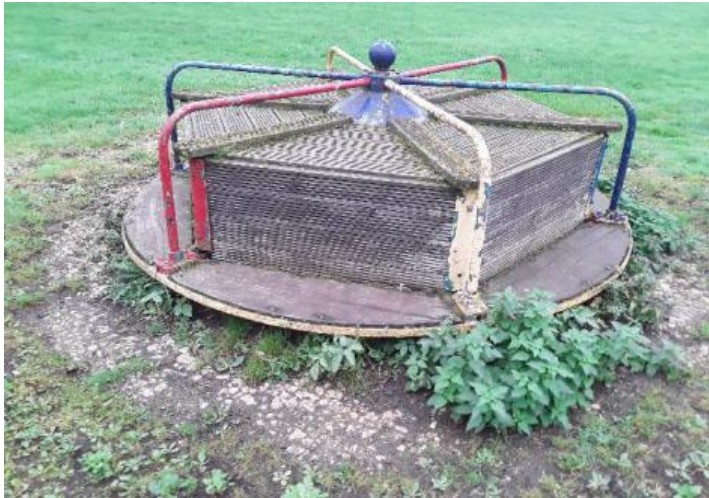
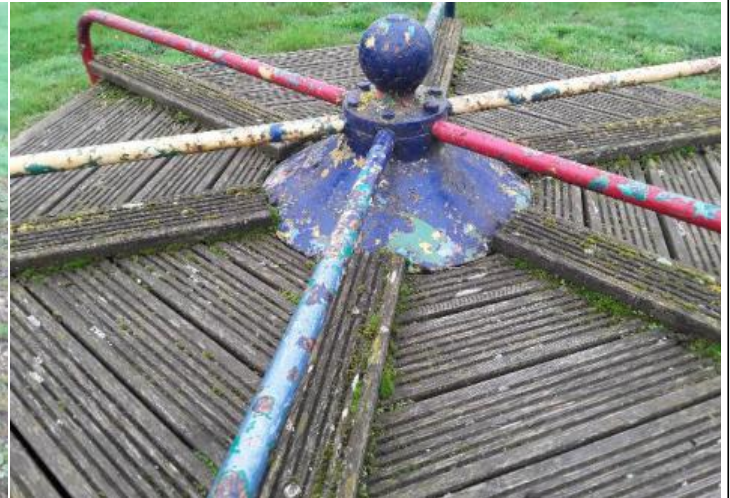
Finding: The bearing is showing signs of wear

Action: Monitor for any further deterioration and replace as required

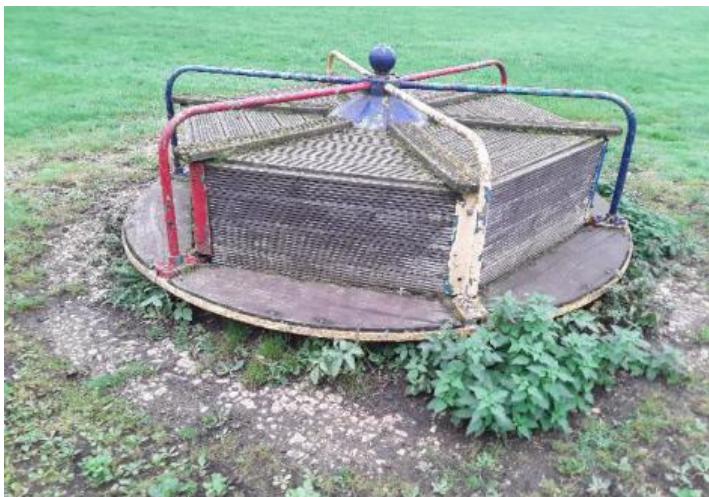
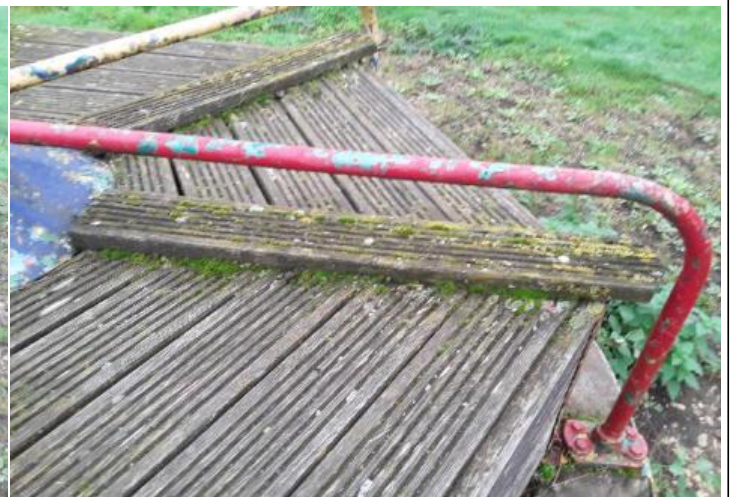
Finding: There is surface corrosion / rust present on the item

Action: Consider treating the item

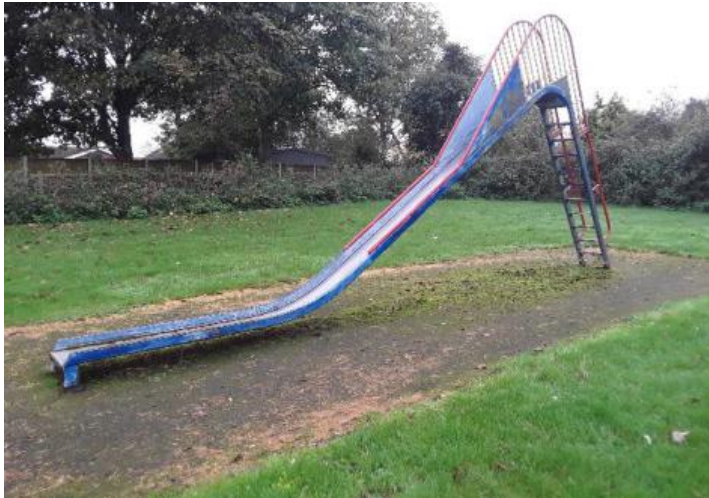
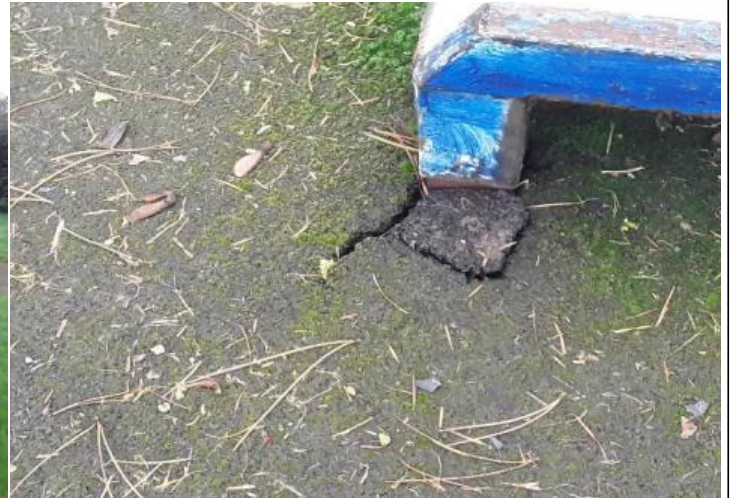
Finding: There is damage to the surface

Action: Repair the damaged areas of surfacing

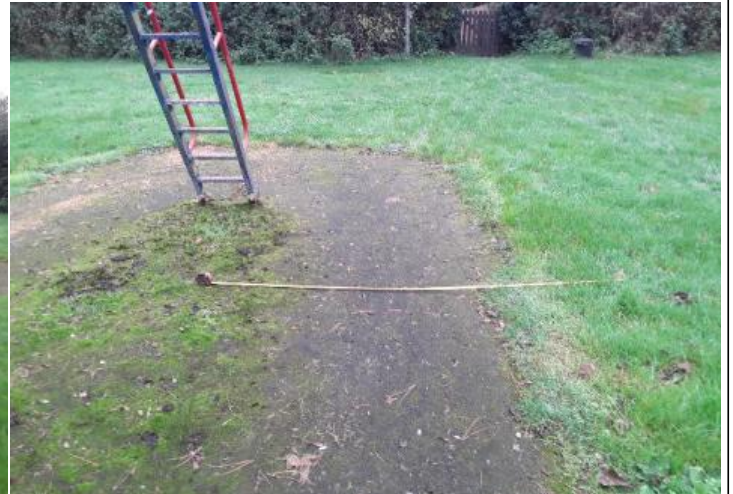
Finding: The surfacing dimensions are short and do not meet with the requirements of the current applicable standard

Action: Monitor - no remedial action recommended

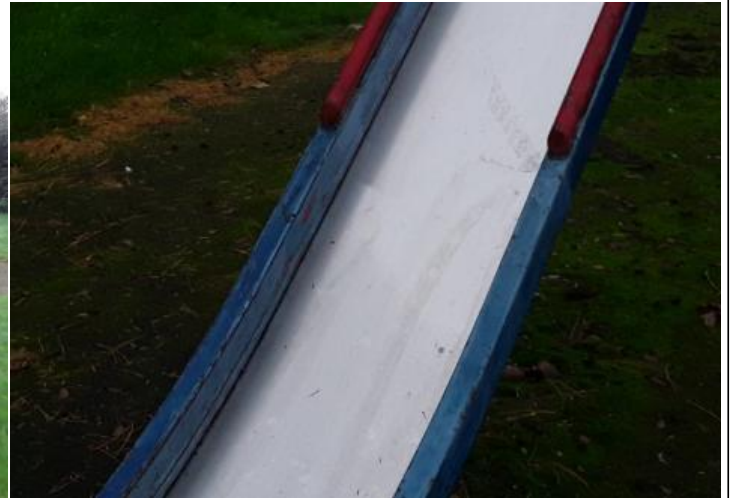
Finding: There are a number of dents in the slide surface

Action: Monitor for any further deterioration and repair as required

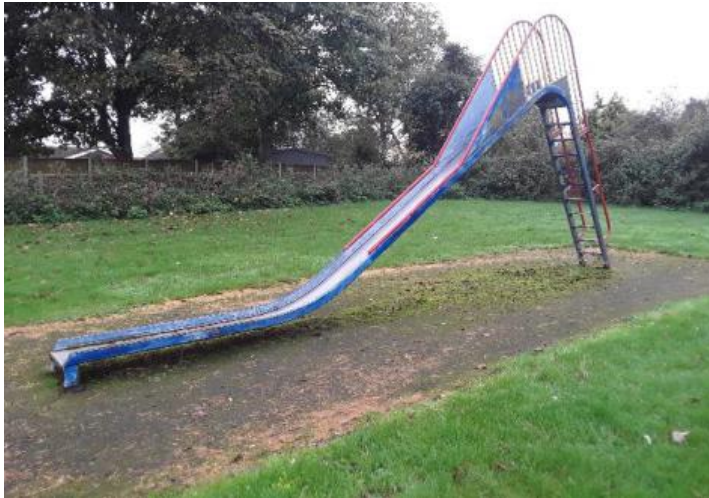
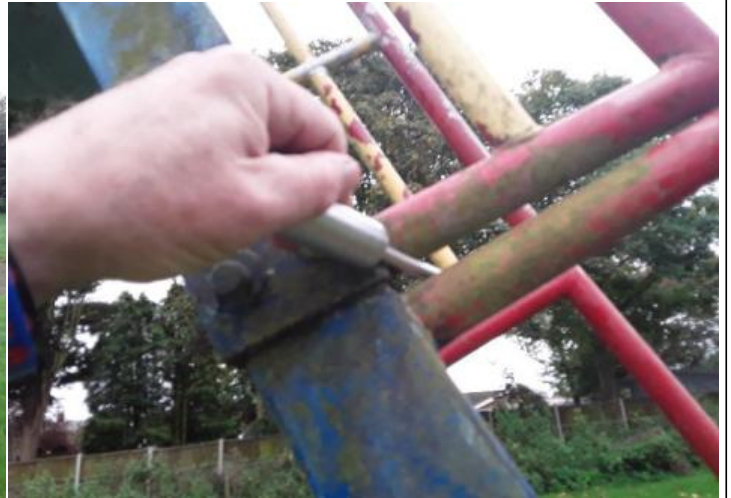
Finding: There is/are finger entrapment/s in the structure and the item fails to meet the requirements of BS EN 1176 Part 1 4.2.7.6 Entrapment of fingers

Action: Monitor - No remedial work recommended

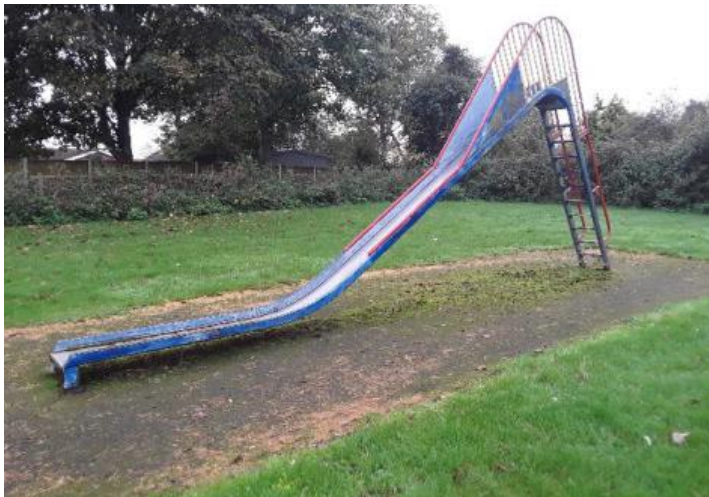
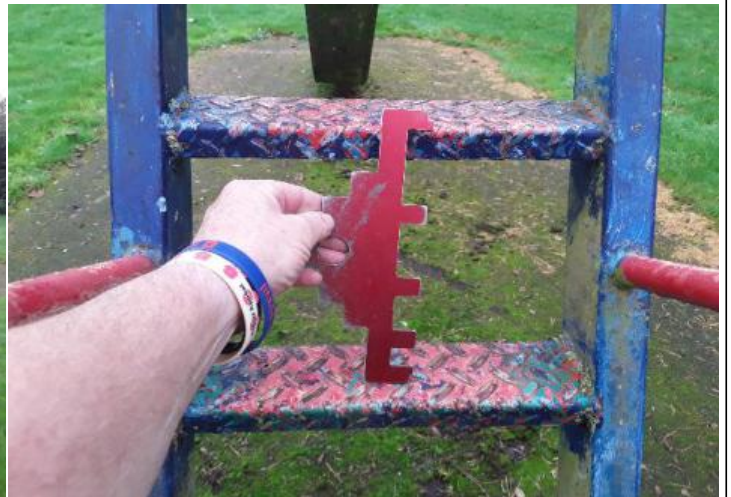
Finding: The item fails to meet the requirements of BS EN 1176 Part 1 4.2.7.2 head and neck entrapment in the barriers and/or steps

Action: Monitor - No remedial work recommended

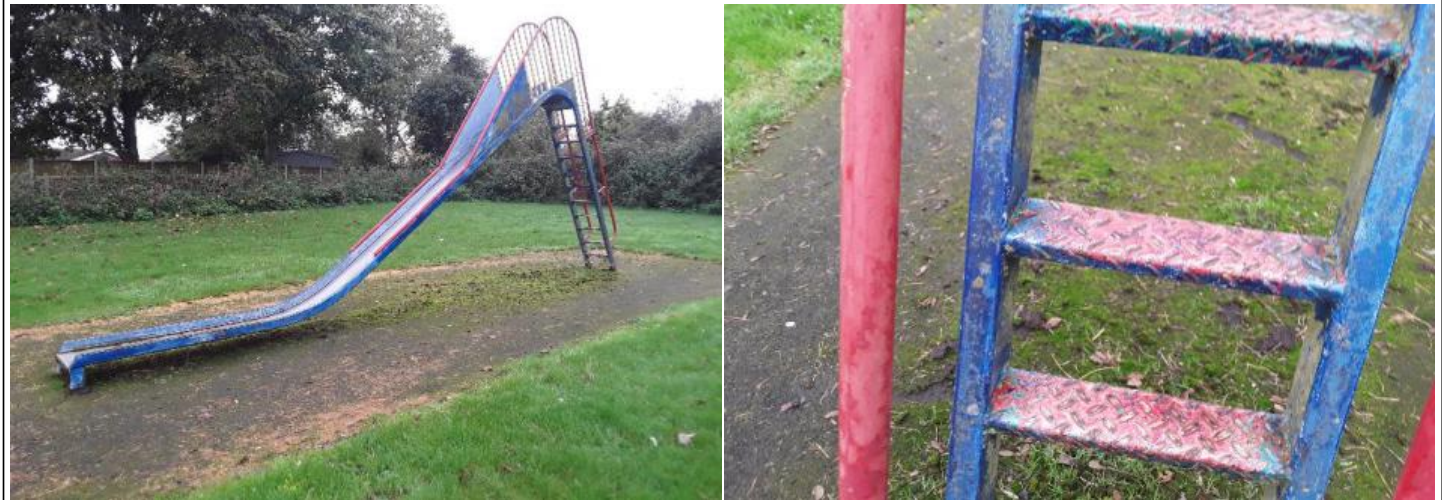
Finding: There is surface corrosion / rust present on the item	Action: Consider treating the item
---	---

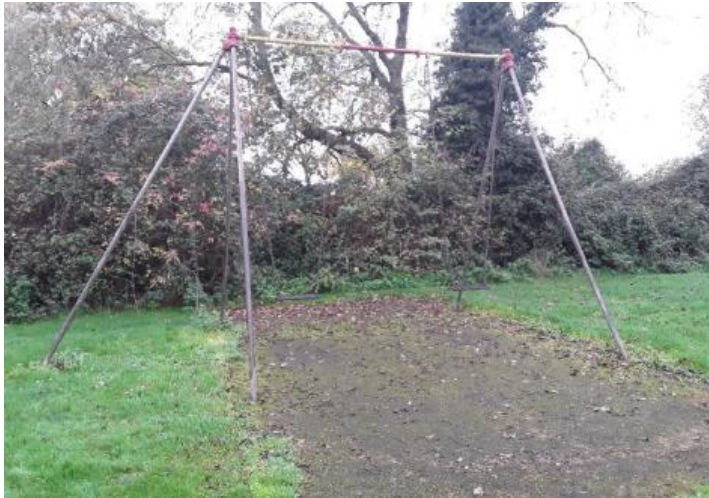
Finding: The fixings or components for this item were in excess of 2.5m above the standing surface and could not be fully accessed by the inspector. We have completed a visual inspection of the fixings from ground level but a maintenance inspection should be undertaken to assess the condition, security and wear of the components at intervals in accordance with the manufacturers recommendations.

Action: Inspect in accordance with the manufacturers recommendations

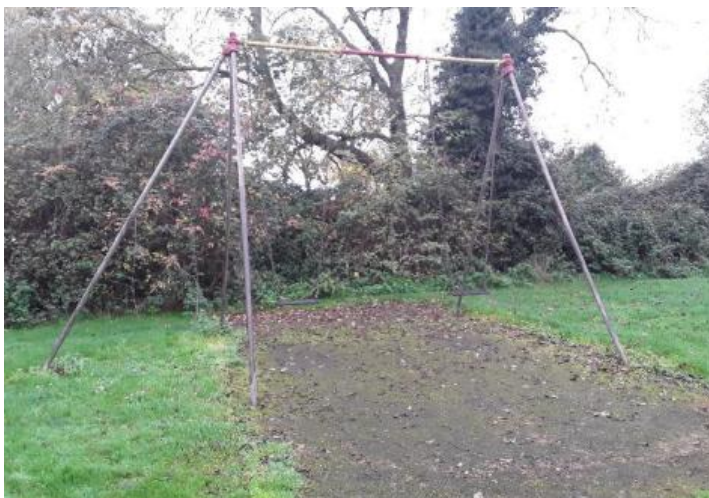
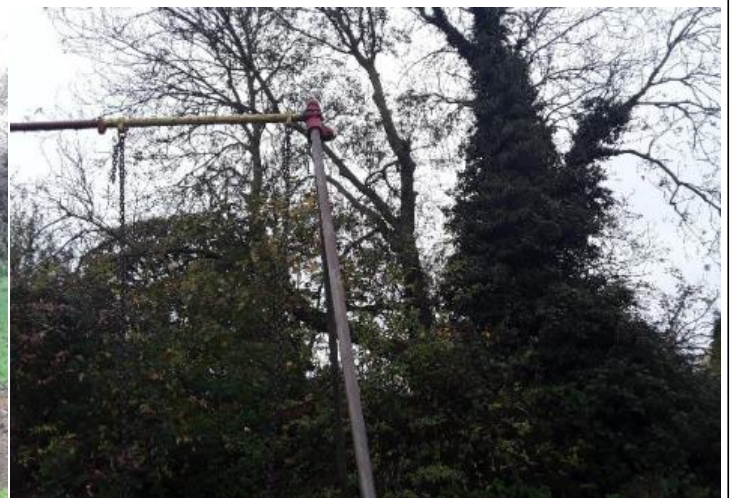
Finding: One frame brace has been removed

Action: Replace the missing component
