Annual Inspection

Pointon Parish Council

Pointon Playing Field

Fen Road, Pointon, NG34 0LZ

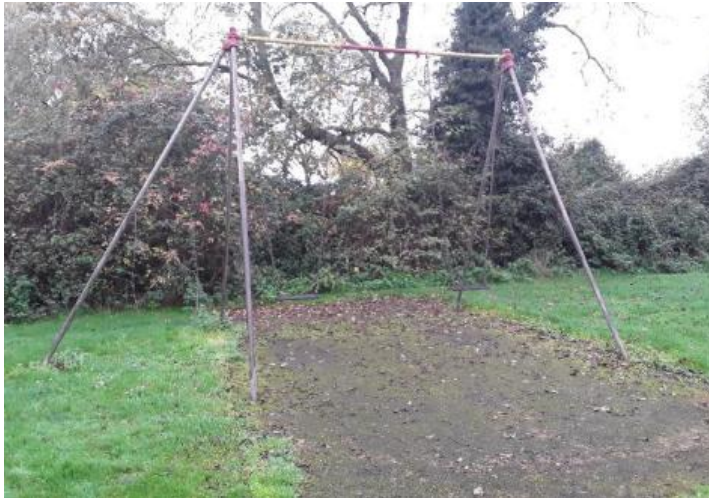
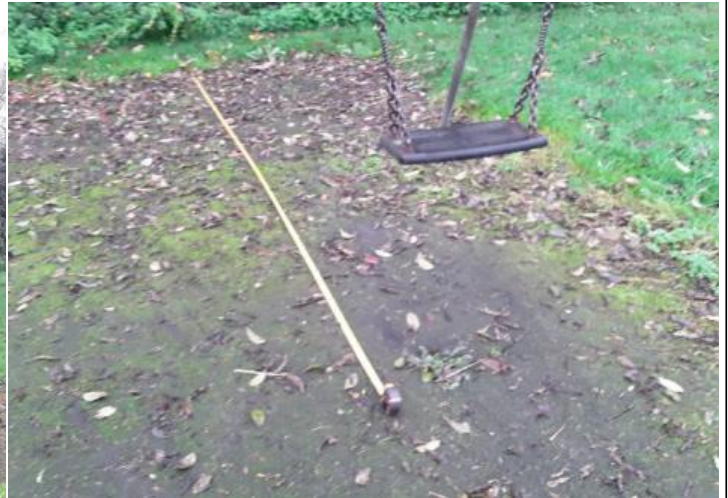
Finding: The surfacing dimensions are short and do not meet with the requirements of the current applicable standard

Action: Monitor - no remedial action recommended

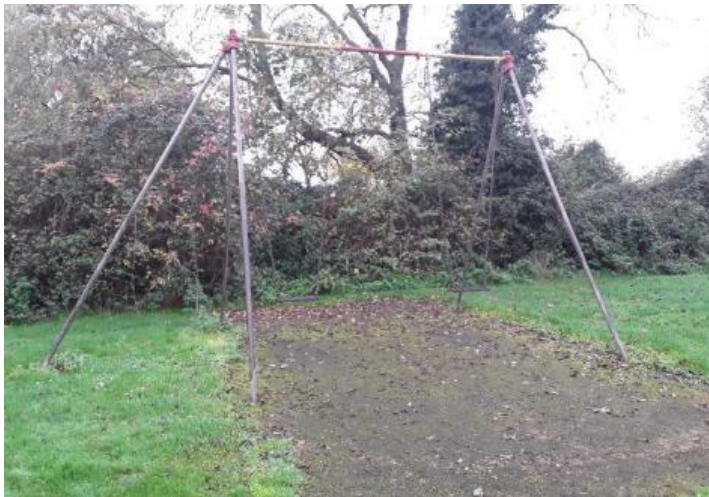
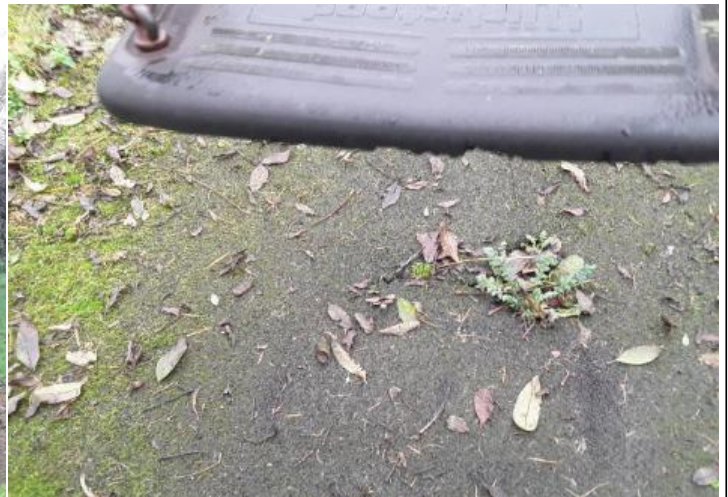
Finding: The seat has minor damage or wear

Action: Monitor for any further deterioration and replace as required

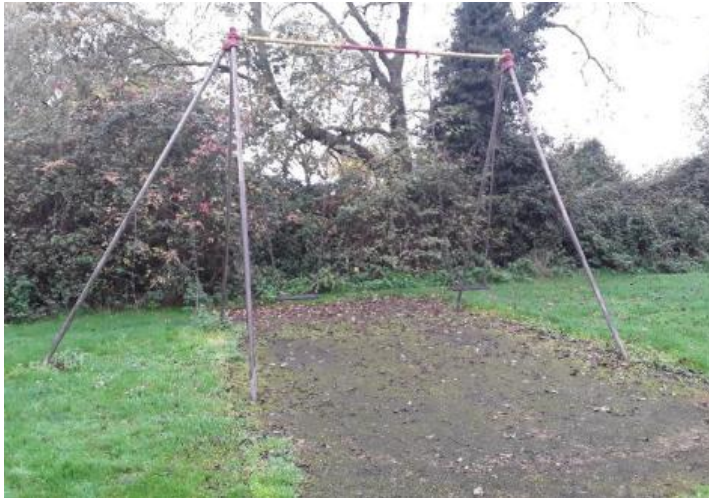
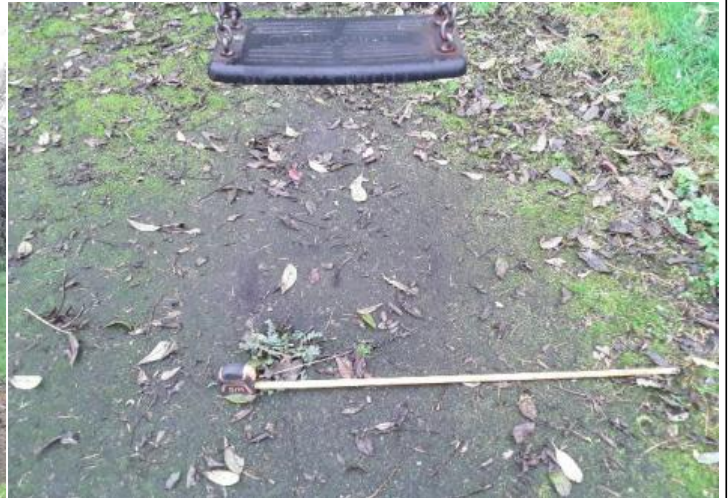
Finding: The surfacing width under the seat/s is / are less than 875mm when measured from the centre of the seat outwards, and fails the requirements of BS EN 1176 Part 2

Action: Monitor - No remedial work recommended

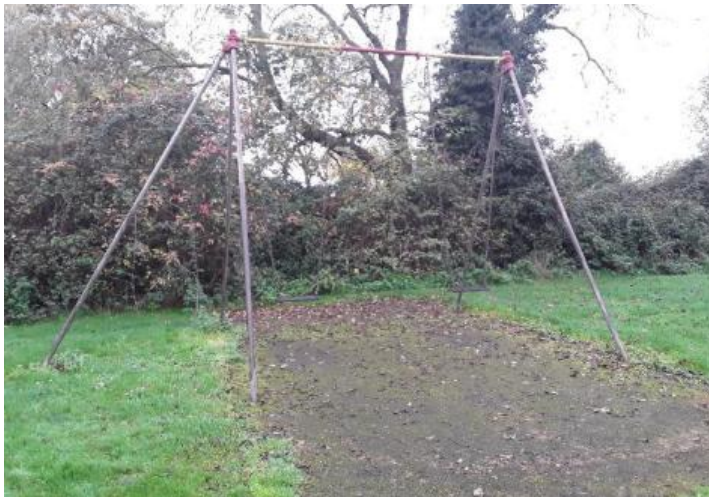
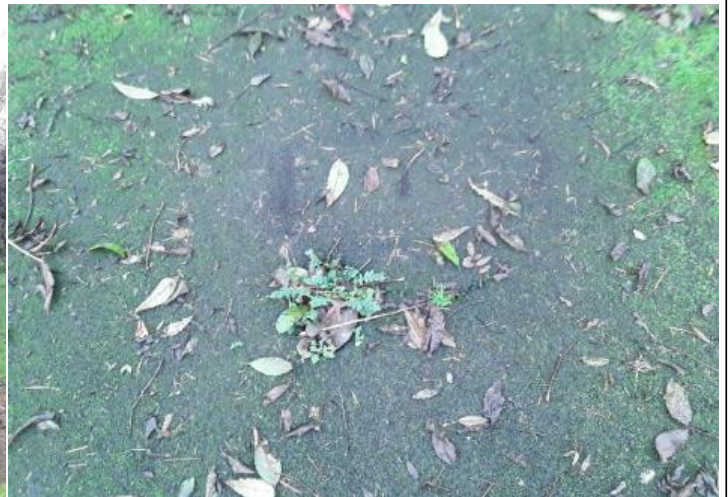
Finding: There is damage to the surface

Action: Repair the damaged areas of surfacing

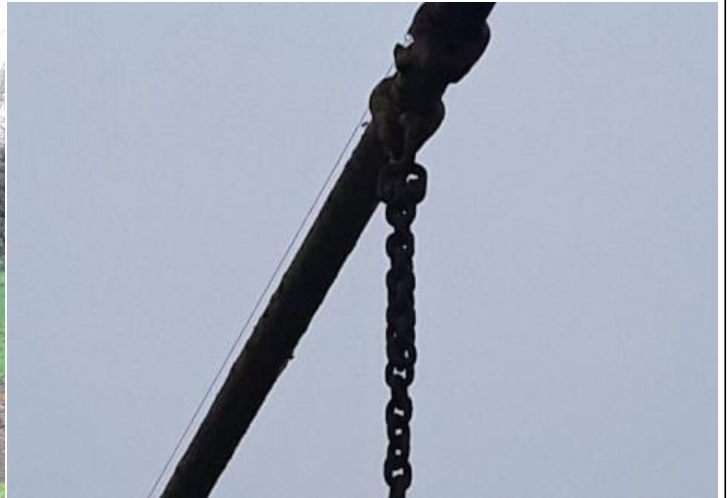
Finding: There is some wear to the shackles.

Action: Monitor for any further deterioration and replace when 40% worn

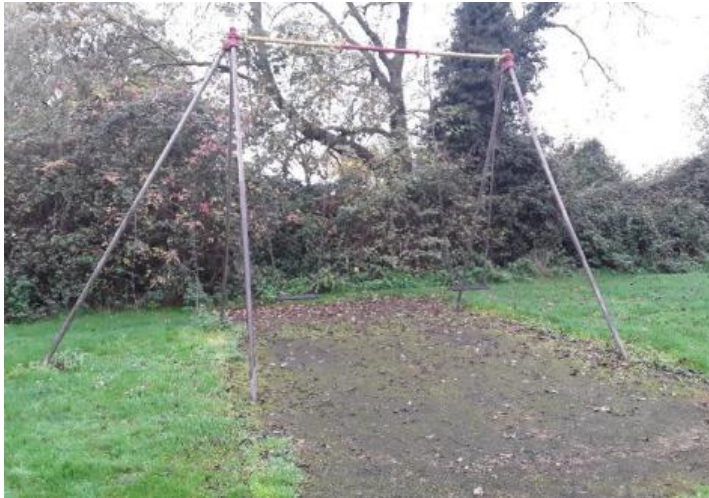
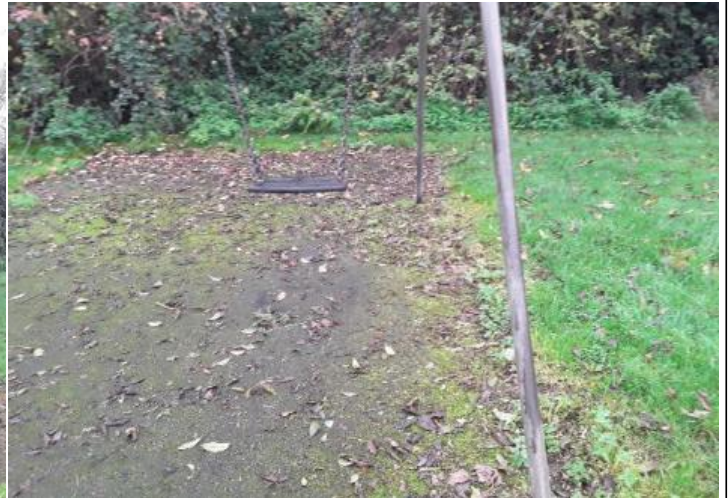
Finding: The seats are too close to the frame as defined in BS EN 1176 Part 2; this is a low risk failure and no remedial action is required

Action: Monitor - No remedial work recommended

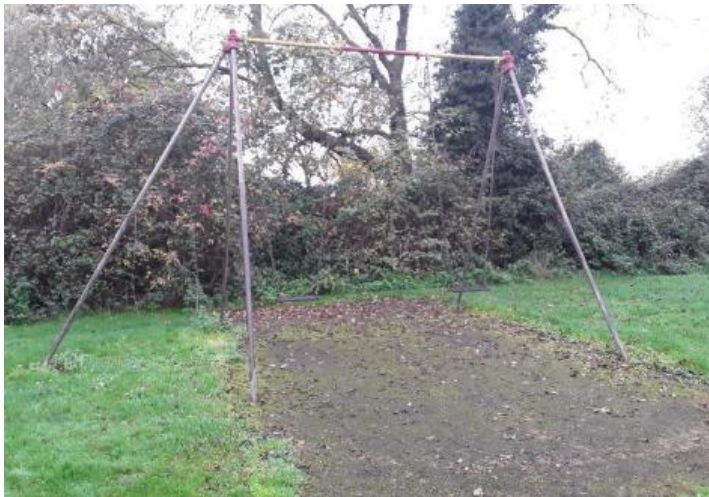
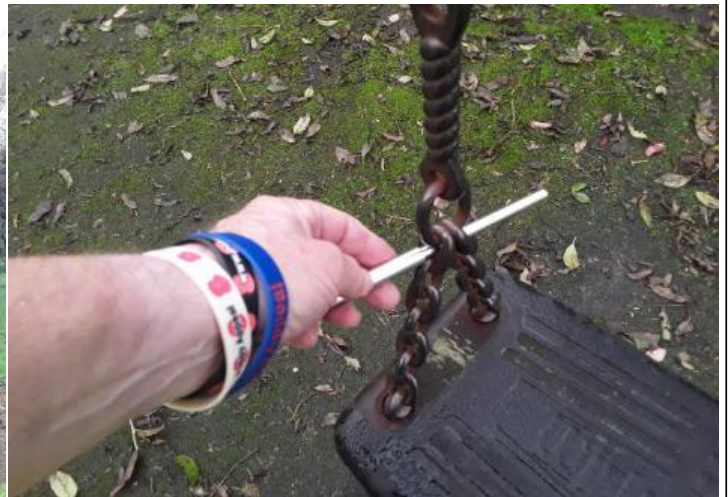
Finding: The chain openings are in excess of the 8.6mm as recommended by BS EN 1176

Action: Monitor - No remedial work recommended

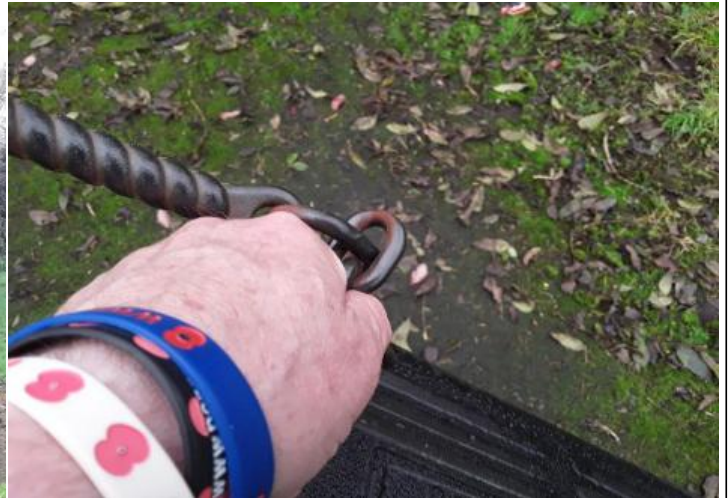
Finding: The chain links are worn and require renewing

Action: Replace worn chains
