the **play inspection** company

Annual Inspection

Pointon Parish Council

Pointon Playing Field

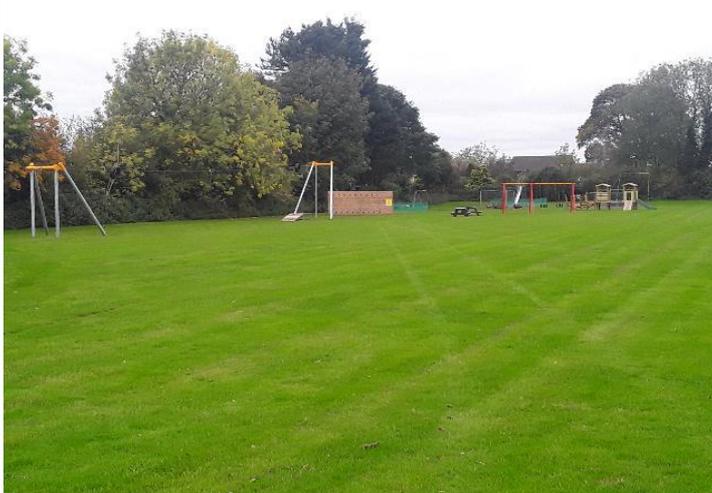
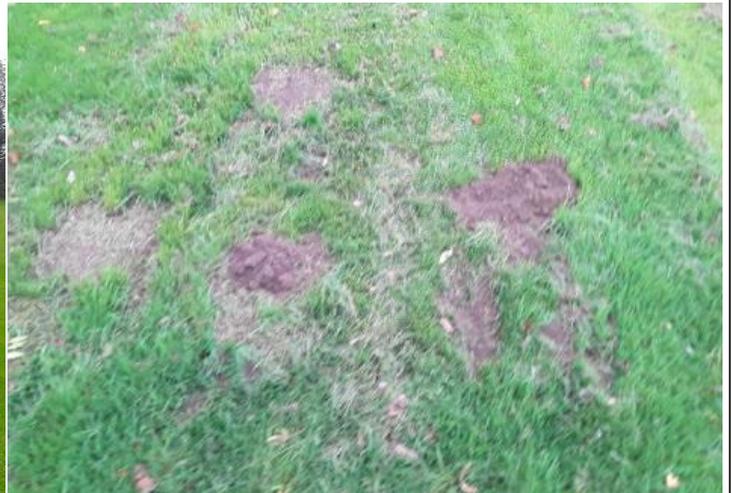
Risk Level: L - Low Risk
Surface: N/A

Finding: There are a number of molehills within the area and these may present unforeseen hazards for users

Action: Remove moles by appropriate means, reinstate surfaces to level and maintain the area

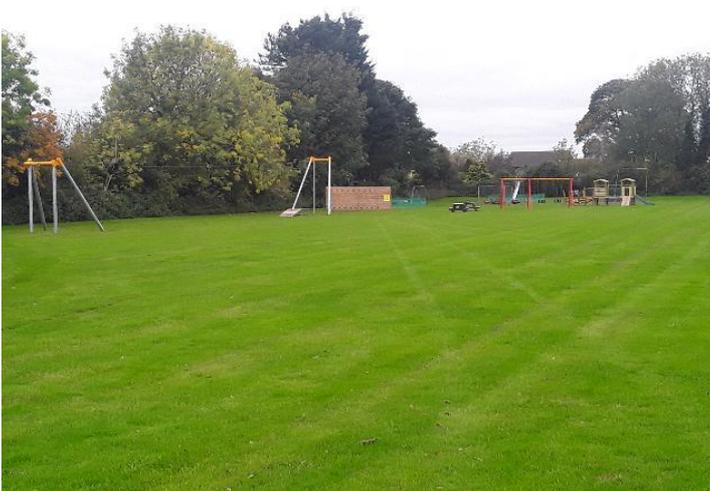
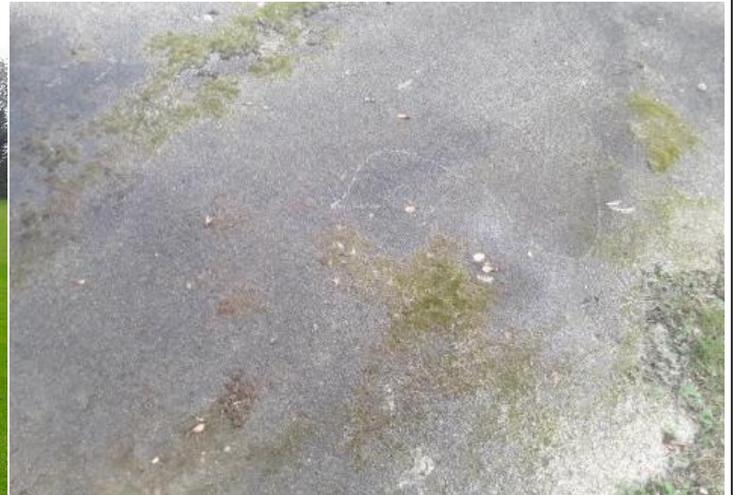
Risk Level: L - Low Risk
Surface: N/A

Finding: There is algae, silt or moss growth on the surface resulting in slippery conditions

Action: Clean and treat appropriately

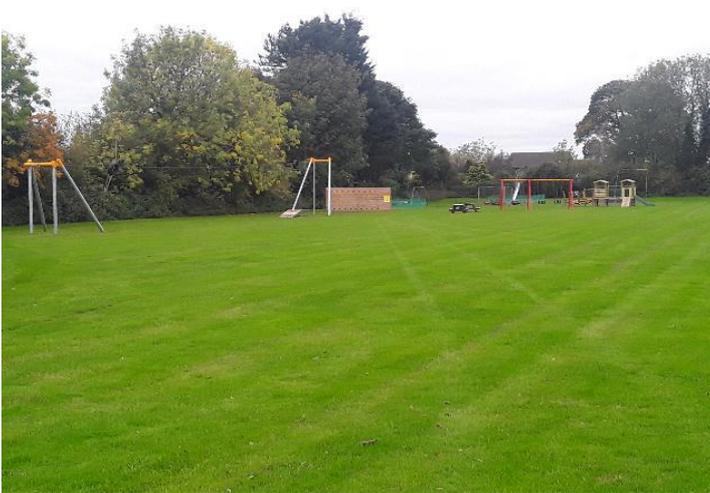
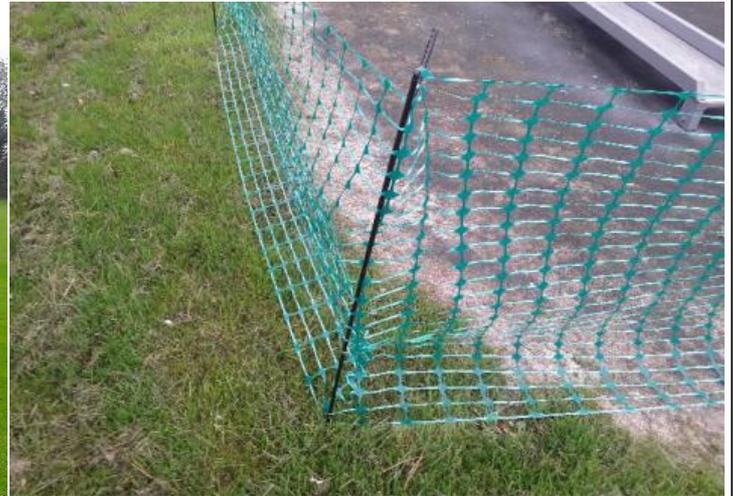
Risk Level: L - Low Risk
Surface: N/A

Finding: Two pieces of equipment have been isolated from use using euro mesh and road pins, however the method of isolating the equipment has introduced additional hazards that may cause harm to visitors to the play area

Action: Provide a more suitable isolation method

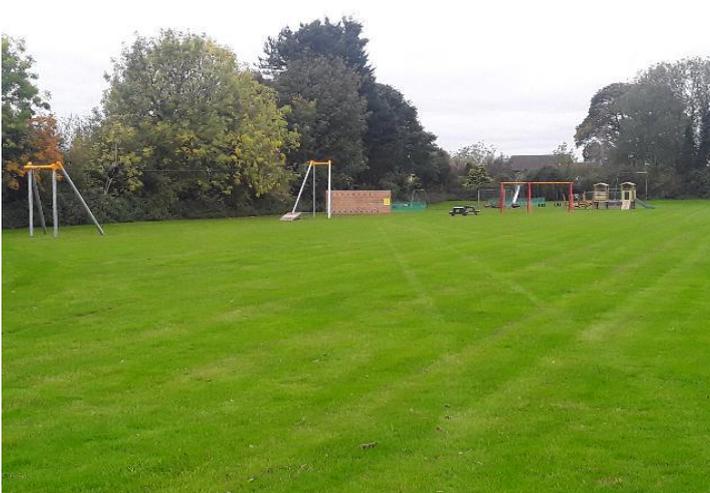
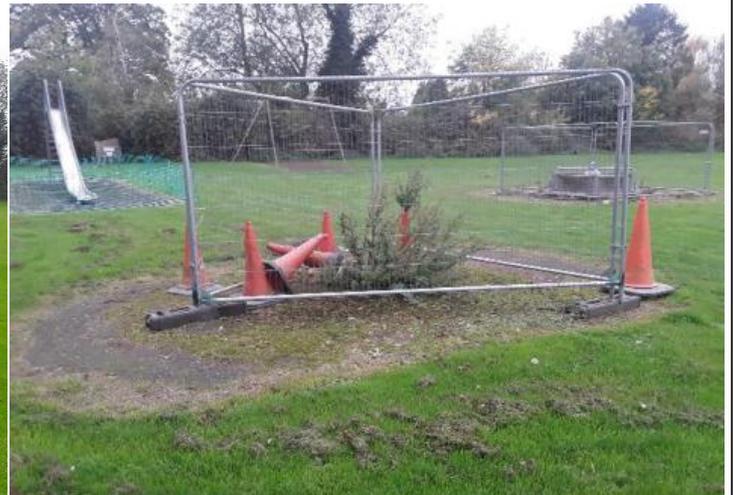
Risk Level: L - Low Risk
Surface: N/A

Finding: A redundant damaged area of wet pour has been fenced off preventing access

Action: Consider reinstating the area to grass

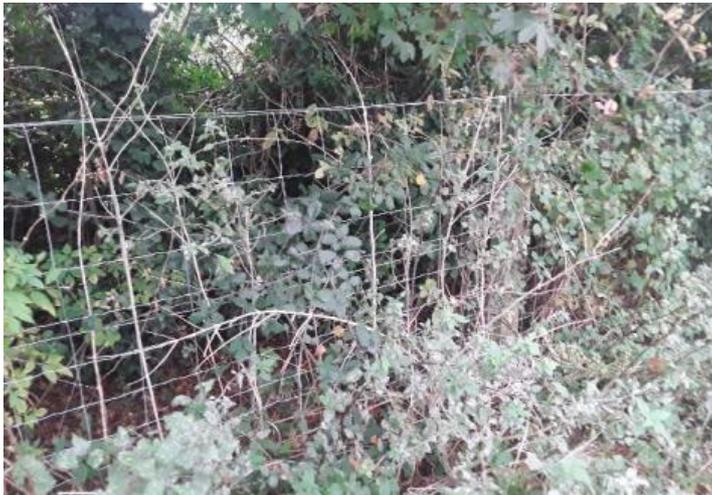
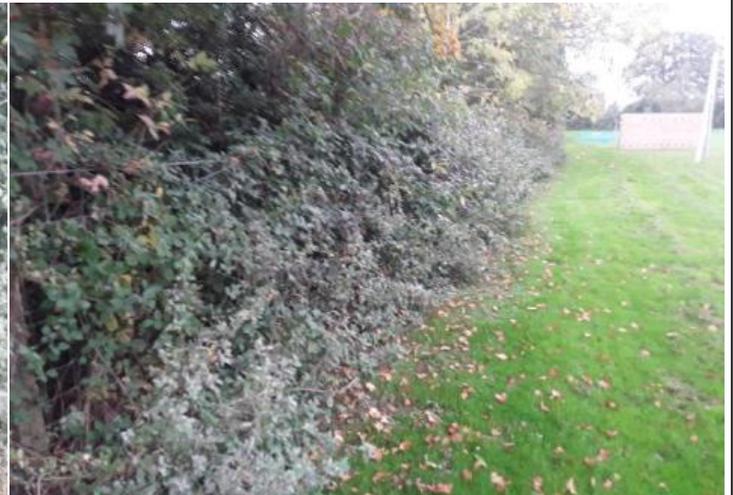
Risk Level: L - Low Risk
Surface: Grass

Finding: The adjacent foliage is overhanging or growing through the fence and the inspector was unable to verify the condition of the fence in a number of places
Action: Cut back and maintain

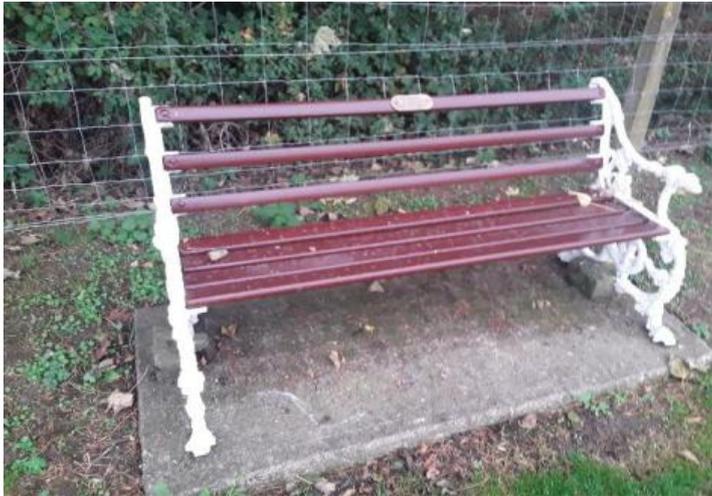
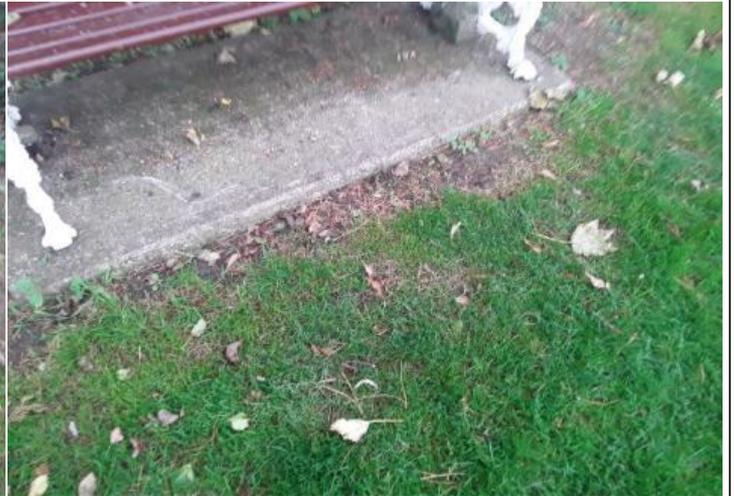
Risk Level: L - Low Risk
Surface: Concrete

Finding: There are trip hazards present over the concrete base

Action: Remove trip hazard

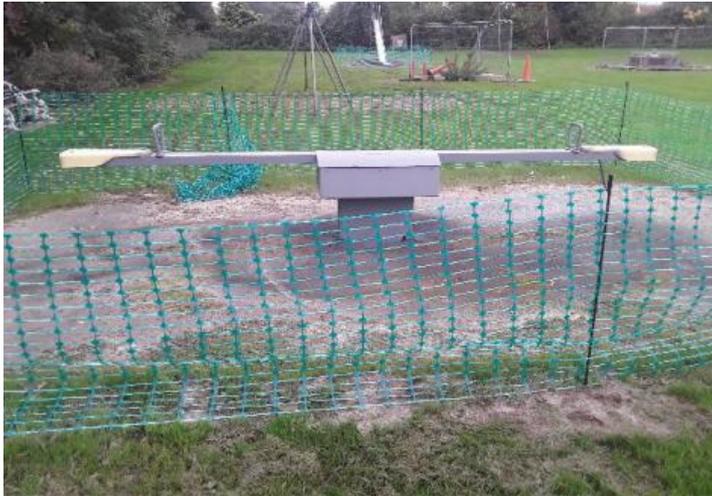
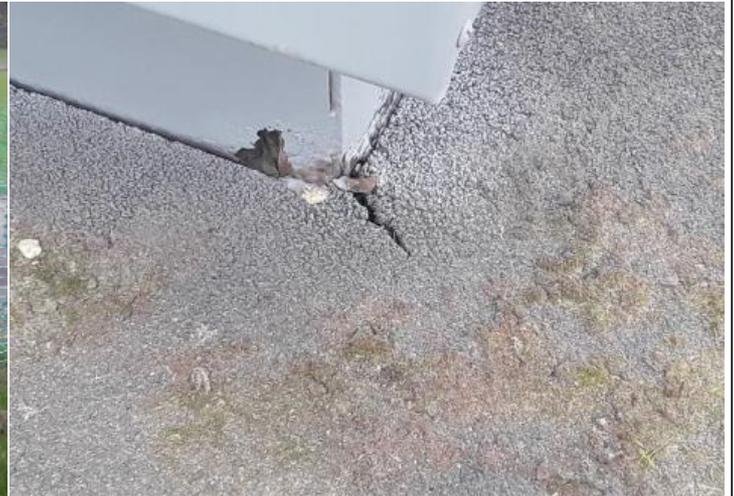
Risk Level: L - Low Risk
Surface: Wet Pour

Finding: The surfacing is damaged

Action: Repair damaged areas of surfacing

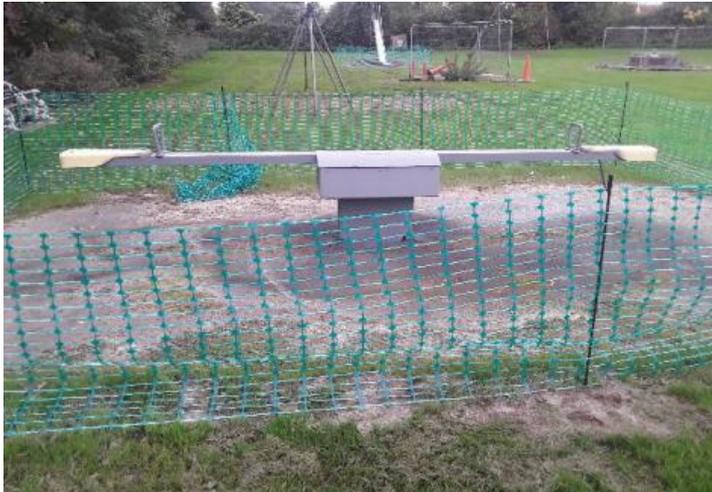
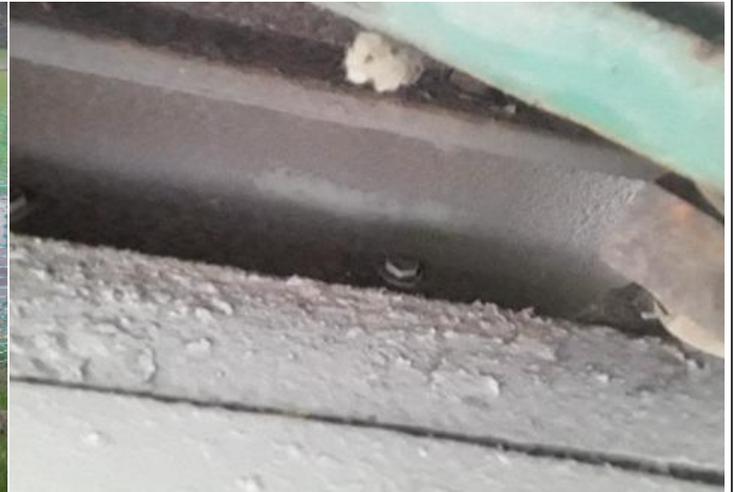
Risk Level: V - Very Low Risk
Surface: Wet Pour

Finding: There is no gaiter protection for accessible moving parts (possible shear trap) as recommended in BS EN 1176 Part 1; 4.2.6 Moving Parts

Action: Monitor - No action given the risk assessment

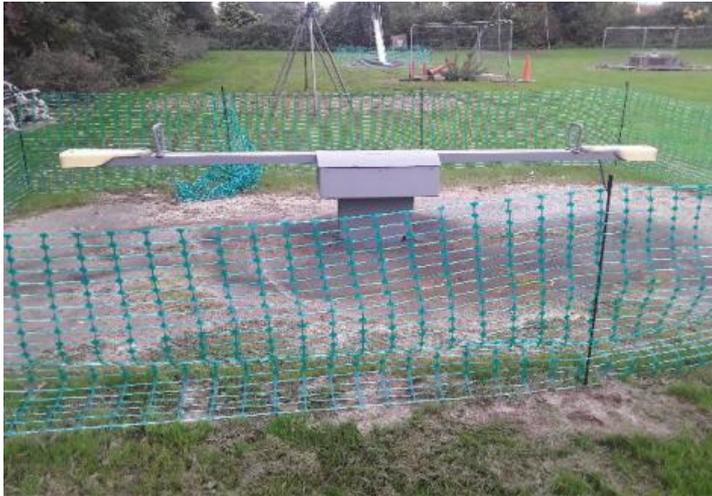
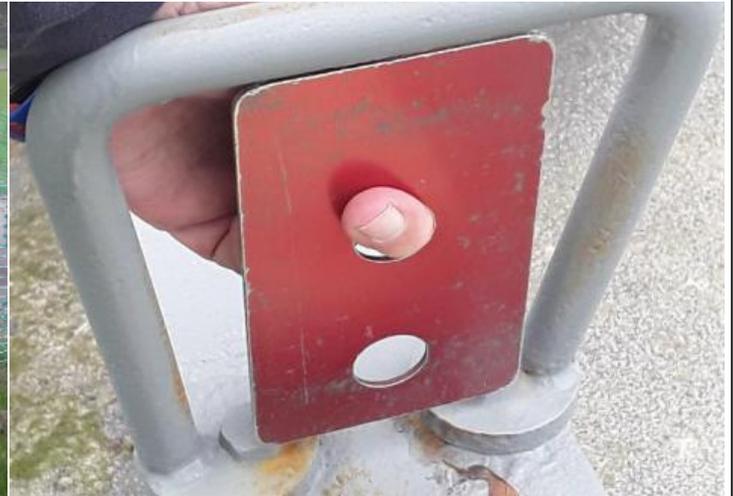
Risk Level: V - Very Low Risk
Surface: Wet Pour

Finding: The item fails to meet the requirements of BS EN 1176 Part 1 4.2.7.2 for head and neck entrapment in the handgrip openings

Action: Monitor - No action given the risk assessment

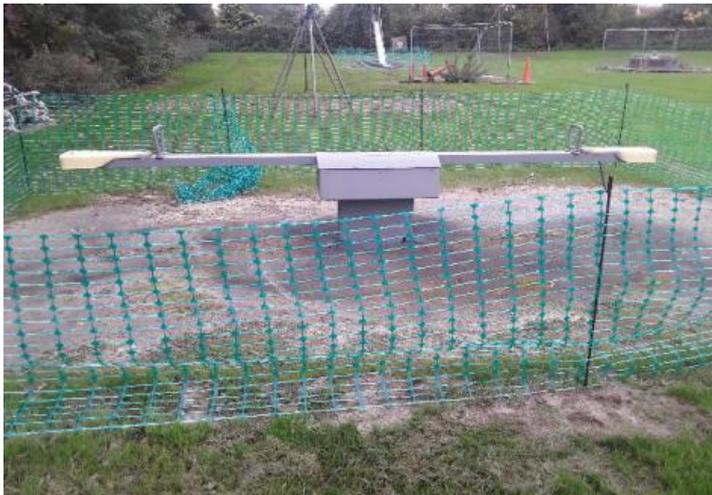
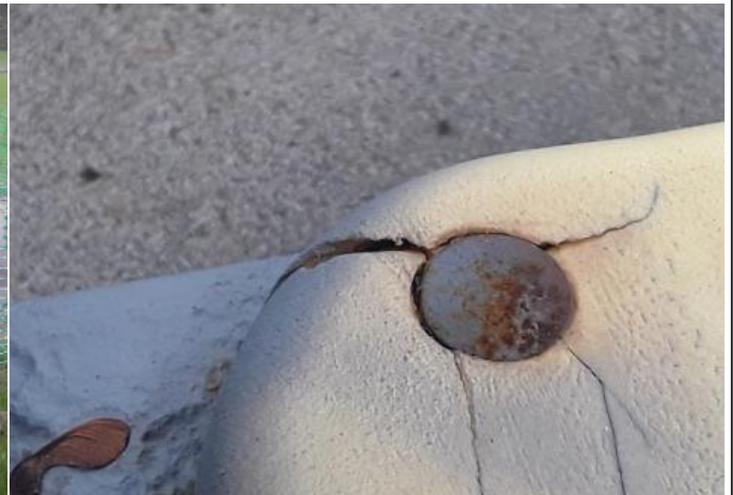
Risk Level: L - Low Risk
Surface: Wet Pour

Finding: The seat is damaged and requires replacing

Action: Replace damaged seat

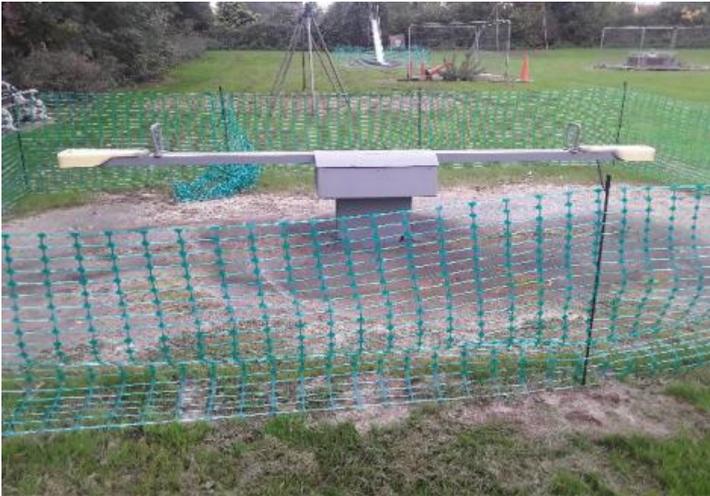
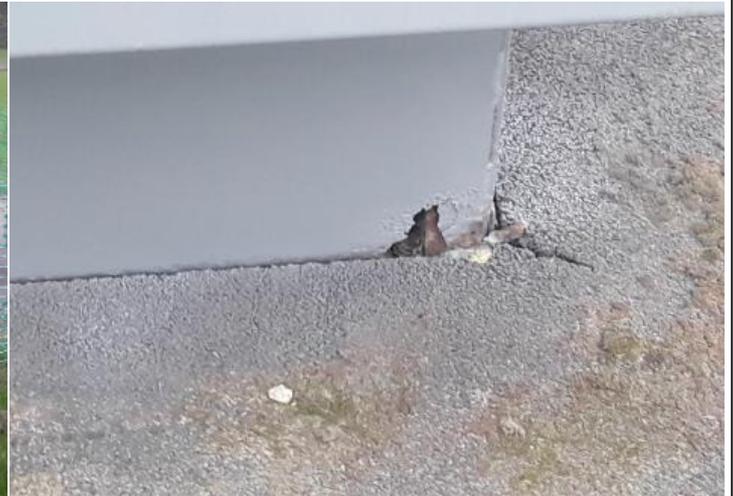
Risk Level: L - Low Risk
Surface: Wet Pour

Finding: Parts of the steel on this item have corroded excessively and the metal has perforated in places

Action: Ensure all affected areas are treated and repaired

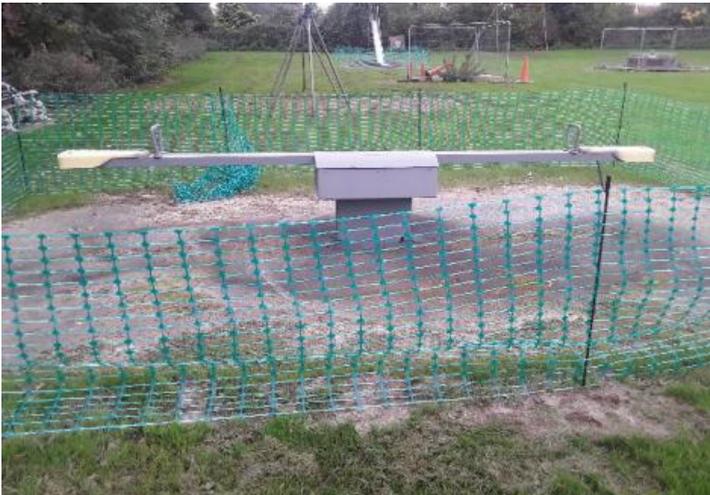
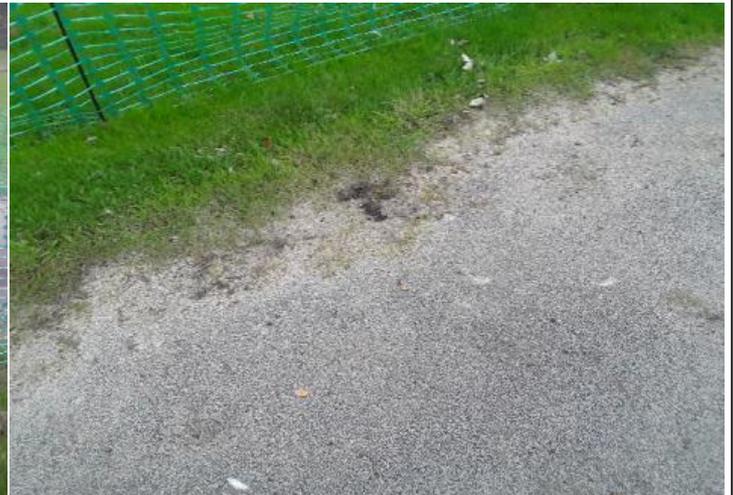
Risk Level: L - Low Risk
Surface: Wet Pour

Finding: The surface has subsided in some areas

Action: Monitor for any further deterioration and repair as required

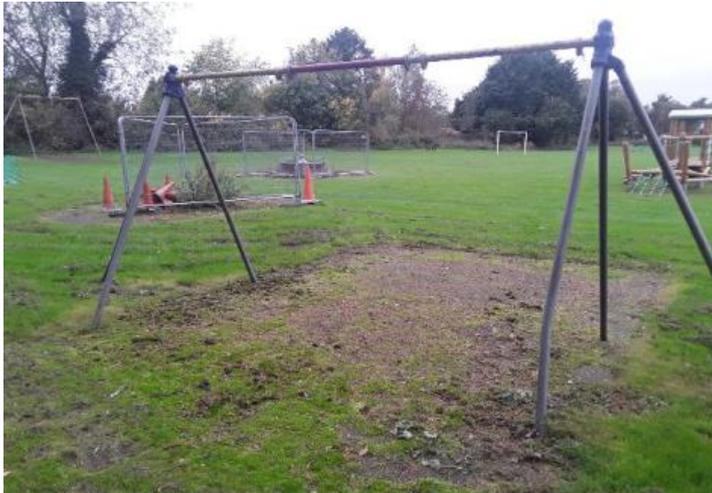
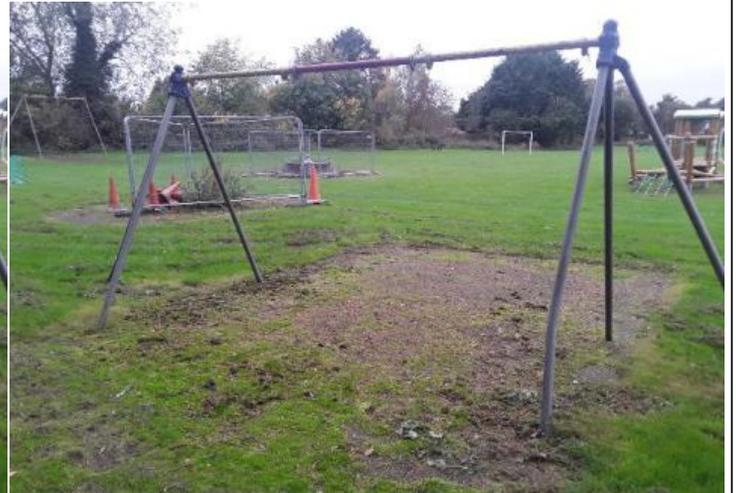
Risk Level: V - Very Low Risk
Surface: Wet Pour

Finding: The item has missing component(s)

Action: Consider replacing missing components

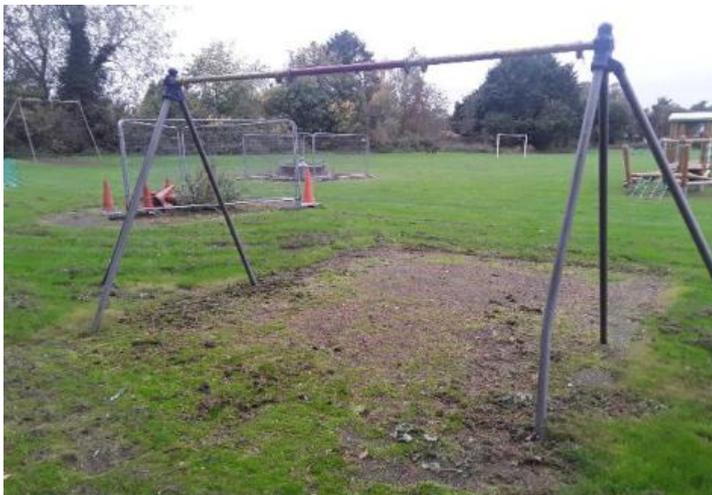
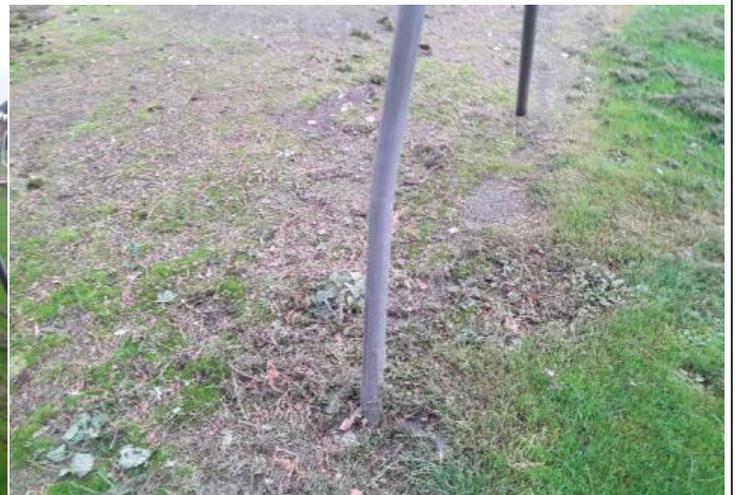
Risk Level: L - Low Risk
Surface: Wet Pour

Finding: There is minor distortion damage to the legs

Action: Monitor and repair if required

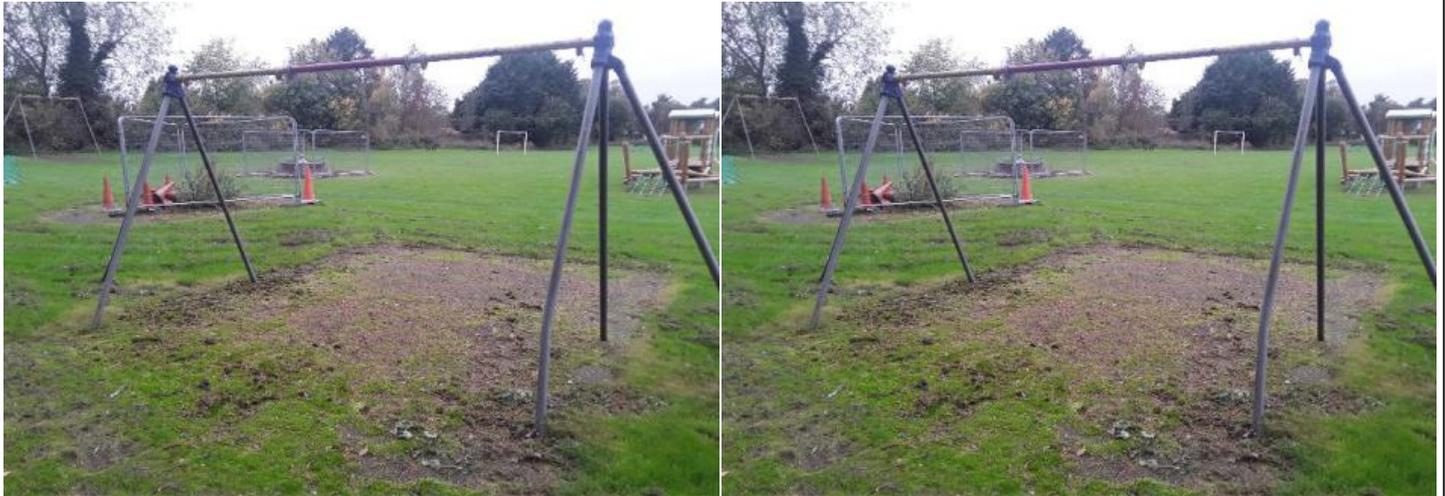
Risk Level: L - Low Risk
Surface: Wet Pour

Finding: The paintwork on this item has been damaged or worn exposing the metal underneath which is rusting / corroding

Action: Treat affected areas and repaint

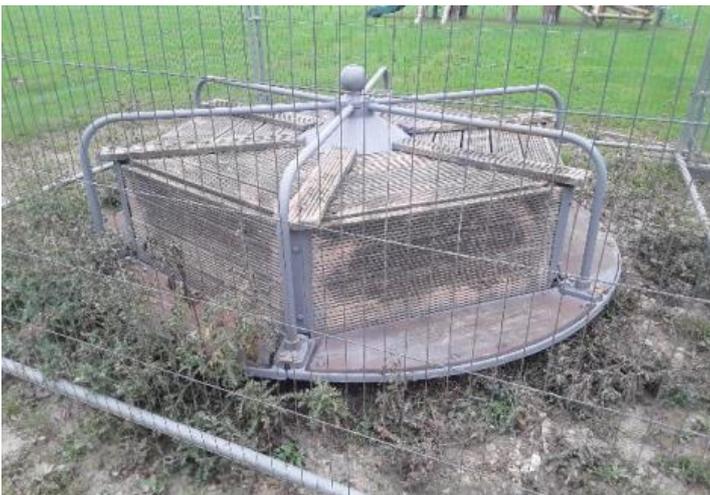
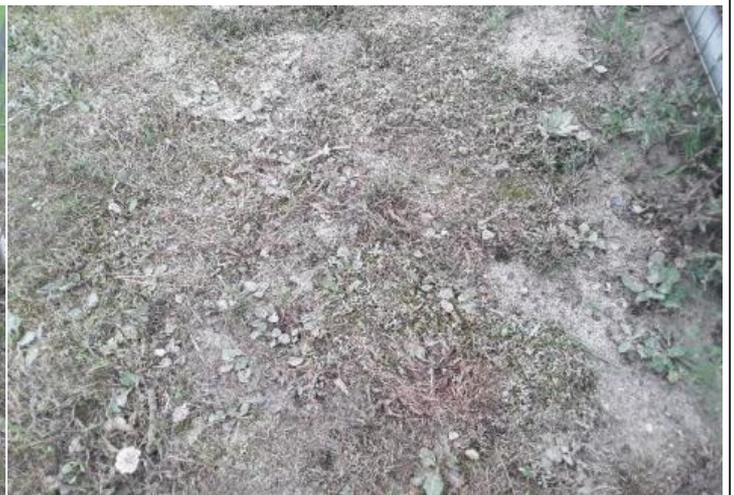
Risk Level: M - Moderate Risk
Surface: Gravel

Finding: The surfacing has degraded and the concrete foundations are exposed

Action: Repair / replace damaged areas of surfacing

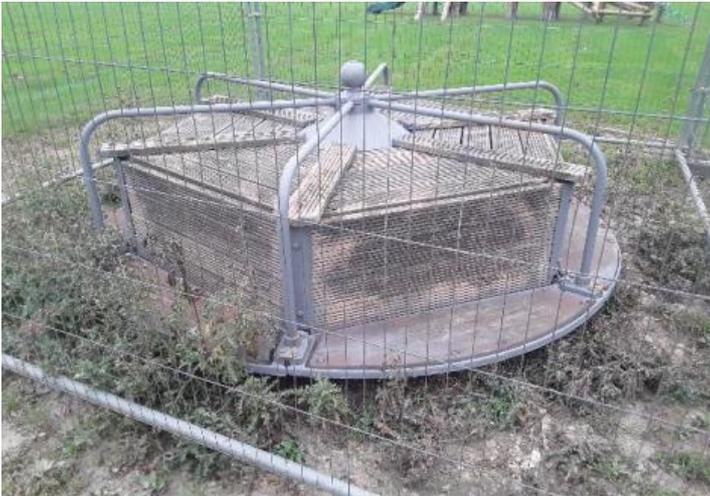
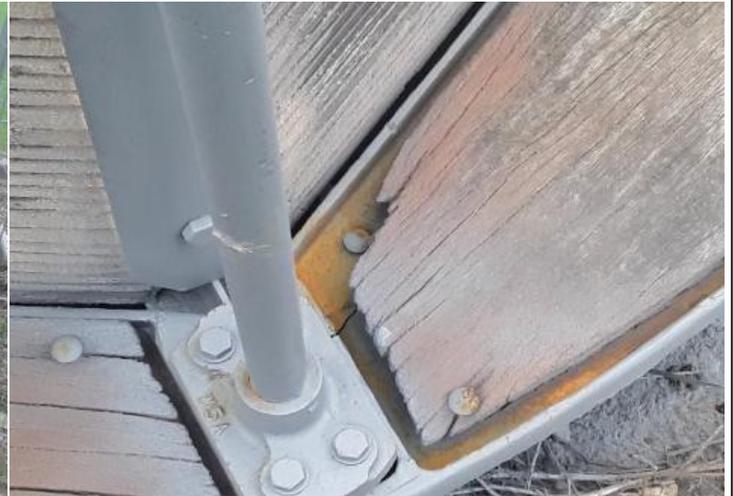
Risk Level: L - Low Risk
Surface: Gravel

Finding: Parts of the timber are rough / splintered or have rot apparent

Action: Remove all rough or sharp edges / replace the rotted components

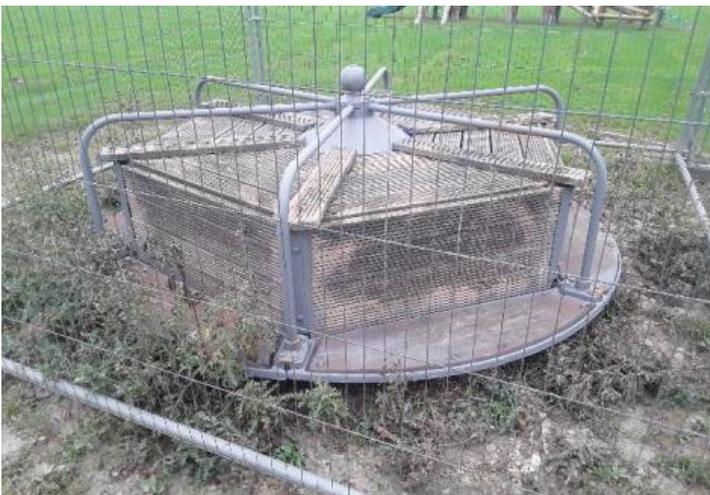
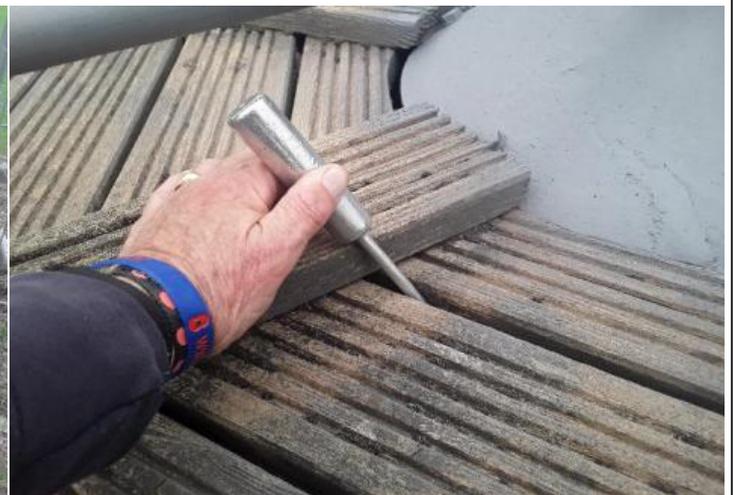
Risk Level: V - Very Low Risk
Surface: Gravel

Finding: There is/are finger entrapment/s in the structure and the item fails to meet the requirements of BS EN 1176 Part 1 4.2.7.6 Entrapment of fingers

Action: Monitor - No action given the risk assessment

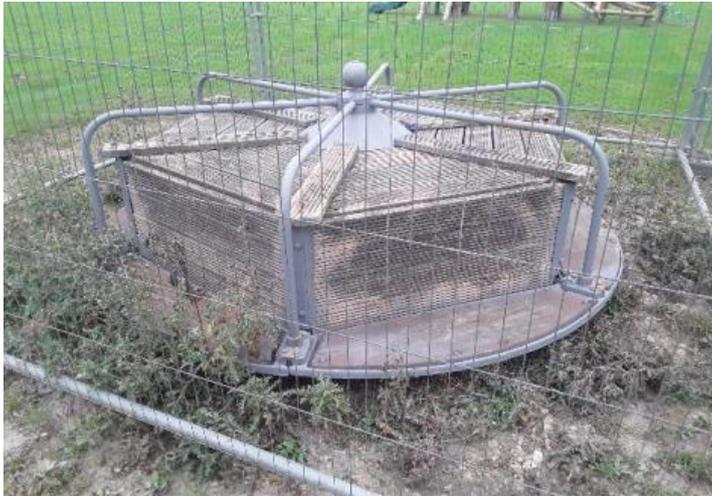
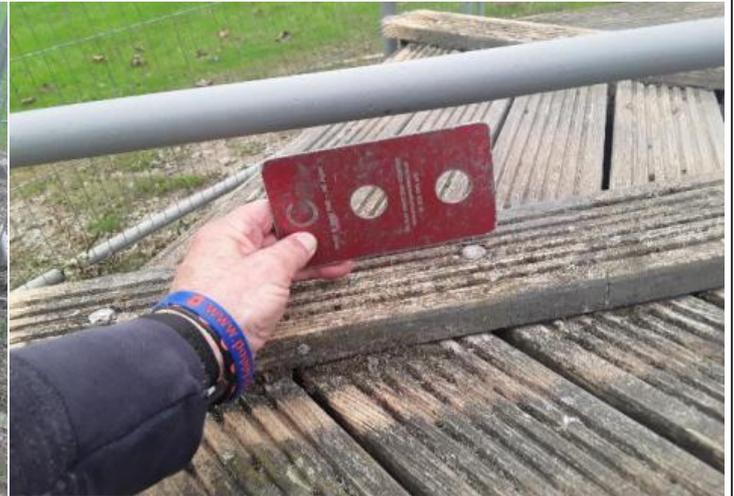
Risk Level: V - Very Low Risk
Surface: Gravel

Finding: The item fails to meet the requirements of BS EN 1176 Part 1 4.2.7.2 for head and neck entrapment in the framework

Action: Monitor - No action given the risk assessment

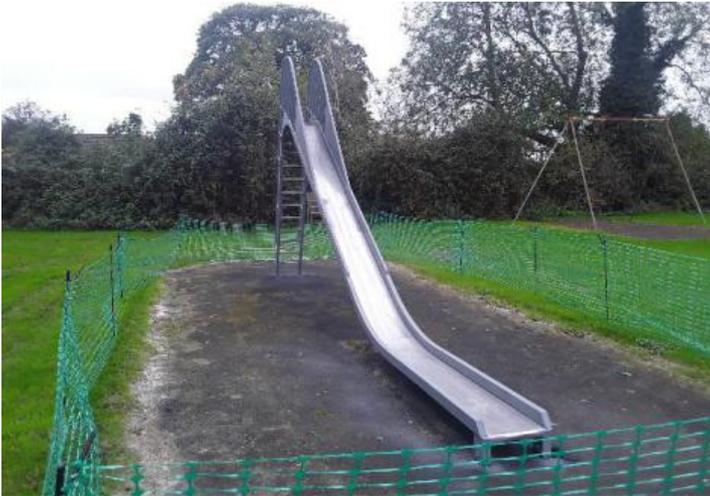
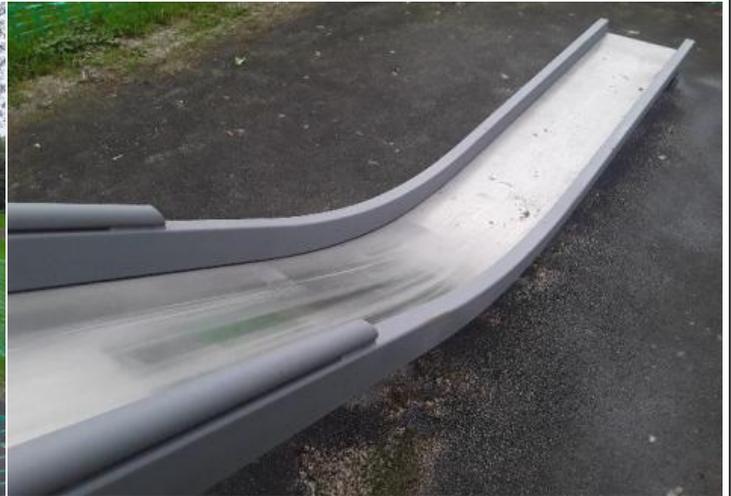
Risk Level: V - Very Low Risk
Surface: Wet Pour

Finding: There are a number of dents in the slide surface

Action: Monitor for any further deterioration and repair as required

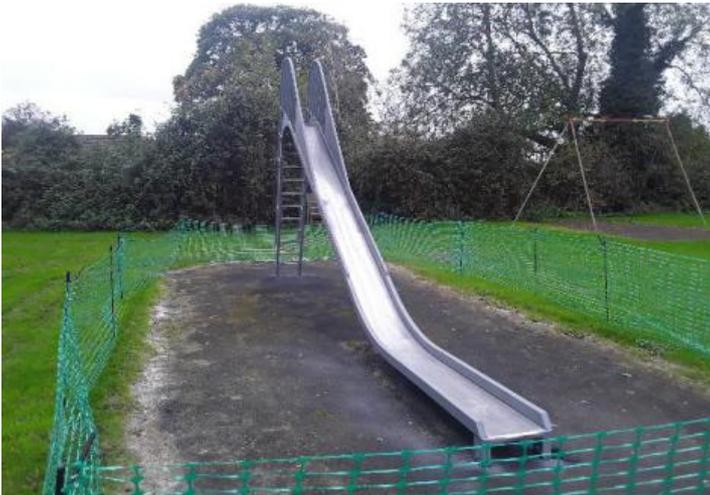
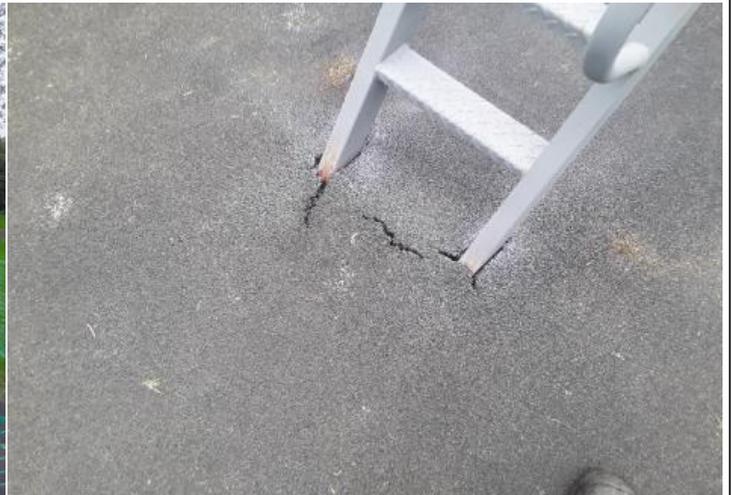
Risk Level: L - Low Risk
Surface: Wet Pour

Finding: The surfacing is damaged

Action: Repair damaged areas of surfacing

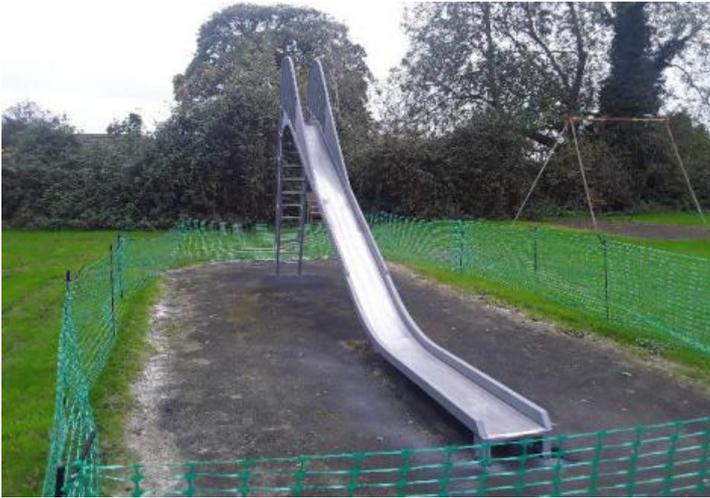
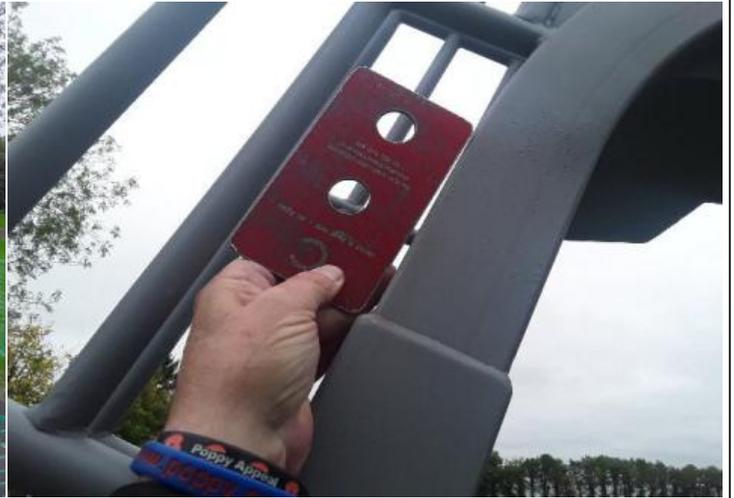
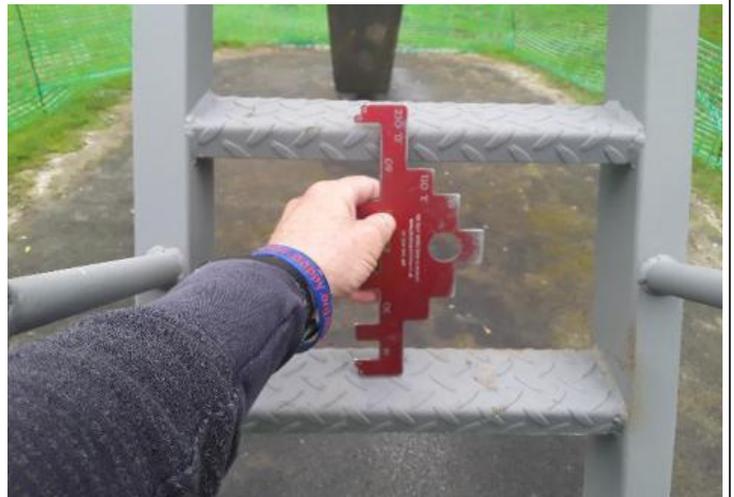
Risk Level: V - Very Low Risk
Surface: Wet Pour

Finding: The item fails to meet the requirements of BS EN 1176 Part 1 4.2.7.2 head and neck entrapment in the barriers and/or steps

Action: Monitor - No action given the risk assessment

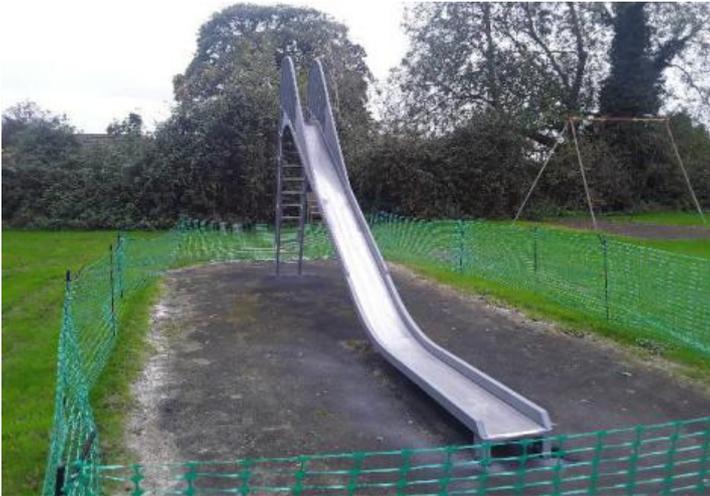
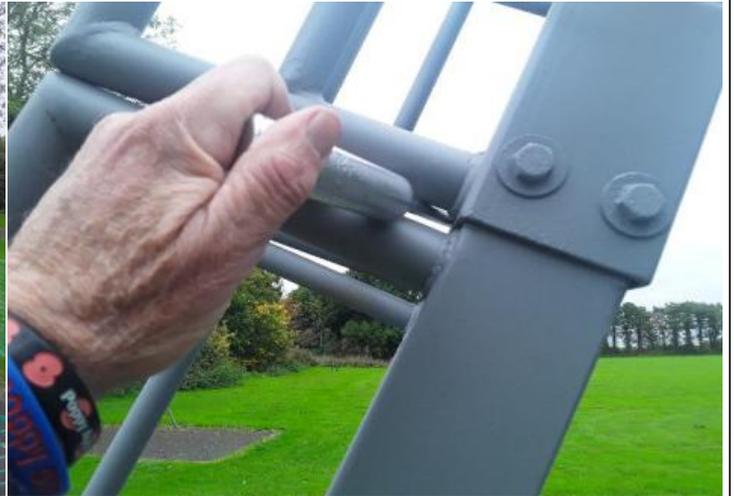
Risk Level: V - Very Low Risk
Surface: Wet Pour

Finding: There is/are finger entrapment/s in the structure and the item fails to meet the requirements of BS EN 1176 Part 1 4.2.7.6 Entrapment of fingers

Action: Monitor - No action given the risk assessment

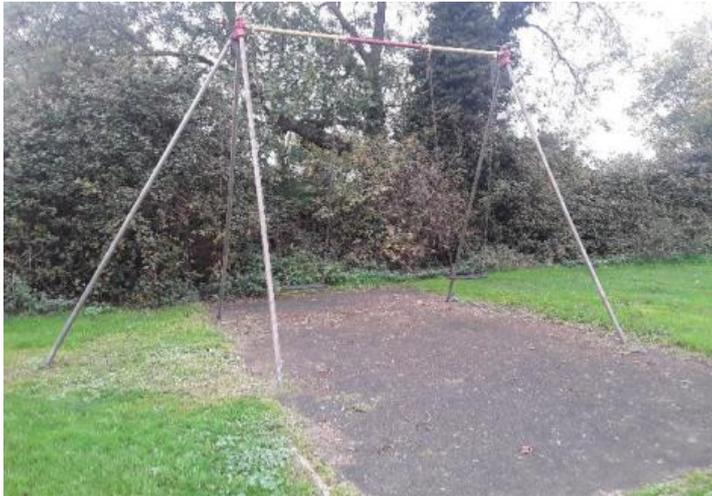
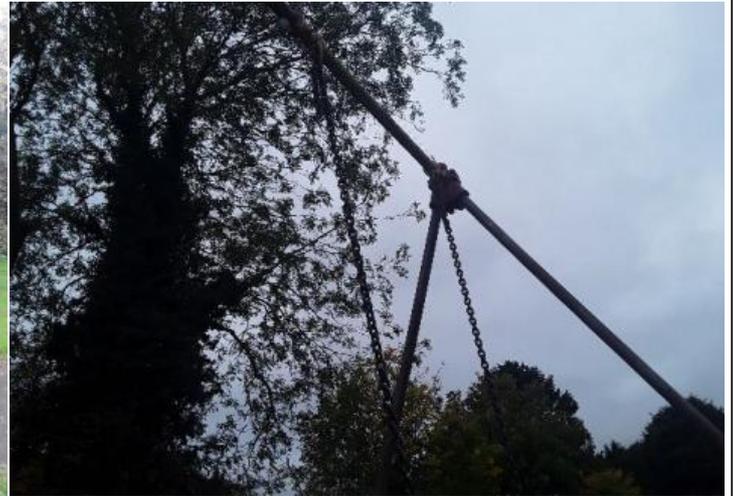
Risk Level: V - Very Low Risk
Surface: Wet Pour

Finding: The bushes are showing signs of wear

Action: Monitor for any further deterioration and replace as required

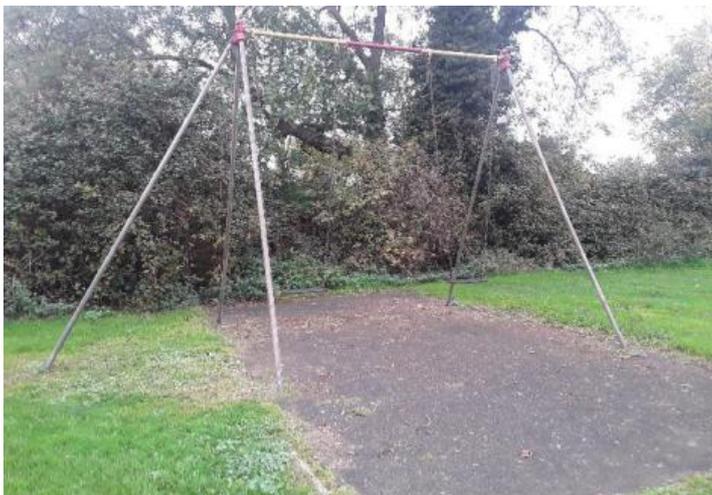
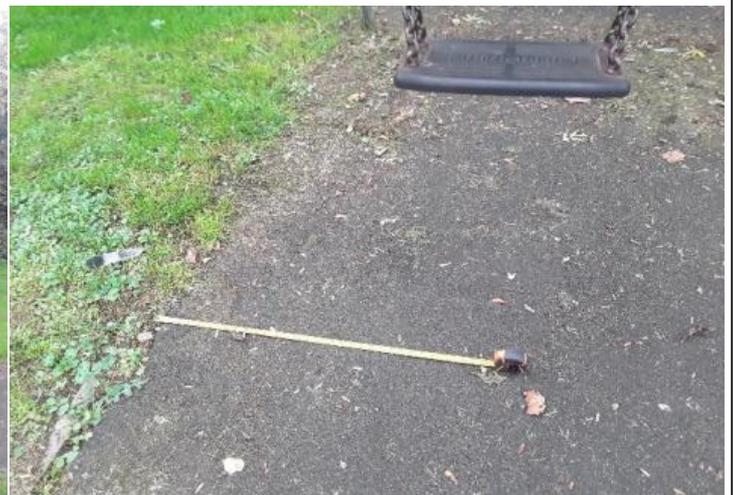
Risk Level: V - Very Low Risk
Surface: Wet Pour

Finding: The surfacing width under the seat/s is / are less than 875mm when measured from the centre of the seat outwards, and fail the requirements of BS EN 1176 Part 2

Action: Monitor - No action given the risk assessment

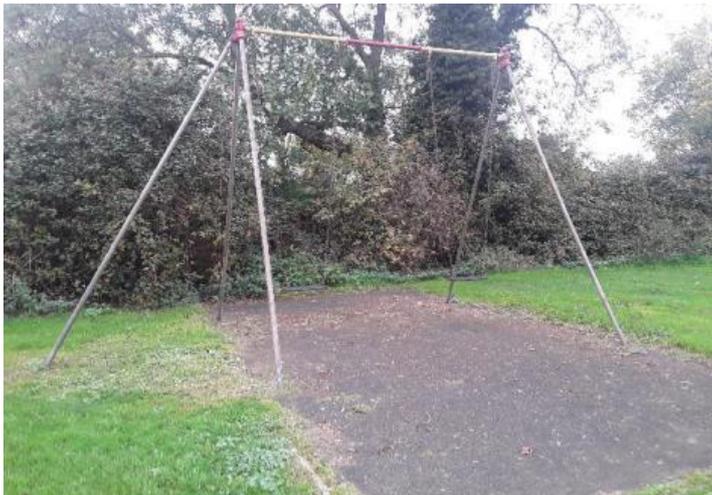
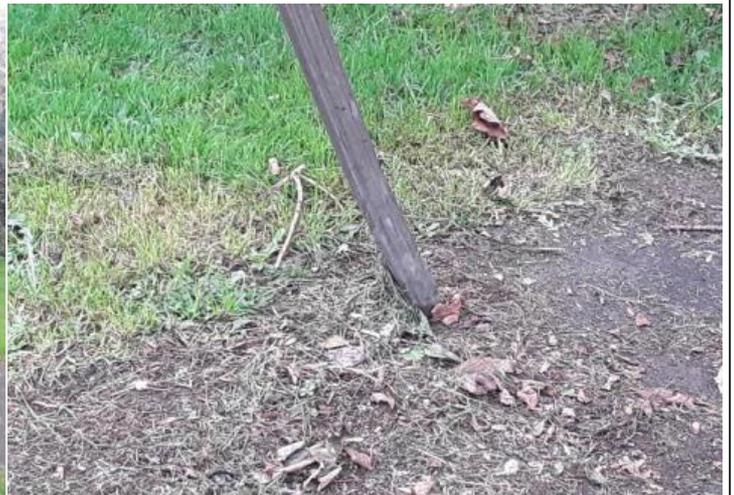
Risk Level: L - Low Risk
Surface: Wet Pour

Finding: There is minor distortion damage to the leg

Action: Monitor and repair if required

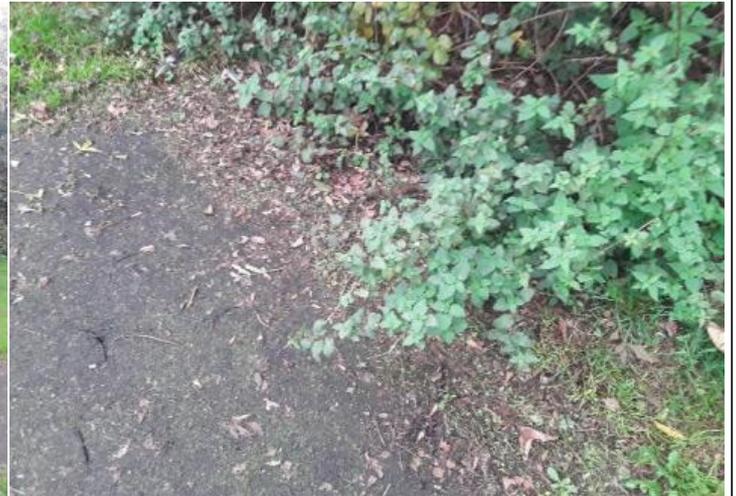
Risk Level: L - Low Risk
Surface: Wet Pour

Finding: The adjacent foliage is overhanging the falling space of the equipment

Action: Cut back and maintain

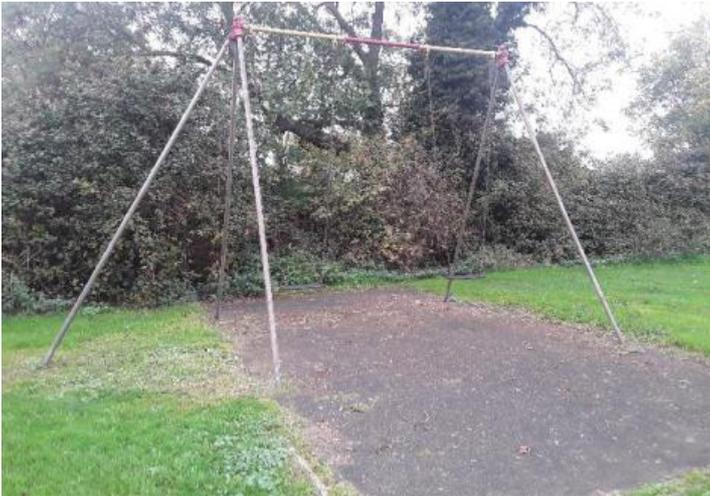
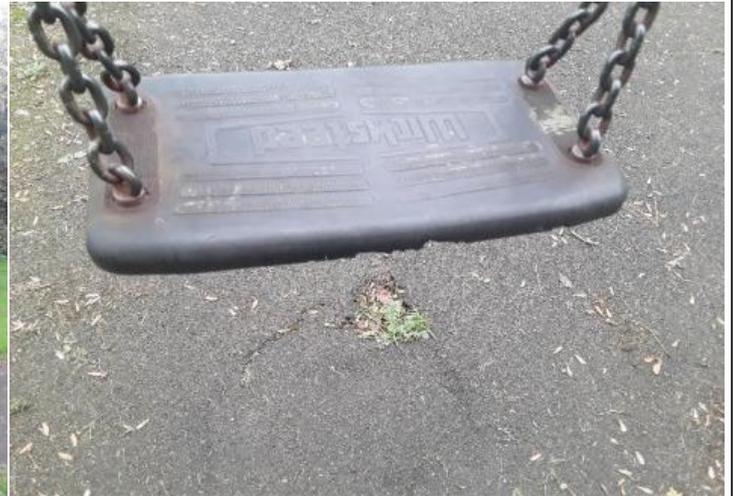
Risk Level: L - Low Risk
Surface: Wet Pour

Finding: The seat has minor damage or wear

Action: Monitor for any further deterioration and replace as required

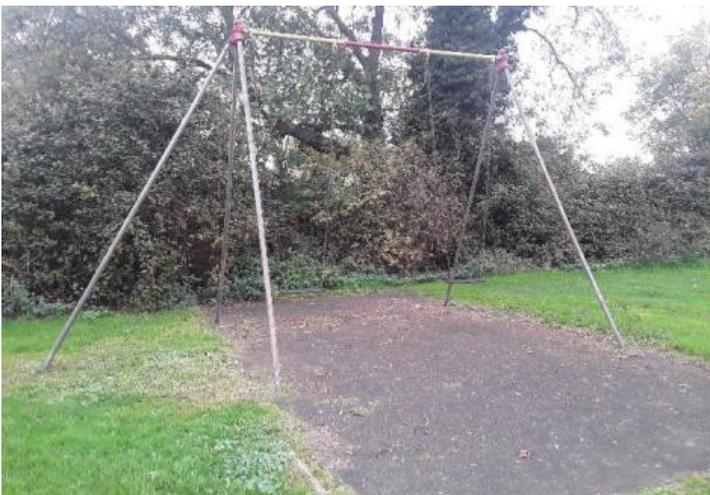
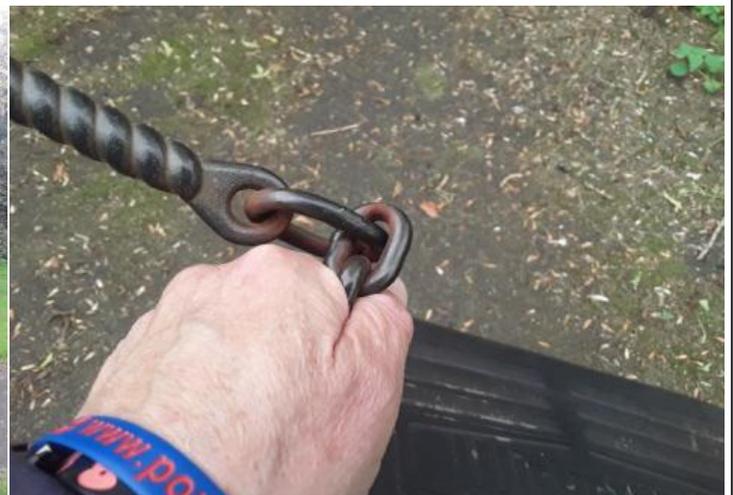
Risk Level: L - Low Risk
Surface: Wet Pour

Finding: The chain links are worn and require renewing

Action: Replace worn chains

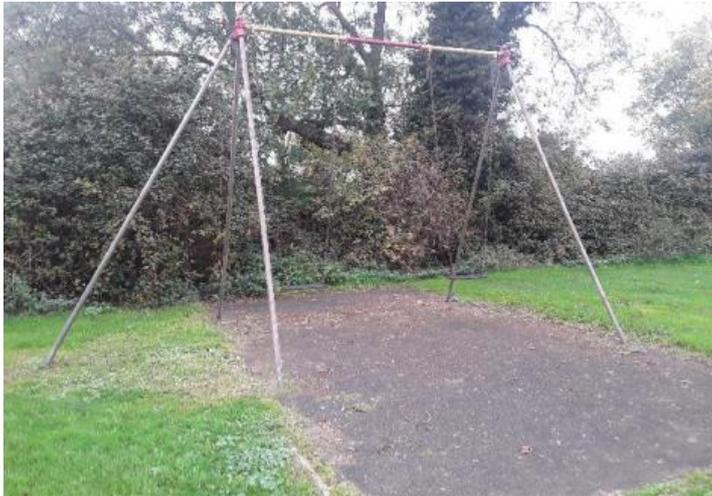
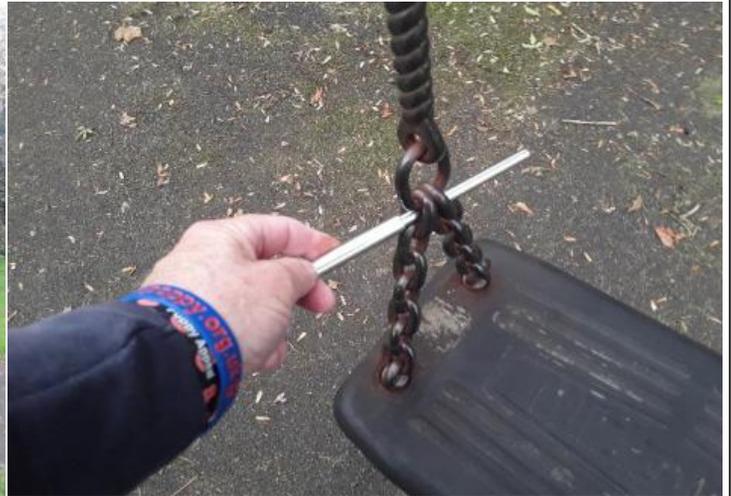
Risk Level: V - Very Low Risk
Surface: Wet Pour

Finding: The chain openings are in excess of the 8.6mm as recommended by BS EN 1176
Action: Monitor - No action given the risk assessment
