the **play inspection** company

Annual Inspection

Pointon Parish Council

Pointon Playing Field

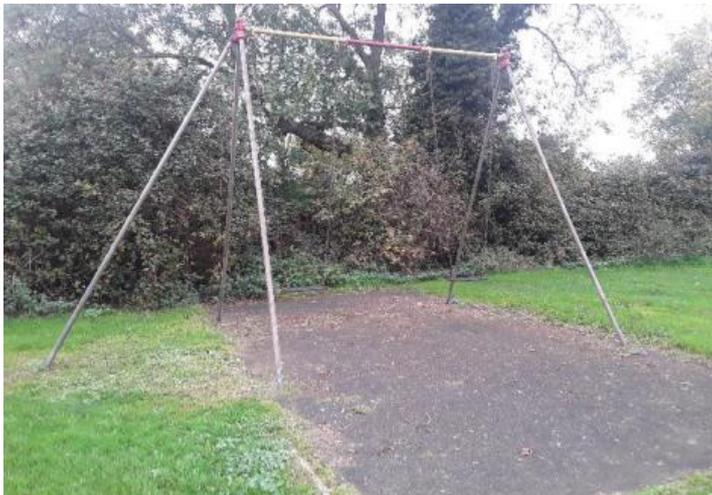
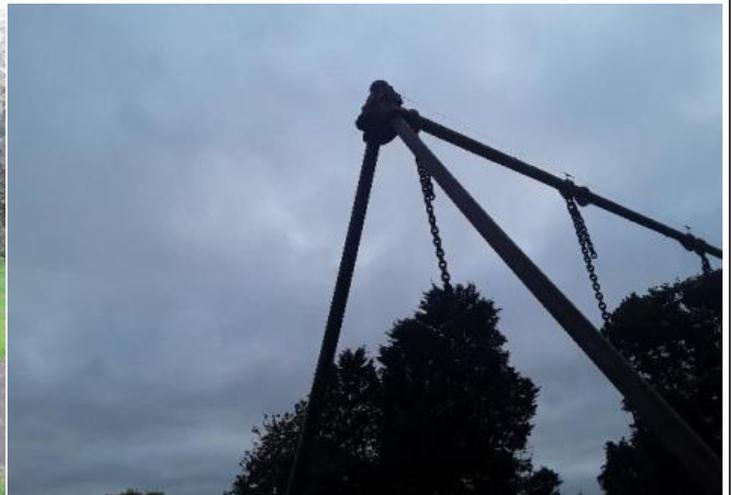
Risk Level: M - Moderate Risk
Surface: Wet Pour

Finding: One stabilising leg has been removed
Action: Replace the missing component

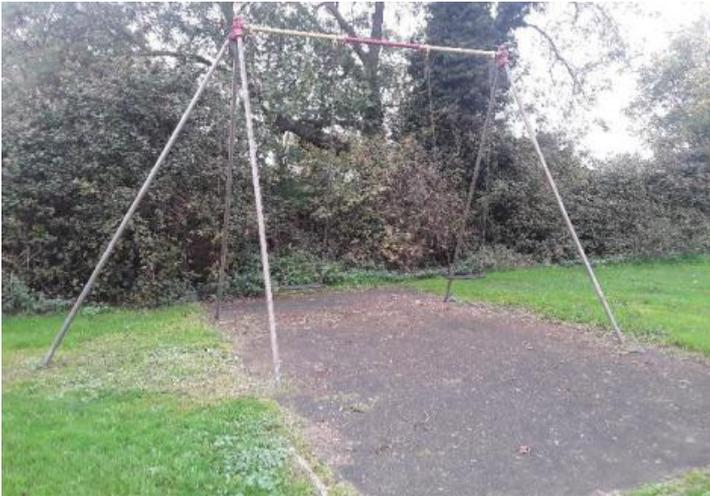
Finding: NOTE - The fixings or components for this item were in excess of 2.5m above the standing surface and could not be fully accessed by the inspector. We have completed a visual inspection of the fixings from ground level but a maintenance inspection should be undertaken to assess the condition, security and wear of the components at intervals in accordance with the manufacturers recommendations.

Action: Inspect in accordance with the manufacturers recommendations

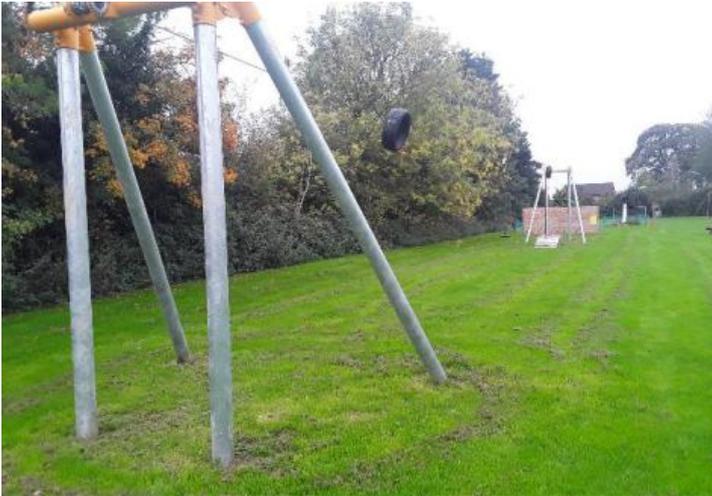
Finding: We have completed a visual inspection of the suspension links, cable and fixing points from ground level, however it is not possible to fully inspect these areas without either hiring equipment to gain access or removing the cable and suspension and inspecting at ground level. We recommend that the main cable and fixing security is thoroughly inspected at least in accordance with the manufacturers recommendations to check for wear, damage, security or internal rusting; this will help to ensure the continued safe use of the equipment

Action: Inspect in accordance with the manufacturers recommendations

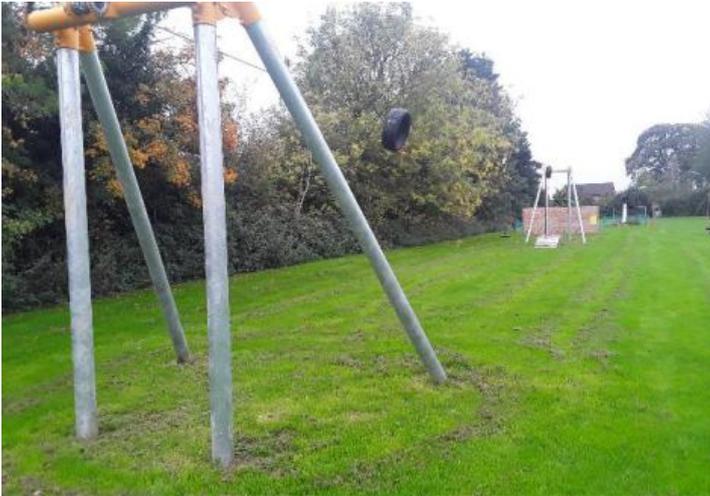
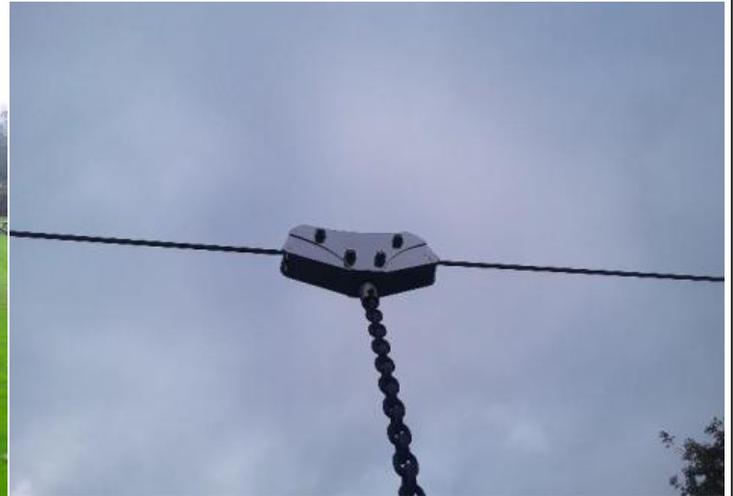
Risk Level: L - Low Risk
Surface: Grass

Finding: The bearings are worn in the traveller

Action: Replace the bearings
