Annual Inspection

Pointon Parish Council

Pointon Playing Field

Fen Road, Pointon, NG34 0LZ

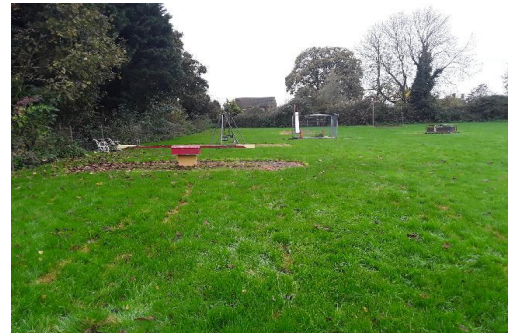
Item: Site General
Manufacturer: Not Applicable
Surface Type: N/A
Item Quantity: 1
Equipment Compliance: N/A
Surface Area Compliance: N/A

There is tree debris on the surfacing - Remove and maintain | Finding 2
There is algae, silt or moss growth on the surface resulting in slippery conditions - Clean and treat appropriately |

There is weed / vegetation growth within the surface - Remove weed / vegetation growth | Finding 4
A redundant damaged area of wet pour has been fenced off preventing access - Consider reinstating the area to grass |

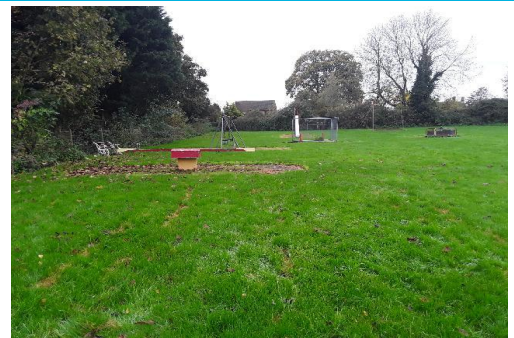
Item: Sign
Manufacturer: Not Applicable
Surface Type: N/A
Item Quantity: 1
Equipment Compliance: N/A
Surface Area Compliance: N/A

It is recommended that signage, with information including the site address, contact information for maintenance issues and emergency contact details are provided for the facility - Provide in accordance with the recommendations |

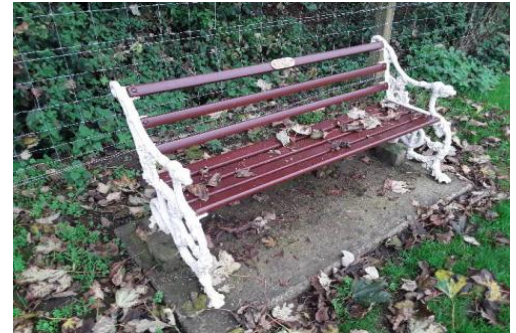
Item: Bench
Manufacturer: Not Identified
Surface Type: Concrete
Item Quantity: 1
Equipment Compliance: N/A
Surface Area Compliance: N/A

There are trip hazards present over the concrete base - Remove trip hazard

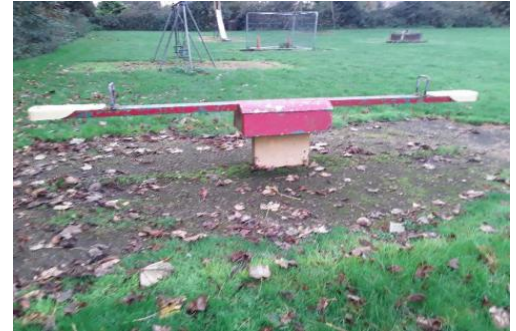
Item: See Saw
Manufacturer: Wicksteed Playgrounds
Surface Type: Wet Pour
Item Quantity: 1
Equipment Compliance: No
Surface Area Compliance: Yes

There is no gaiter protection for accessible moving parts (possible shear trap) as recommended in BS EN 1176 Part 1; 4.2.6 Moving Parts - Monitor - No remedial work recommended

There is damage to the surface - Repair the damaged areas of surfacing

The seat has minor damage or wear - Monitor for any further deterioration and replace as required

There is surface corrosion / rust present on the item - Consider treating the item

There is wear damage to the dampening mechanism - Monitor and replace if required

The surface has subsided in some areas - Monitor for any further deterioration and repair as required

The item fails to meet the requirements of BS EN 1176 Part 1 4.2.7.2 for head and neck entrapment in the handgrip openings - Monitor - No remedial work recommended

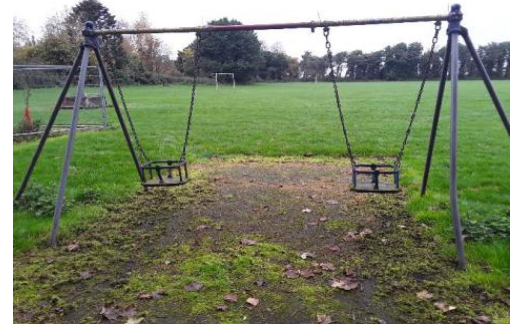
Item: 1 Bay 2 Seat (Cradle)
Manufacturer: Wicksteed Playgrounds
Surface Type: Wet Pour
Item Quantity: 1
Equipment Compliance: No
Surface Area Compliance: Yes

There is minor distortion damage to the leg - Monitor and repair if required

The seats are too close to the frame as defined in BS EN 1176 Part 2; this is a low risk failure and no remedial action is required - Monitor - No remedial work recommended

The surfacing width under the seat/s is / are less than 875mm when measured from the centre of the seat outwards, and fails the requirements of BS EN 1176 Part 2 - Monitor - No remedial work recommended

The chain openings are in excess of the 8.6mm as recommended by BS EN 1176 - Monitor - No remedial work recommended

There is some notable evidence of chain wear - Monitor for any further deterioration and replace when 40% worn

There is some wear to the shackles. - Monitor for any further deterioration and replace when 40% worn

The fixings have corroded - Replace all corroded fixings

The split pins are missing from the shackles - Insert split pins to secure the shackles

There is surface corrosion / rust present on the item - Consider treating the item

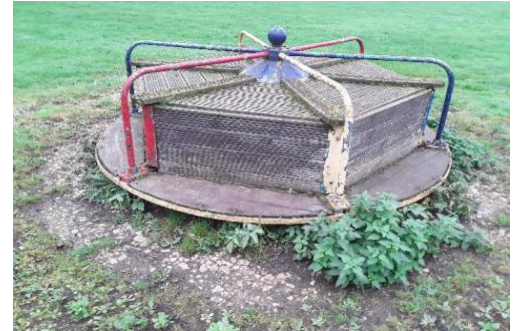
Item: Carousel
Manufacturer: Wicksteed Playgrounds
Surface Type: Gravel
Item Quantity: 1
Equipment Compliance: No
Surface Area Compliance: No

The safety surface has degraded / reduced and the concrete foundations are exposed - Replace the missing safety surface

The item fails to meet the requirements of BS EN 1176 Part 1 4.2.7.2 for head and neck entrapment in the handgrip openings - Monitor - No remedial work recommended

The bearing is showing signs of wear - Monitor for any further deterioration and replace as required

The surfacing dimensions are short and do not meet with the requirements of the current applicable standard - Monitor - no remedial action recommended

The distance between the underside of the roundabout platform and the playing surface is in excess of 110mm and contravenes the requirements of BS EN 1176 Part 5 which requires that the distance be maintained between 60mm-110mm - for the entire circumference of the roundabout - Replace the safety surface

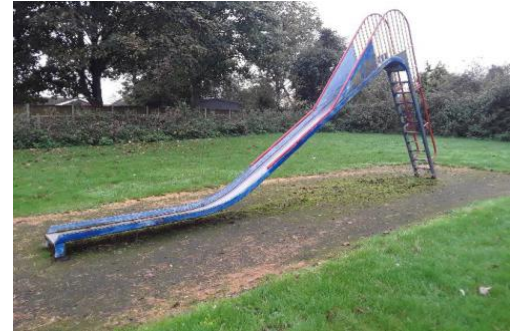
Item: Free Standing Slide
Manufacturer: Wicksteed Playgrounds
Surface Type: Wet Pour
Item Quantity: 1
Equipment Compliance: No
Surface Area Compliance: No

There is damage to the surface - Repair the damaged areas of surfacing

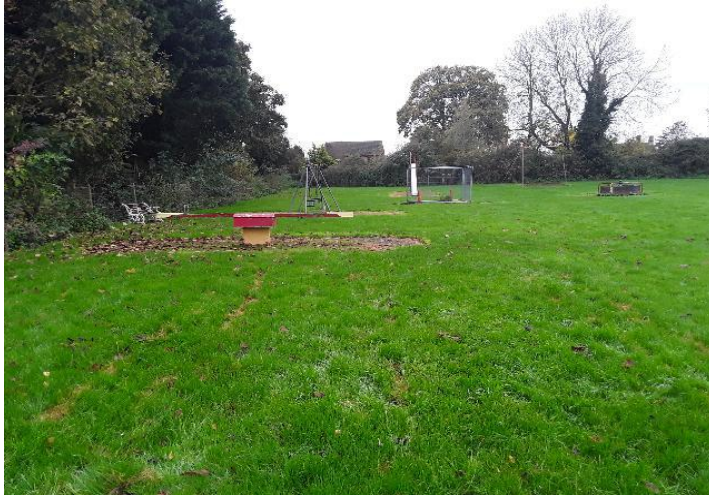
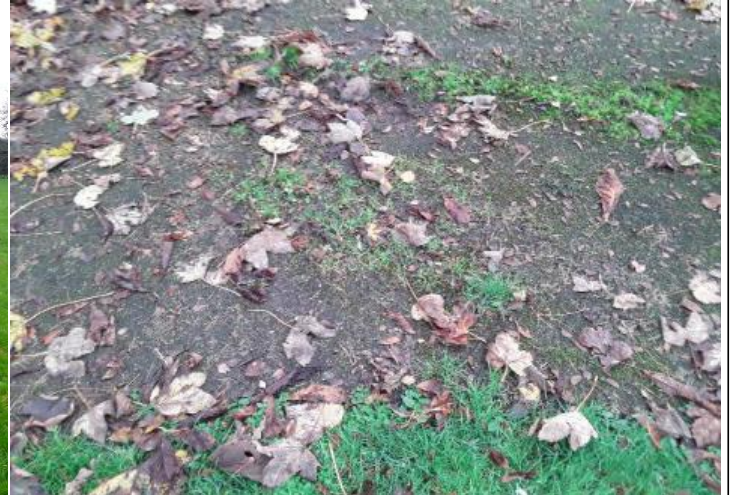
Item: Ancillary Items - Site General
Manufacturer: Not Applicable

Finding: There is tree debris on the surfacing

Action: Remove and maintain

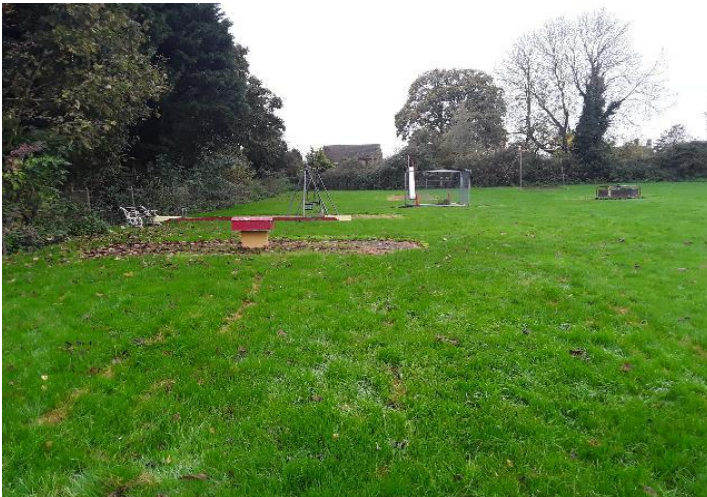
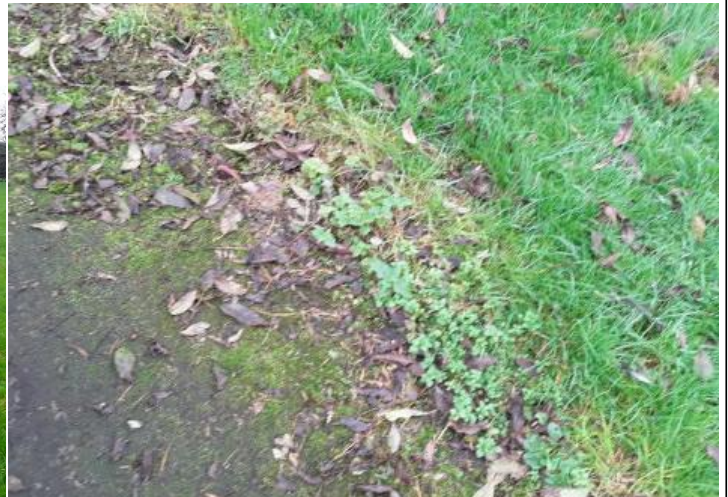
Item: Ancillary Items - Site General
Manufacturer: Not Applicable

Finding: There is weed / vegetation growth within the surface

Action: Remove weed / vegetation growth

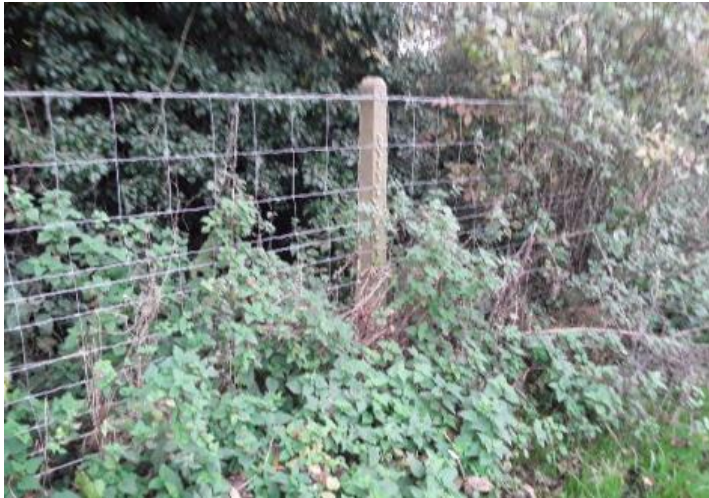
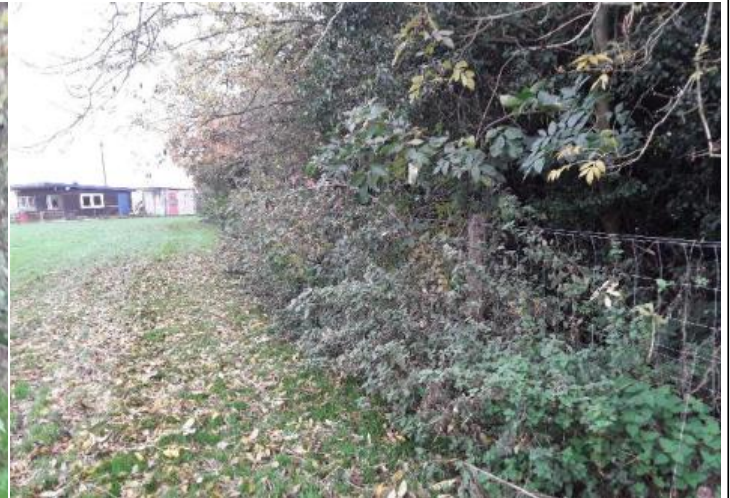
Item: Fences - Fence
Manufacturer: Not Identified

Finding: The adjacent foliage is overhanging or growing through the fence

Action: Cut back and maintain

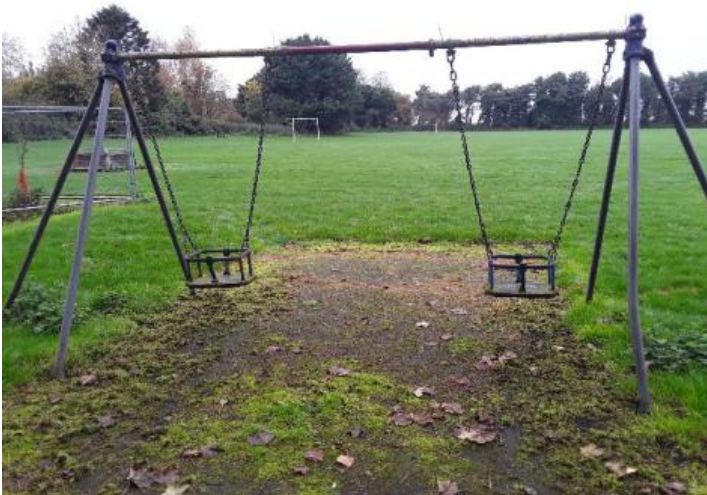
Item: Swings - 1 Bay 2 Seat (Cradle)
Manufacturer: Wicksteed Playgrounds

Finding: The seats are too close to the frame as defined in BS EN 1176 Part 2; this is a low risk failure and no remedial action is required

Action: Monitor - No remedial work recommended

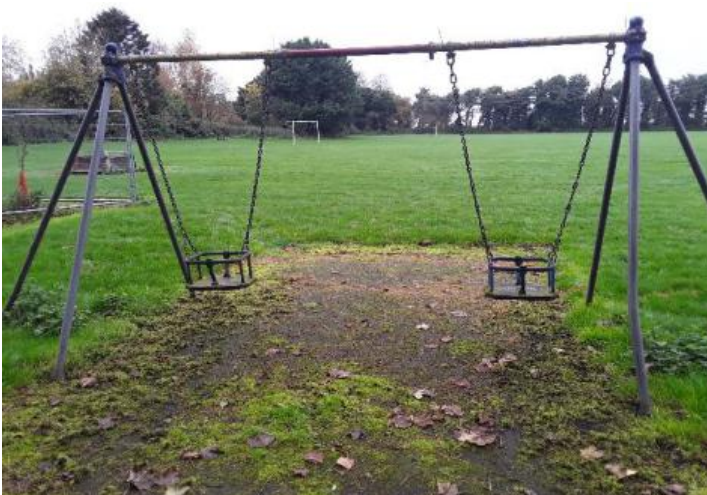
Item: Swings - 1 Bay 2 Seat (Cradle)
Manufacturer: Wicksteed Playgrounds

Finding: The surfacing width under the seat/s is / are less than 875mm when measured from the centre of the seat outwards, and fails the requirements of BS EN 1176 Part 2

Action: Monitor - No remedial work recommended

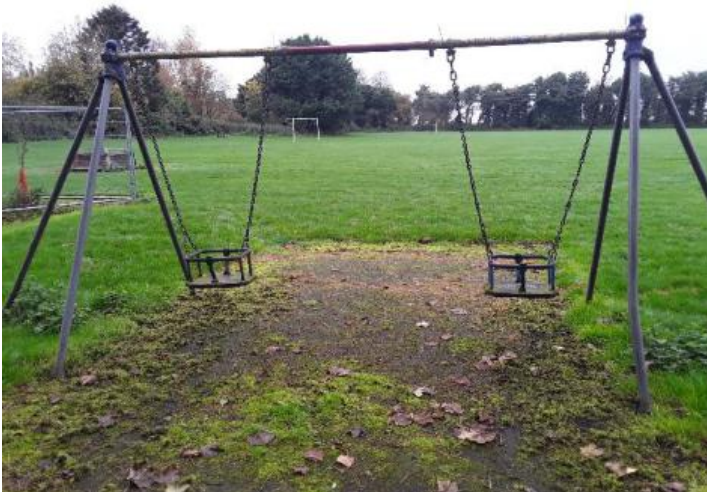
Item: Swings - 1 Bay 2 Seat (Cradle)
Manufacturer: Wicksteed Playgrounds

Finding: The chain openings are in excess of the 8.6mm as recommended by BS EN 1176 **Action:** Monitor - No remedial work recommended

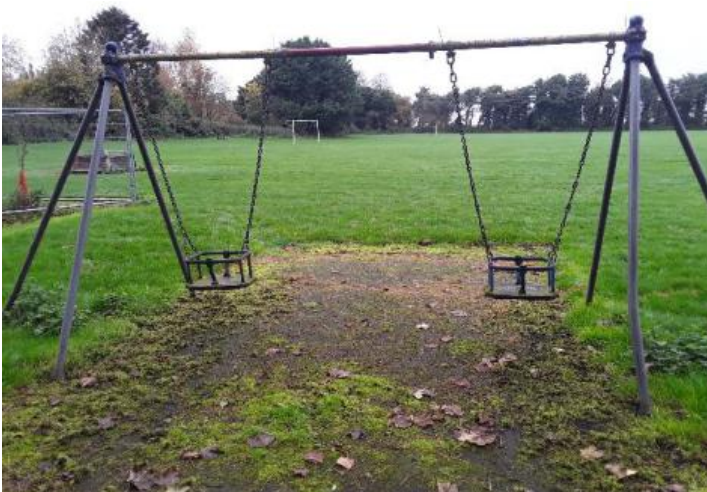
Item: Swings - 1 Bay 2 Seat (Cradle)
Manufacturer: Wicksteed Playgrounds

Finding: There is some notable evidence of chain wear **Action:** Monitor for any further deterioration and replace when 40% worn

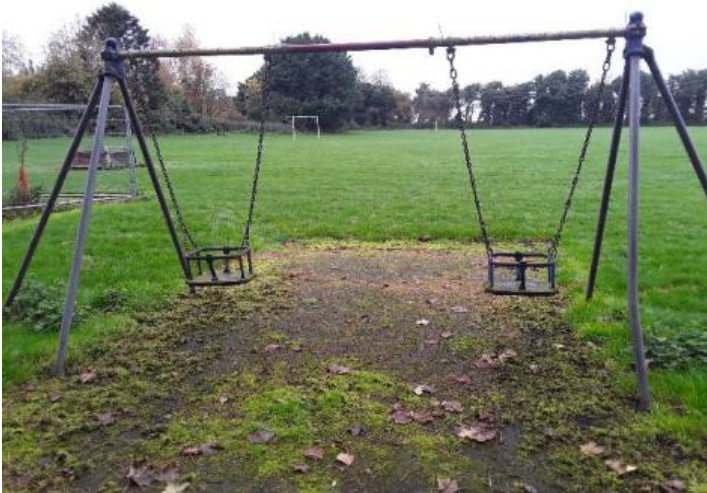
Item: Swings - 1 Bay 2 Seat (Cradle)
Manufacturer: Wicksteed Playgrounds

Finding: There is some wear to the shackles.

Action: Monitor for any further deterioration and replace when 40% worn

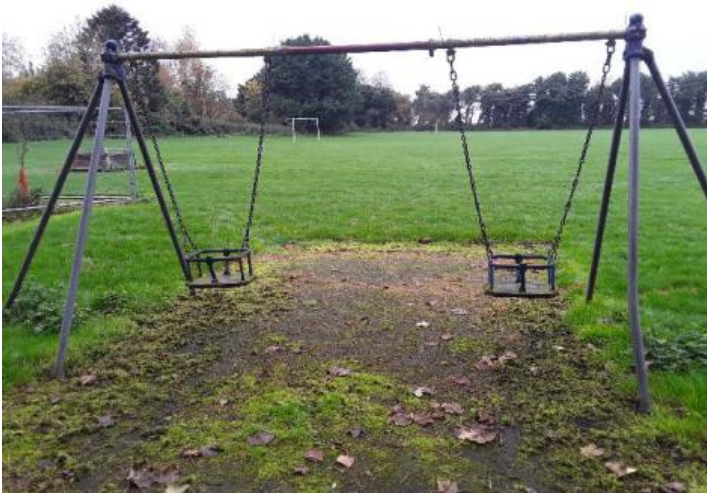
Item: Swings - 1 Bay 2 Seat (Cradle)
Manufacturer: Wicksteed Playgrounds

Finding: The fixings have corroded

Action: Replace all corroded fixings

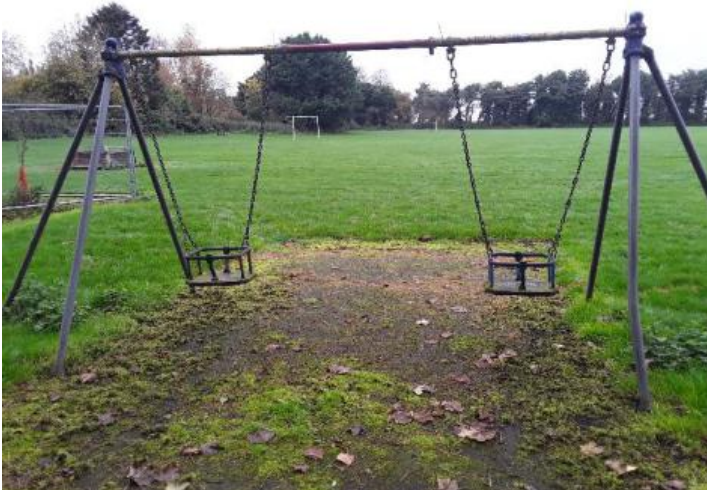
Item: Swings - 1 Bay 2 Seat (Cradle)
Manufacturer: Wicksteed Playgrounds

Finding: The split pins are missing from the shackles

Action: Insert split pins to secure the shackles

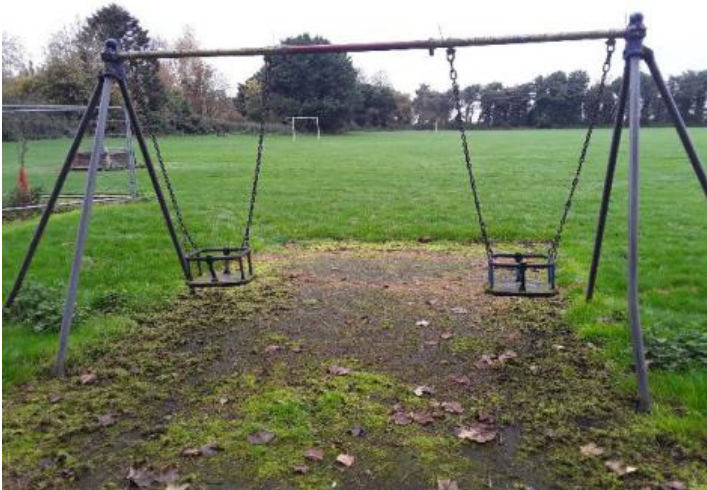
Item: Swings - 1 Bay 2 Seat (Cradle)
Manufacturer: Wicksteed Playgrounds

Finding: There is surface corrosion / rust present on the item

Action: Consider treating the item

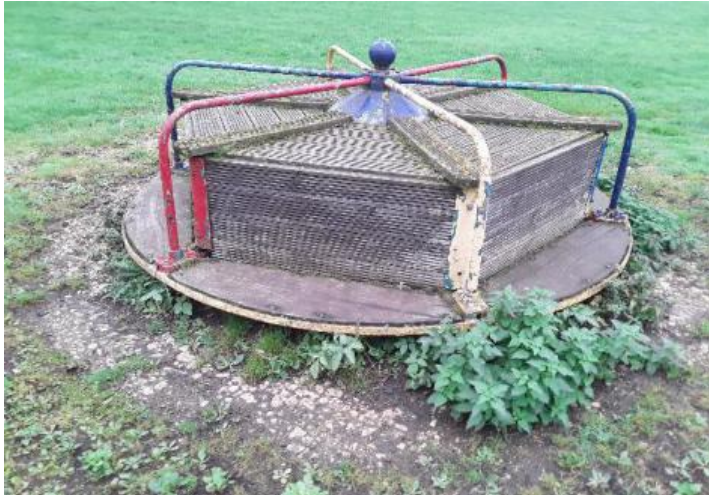
Item: Rotor Play - Carousel
Manufacturer: Wicksteed Playgrounds

Finding: The safety surface has degraded / reduced and the concrete foundations are exposed

Action: Replace the missing safety surface

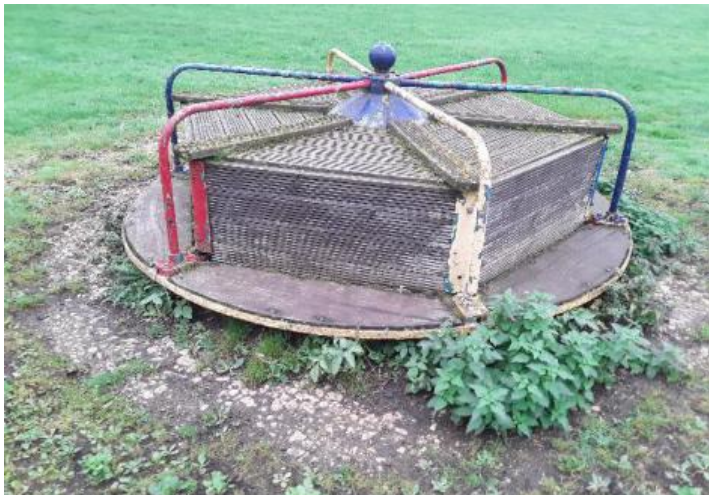
Item: Rotor Play - Carousel
Manufacturer: Wicksteed Playgrounds

Finding: The surfacing dimensions are short and do not meet with the requirements of the current applicable standard

Action: Monitor - no remedial action recommended

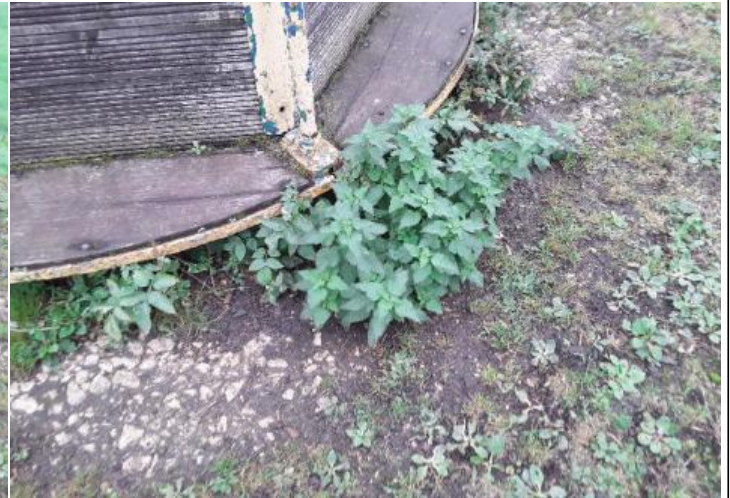
Item: Rotor Play - Carousel
Manufacturer: Wicksteed Playgrounds

Finding: There is nettle growth under the roundabout

Action: Remove the nettles

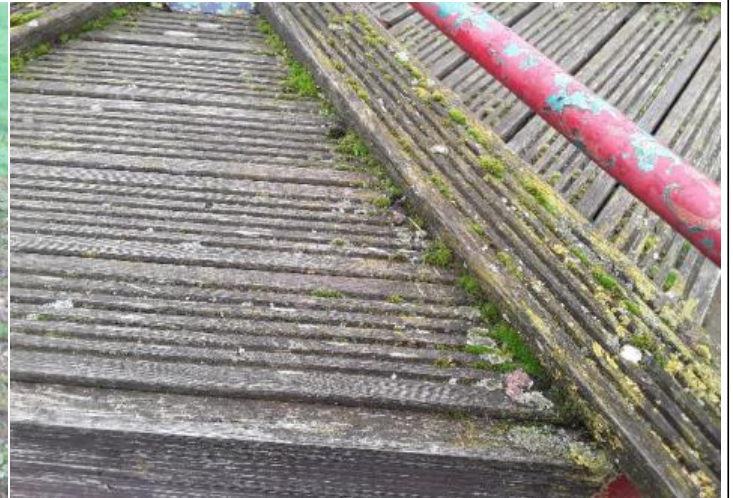
Item: Rotor Play - Carousel
Manufacturer: Wicksteed Playgrounds

Finding: There is algae or moss on the surface of the equipment

Action: Clean and treat appropriately

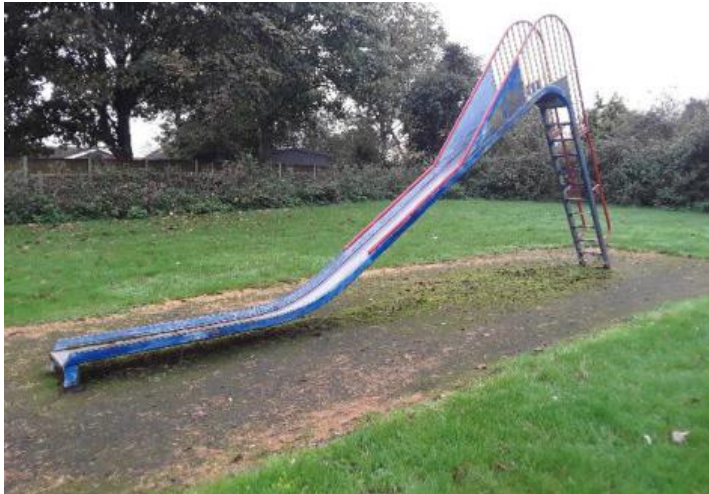
Item: Other - Free Standing Slide
Manufacturer: Wicksteed Playgrounds

Finding: The surfacing dimensions are short and do not meet with the requirements of the current applicable standard

Action: Monitor - no remedial action recommended

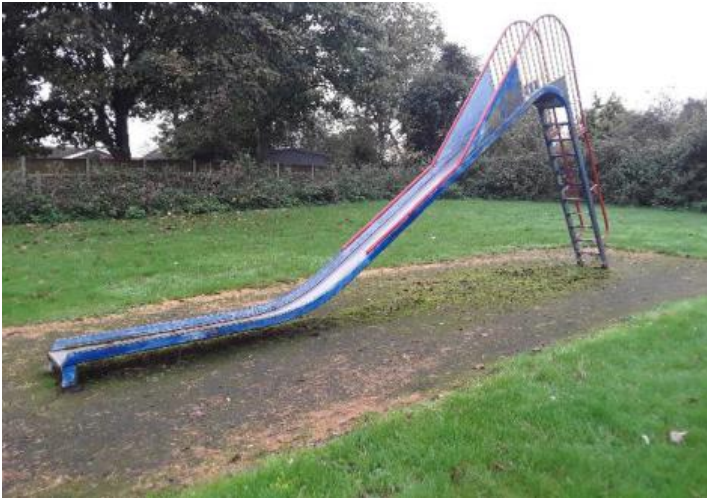
Item: Other - Free Standing Slide
Manufacturer: Wicksteed Playgrounds

Finding: There are a number of dents in the slide surface

Action: Monitor for any further deterioration and repair as required

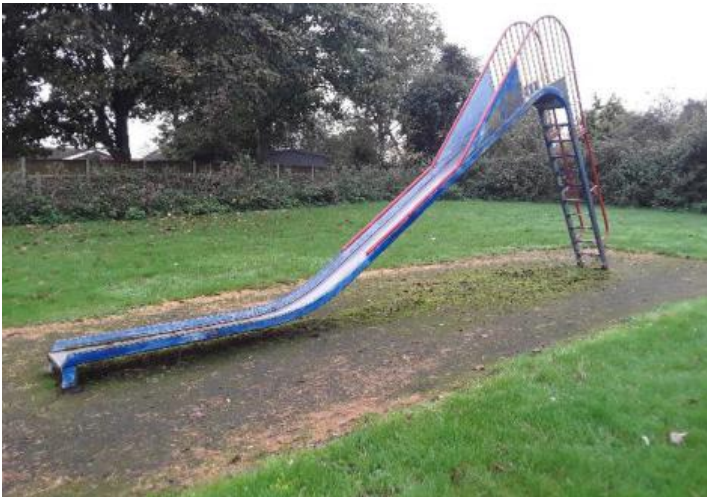
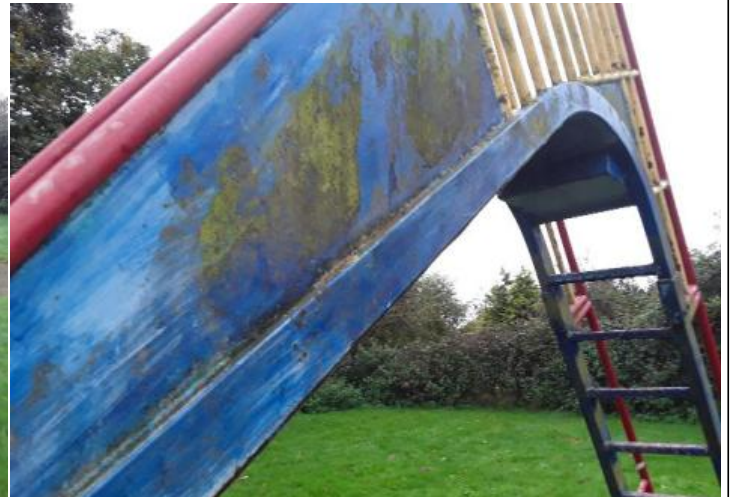
Item: Other - Free Standing Slide
Manufacturer: Wicksteed Playgrounds

Finding: There is algae or moss on the surface of the equipment

Action: Clean and treat appropriately

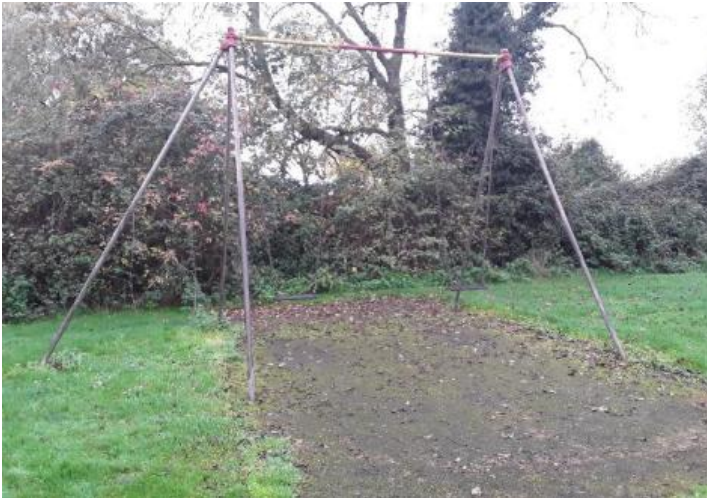
Item: Swings - 1 Bay 2 Seat (Flat)
Manufacturer: Wicksteed Playgrounds

Finding: There is some wear to the shackles.

Action: Monitor for any further deterioration and replace when 40% worn

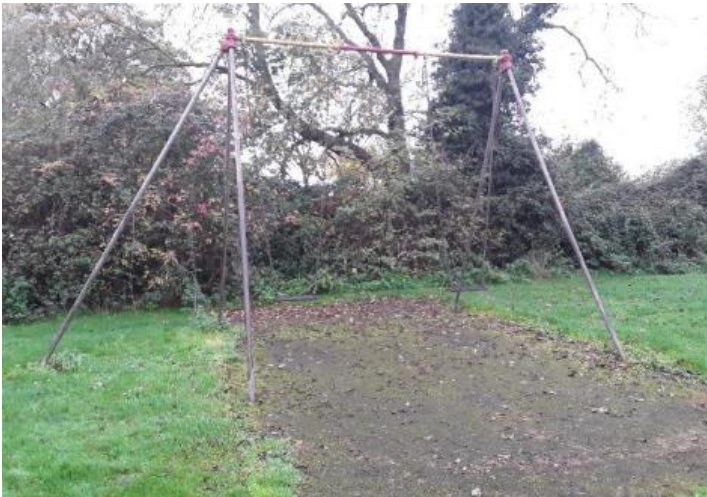
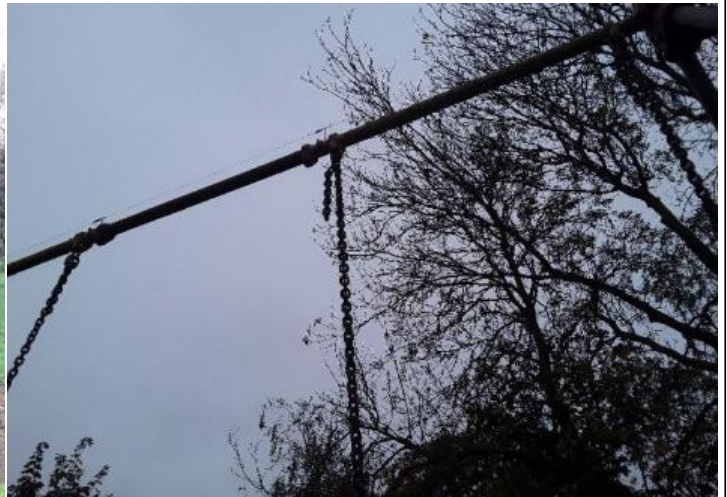
Item: Swings - 1 Bay 2 Seat (Flat)
Manufacturer: Wicksteed Playgrounds

Finding: There are excessive chain tails

Action: Cut back excessive chain links
