the **play inspection** company

Annual Inspection

Pointon Parish Council

Pointon Playing Field

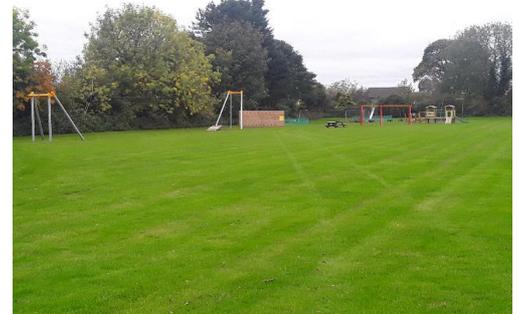
Item: Site General
Manufacturer: Not Applicable
Surface Type: N/A
Item Quantity: 1
Equipment Compliance: N/A
Surface Area Compliance: N/A

There is some tree debris on the surfacing - Remove and maintain

There are a number of molehills within the area and these may present unforeseen hazards for users - Remove moles by appropriate means, reinstate surfaces to level and maintain the area

There is algae, silt or moss growth on the surface resulting in slippery conditions - Clean and treat appropriately

Two pieces of equipment have been isolated from use using euro mesh and road pins, however the method of isolating the equipment has introduced additional hazards that may cause harm to visitors to the play area - Provide a more suitable isolation method

A redundant damaged area of wet pour has been fenced off preventing access - Consider reinstating the area to grass

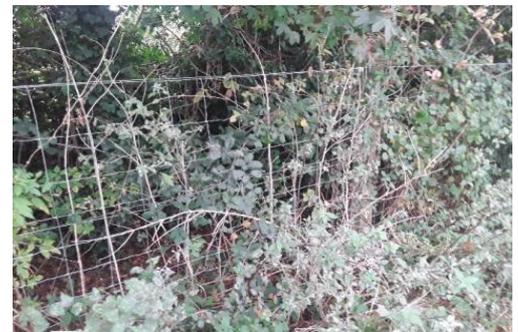
Item: Fence
Manufacturer: Not Identified
Surface Type: Grass
Item Quantity: 1
Equipment Compliance: N/A
Surface Area Compliance: N/A

The adjacent foliage is overhanging or growing through the fence and the inspector was unable to verify the condition of the fence in a number of places - Cut back and maintain

i 8 - Low Risk

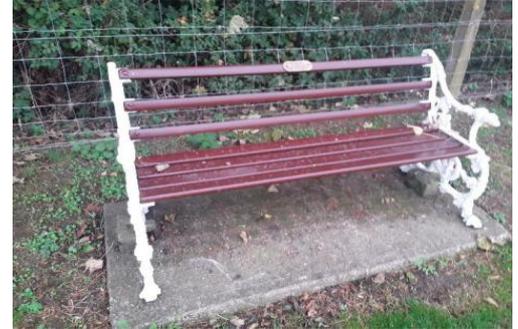
Item: Bench
Manufacturer: Not Identified
Surface Type: Concrete
Item Quantity: 1
Equipment Compliance: N/A
Surface Area Compliance: N/A

There are trip hazards present over the concrete base - Remove trip hazard

i 8 - Low Risk

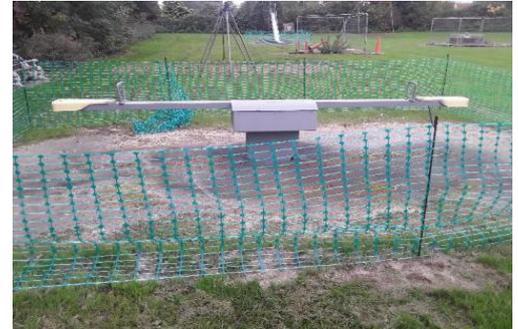
Item: See Saw
Manufacturer: Wicksteed Playgrounds
Surface Type: Wet Pour
Item Quantity: 1
Equipment Compliance: No
Surface Area Compliance: Yes

The surfacing is damaged - Repair damaged areas of surfacing

There is no gaiter protection for accessible moving parts (possible shear trap) as recommended in BS EN 1176 Part 1; 4.2.6 Moving Parts - Monitor - No action given the risk assessment

The item fails to meet the requirements of BS EN 1176 Part 1 4.2.7.2 for head and neck entrapment in the handgrip openings - Monitor - No action given the risk assessment

The seat is damaged and requires replacing - Replace damaged seat

Parts of the steel on this item have corroded excessively and the metal has perforated in places - Ensure all affected areas are treated and repaired

The surface has subsided in some areas - Monitor for any further deterioration and repair as required

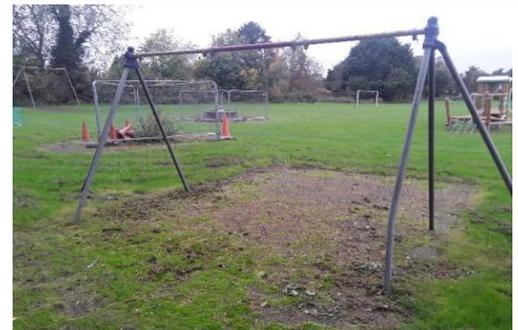
Item: 1 Bay 2 Seat (Cradle)
Manufacturer: Wicksteed Playgrounds
Surface Type: Wet Pour
Item Quantity: 1
Equipment Compliance: N/A
Surface Area Compliance: N/A

The item has missing component(s) - Consider replacing missing components

There is minor distortion damage to the legs - Monitor and repair if required

The paintwork on this item has been damaged or worn exposing the metal underneath which is rusting / corroding - Treat affected areas and repaint

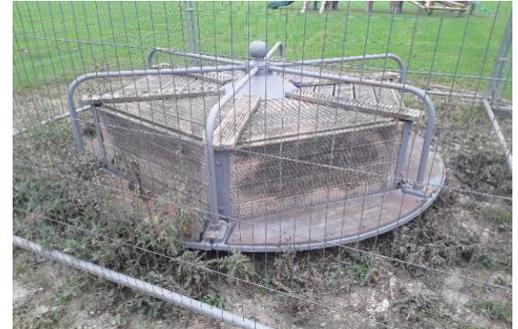
Item: Carousel
Manufacturer: Wicksteed Playgrounds
Surface Type: Gravel
Item Quantity: 1
Equipment Compliance: No
Surface Area Compliance: No

The distance between the underside of the roundabout platform and the playing surface is in excess of 110mm and contravenes the requirements of BS EN 1176 Part 5 which requires that the distance be maintained between 60mm-110mm - for the entire circumference of the roundabout - Monitor - No action given the risk assessment

Parts of the timber are rough / splintered or have rot apparent - Remove all rough or sharp edges / replace the rotted components

The item fails to meet the requirements of BS EN 1176 Part 1 4.2.7.2 for head and neck entrapment in the framework - Monitor - No action given the risk assessment

The surfacing has degraded and the concrete foundations are exposed - Repair / replace damaged areas of surfacing

There is/are finger entrapment/s in the structure and the item fails to meet the requirements of BS EN 1176 Part 1 4.2.7.6 Entrapment of fingers - Monitor - No action given the risk assessment

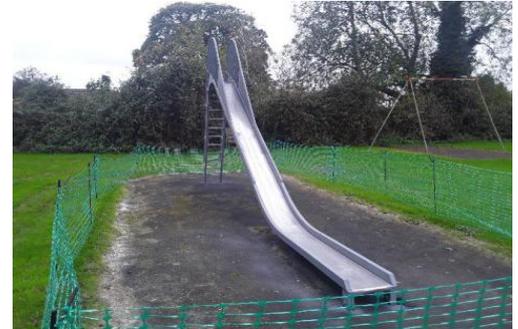
Item: Free Standing Slide
Manufacturer: Wicksteed Playgrounds
Surface Type: Wet Pour
Item Quantity: 1
Equipment Compliance: No
Surface Area Compliance: No

There are a number of dents in the slide surface - Monitor for any further deterioration and repair as required

The surfacing is damaged - Repair damaged areas of surfacing

The item fails to meet the requirements of BS EN 1176 Part 1 4.2.7.2 head and neck entrapment in the barriers and/or steps - Monitor - No action given the risk assessment

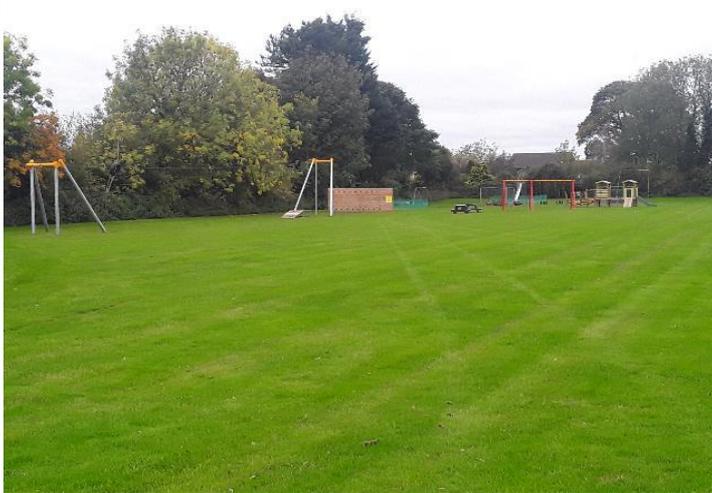
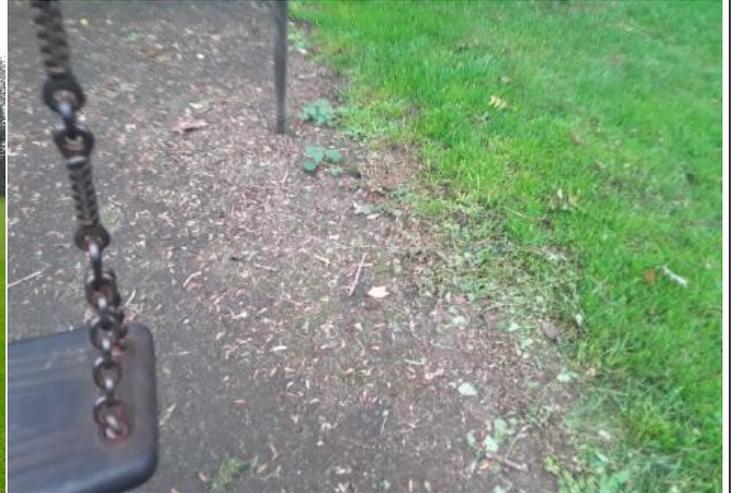
Item: Ancillary Items - Site General
Manufacturer: Not Applicable

Risk Level: L - Low Risk
Surface: N/A

Finding: There is some tree debris on the surfacing

Action: Remove and maintain

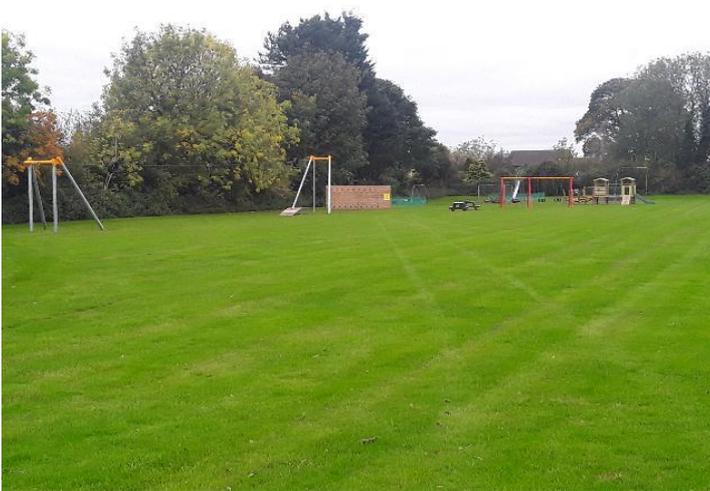
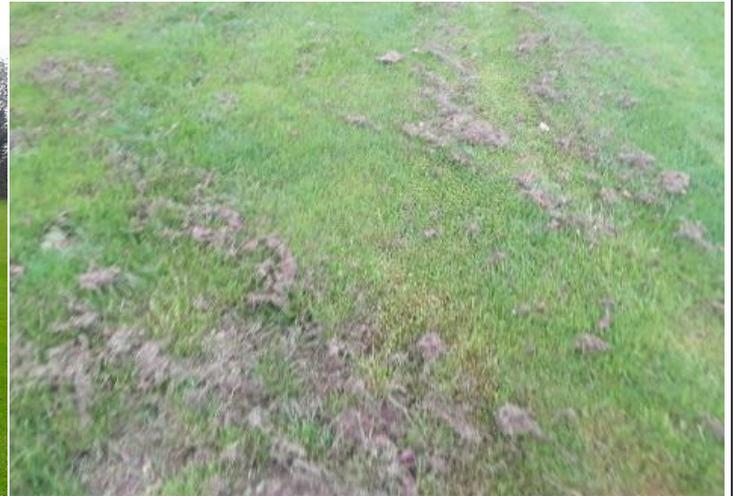
Item: Ancillary Items - Site General
Manufacturer: Not Applicable

Risk Level: L - Low Risk
Surface: N/A

Finding: There are grass cuttings on the surfacing

Action: Remove the grass cuttings

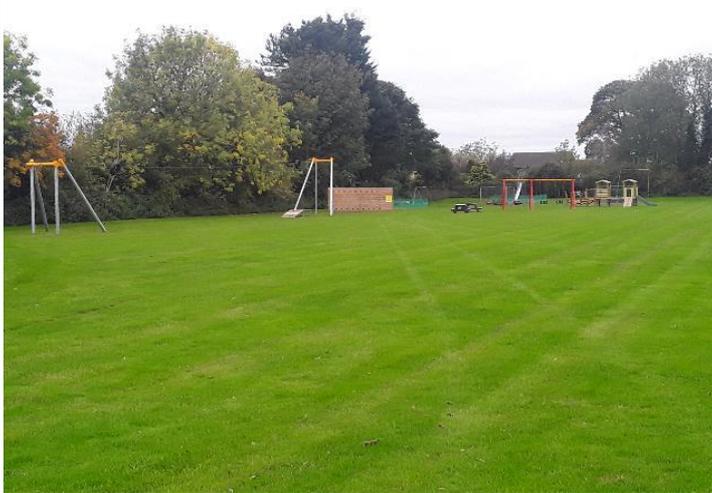
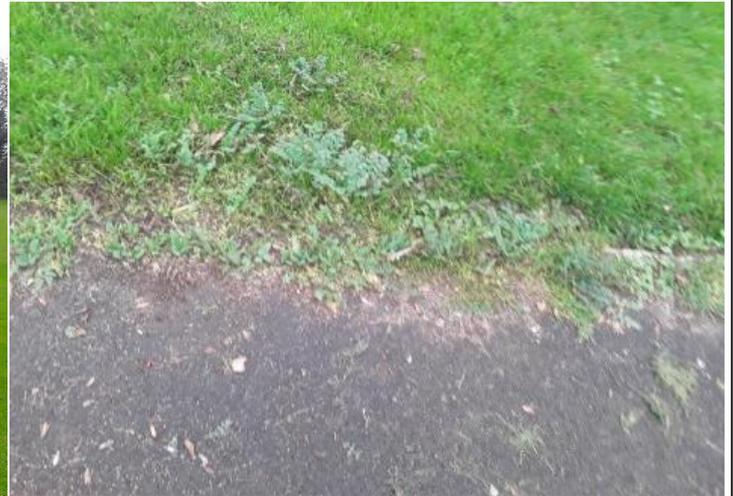
Item: Ancillary Items - Site General
Manufacturer: Not Applicable

Finding: There is weed / vegetation growth on and around the surface
Action: Remove weed / vegetation growth

i 6 - Low Risk (Finding 1)

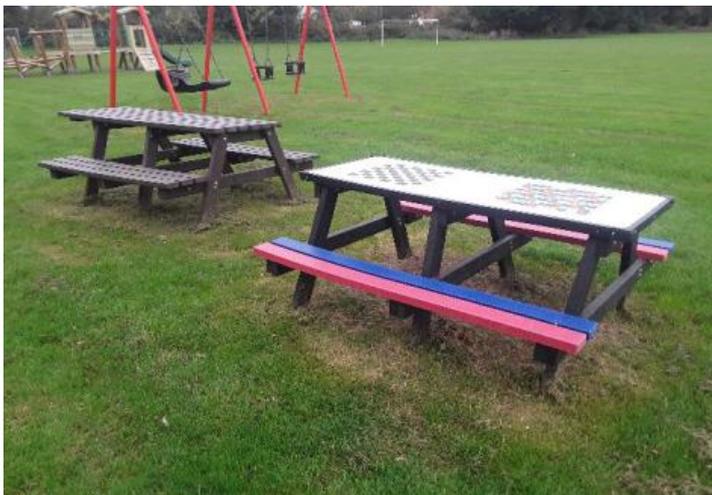
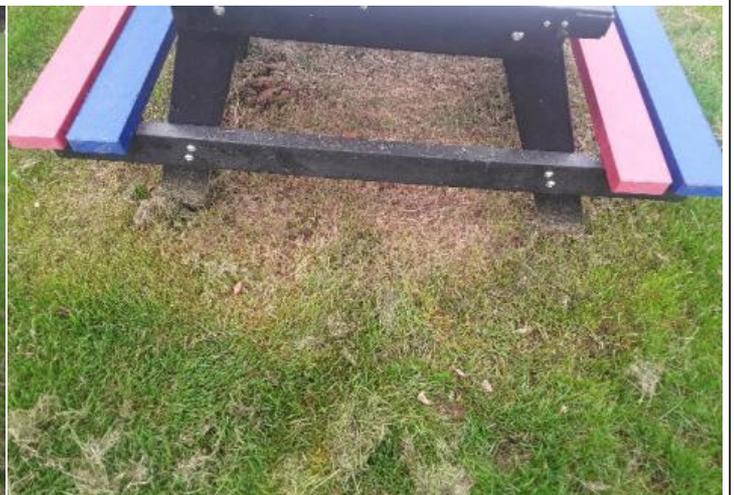
Item: Ancillary Items - Picnic Table
Manufacturer: Not Identified

Risk Level: L - Low Risk
Surface: Grass

Finding: The table/s is/are not secured to the ground and there is some potential for the item/s to be moved within falling spaces of equipment

Action: Secure to the ground

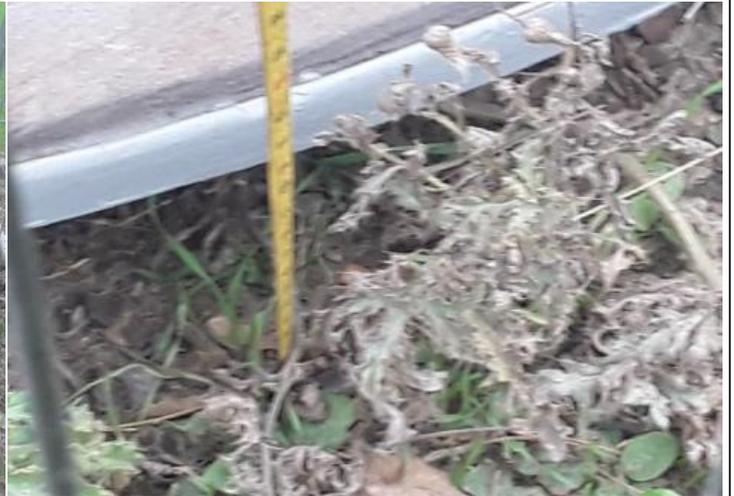
Item: Rotor Play - Carousel
Manufacturer: Wicksteed Playgrounds

Risk Level: L - Low Risk
Surface: Gravel

Finding: The distance between the underside of the roundabout platform and the playing surface is in excess of 110mm and contravenes the requirements of BS EN 1176 Part 5 which requires that the distance be maintained between 60mm-110mm - for the entire circumference of the roundabout

Action: Monitor - No action given the risk assessment

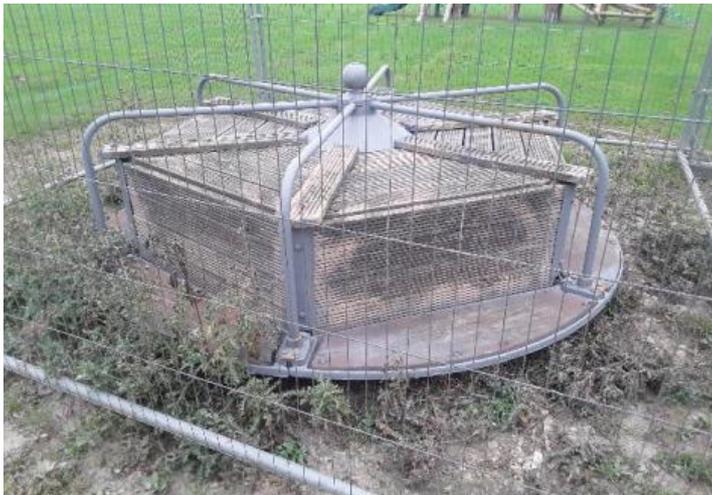
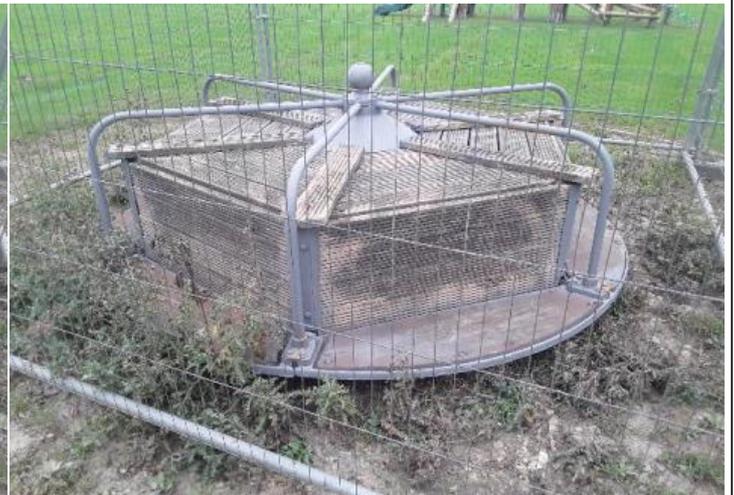
Item: Rotor Play - Carousel
Manufacturer: Wicksteed Playgrounds

Risk Level: V - Very Low Risk
Surface: Gravel

Finding: The surfacing dimensions are short and do not meet with the requirements of the current applicable standard

Action: Monitor - No action given the risk assessment

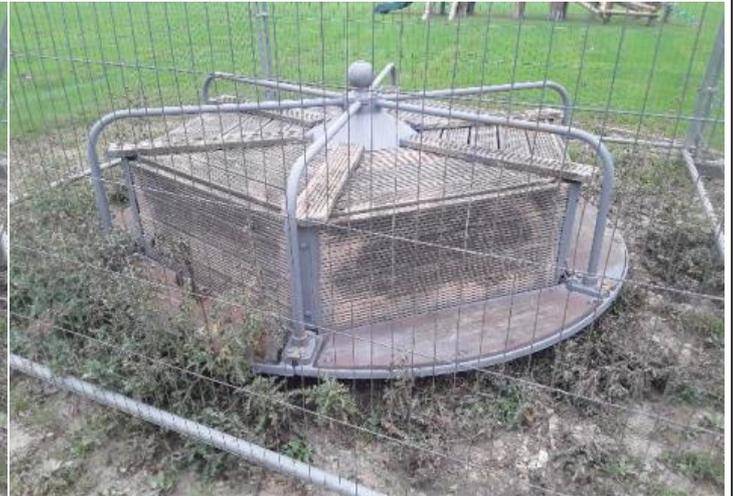
Item: Rotor Play - Carousel
Manufacturer: Wicksteed Playgrounds

Risk Level: L - Low Risk
Surface: Gravel

Finding: There is nettle / weed growth under and around the equipment

Action: Remove the nettles / weeds

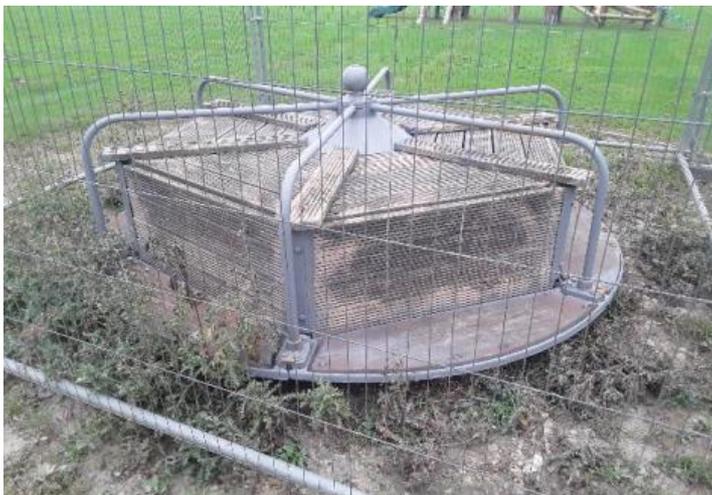
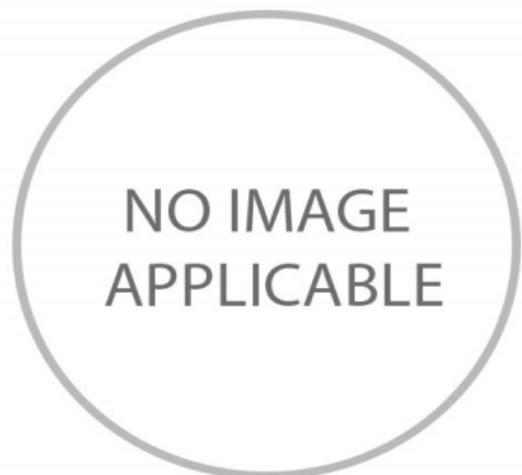
Item: Rotor Play - Carousel
Manufacturer: Wicksteed Playgrounds

Finding: NOTE: The item was isolated at the time of the inspection

Action: Remove the heras fencing once refurbishment is completed

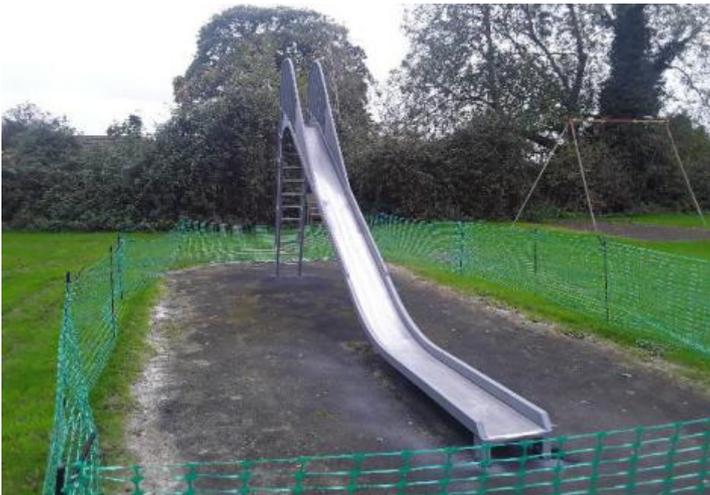
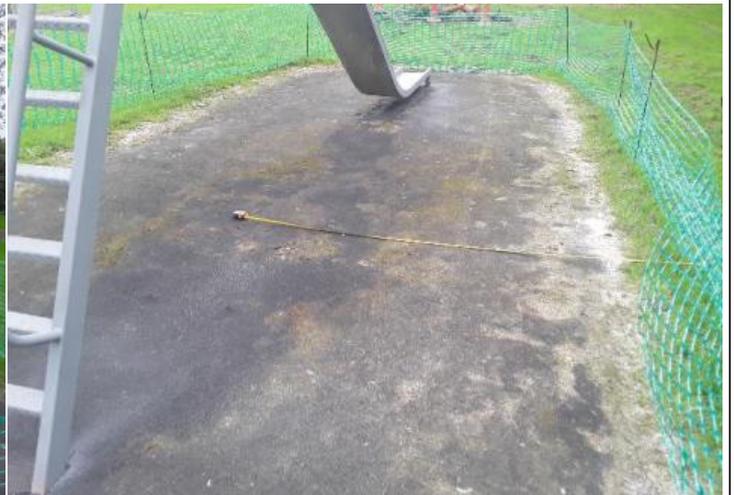
Item: Other - Free Standing Slide
Manufacturer: Wicksteed Playgrounds

Risk Level: V - Very Low Risk
Surface: Wet Pour

Finding: The surfacing dimensions are short and do not meet with the requirements of the current applicable standard

Action: Monitor - No action given the risk assessment

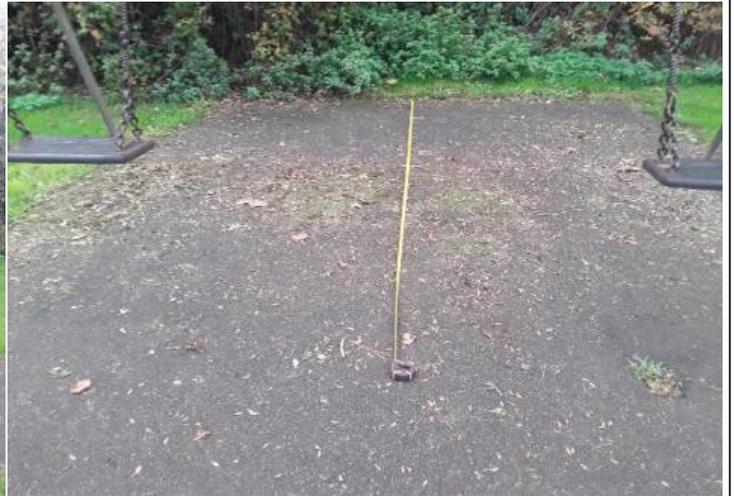
Item: Swings - 1 Bay 2 Seat (Flat)
Manufacturer: Wicksteed Playgrounds

Risk Level: V - Very Low Risk
Surface: Wet Pour

Finding: The surfacing dimensions are short and do not meet with the requirements of the current applicable standard

Action: Monitor - No action given the risk assessment

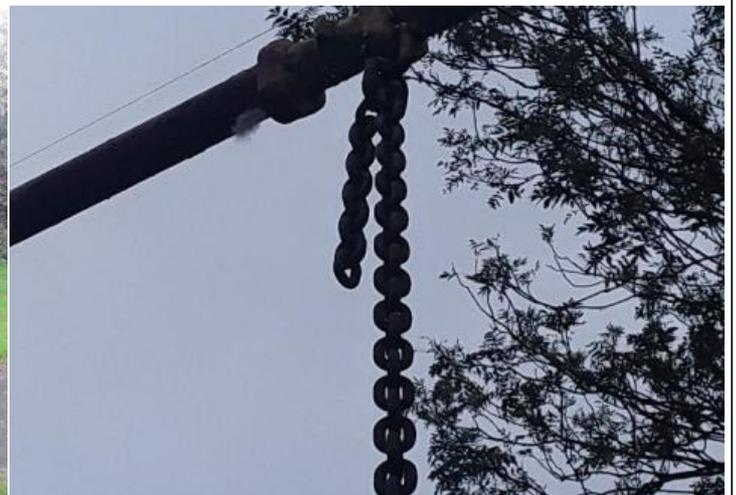
Item: Swings - 1 Bay 2 Seat (Flat)
Manufacturer: Wicksteed Playgrounds

Risk Level: L - Low Risk
Surface: Wet Pour

Finding: There are excessive chain tails

Action: Cut back excessive chain links
