Safety Inspection Report

Annual Inspection

Playing Field

Pointon & Sempringham Parish Council

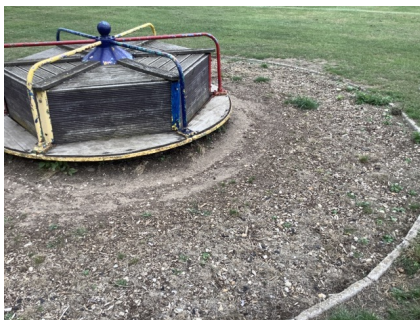
Loose fill levels are too low to provide adequate protection.

Surface worn down to stone level. The inspector recommends an alternative harder wearing surface is used.

Rake and fork over and top up as required to maintain minimum depth (usually 300 mm)., Read the notes for further action.

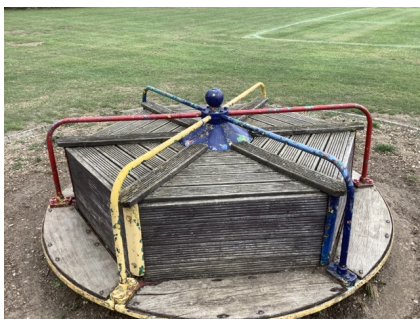
Paintwork is in poor condition.

De-scale back to good base material and coat with lead free paint, using appropriate precautions. Repairs may be necessary where corrosion is severe.

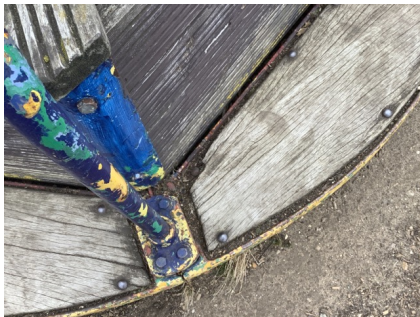
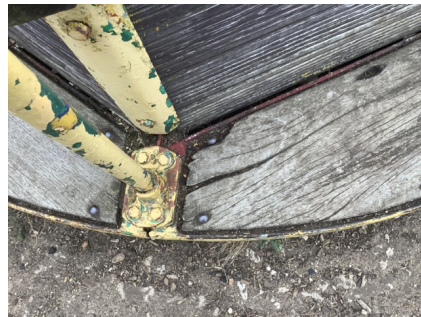
Timber is decayed.

Replace affected parts.

Replace affected floor panels.

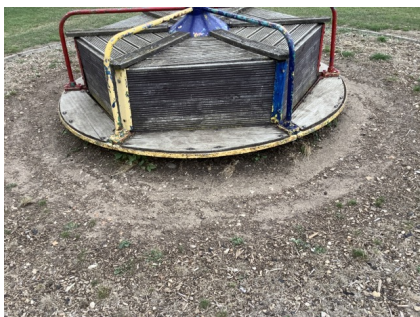
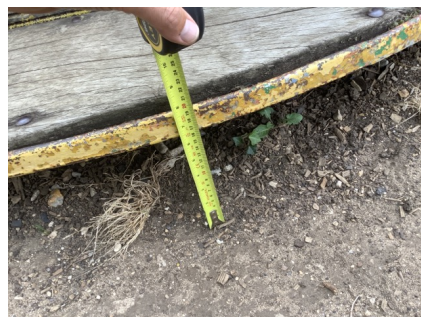
Clearance between the underside of the roundabout and the surface is incorrect.

Top-up surface to reduce the gap between 60 mm and 110 mm.

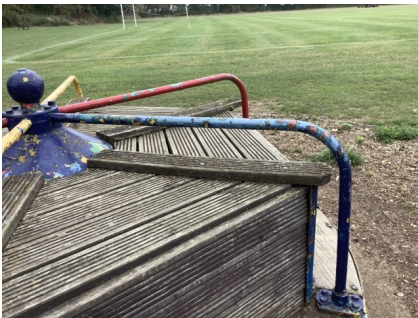
There is a head entrapment.

The unit was installed prior to the publication of the current standards. There is no requirement to make retrospective changes.

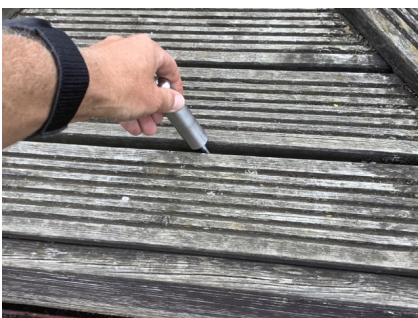
Finger entrapment.

No reasonably practicable action is identified.

Monitor.

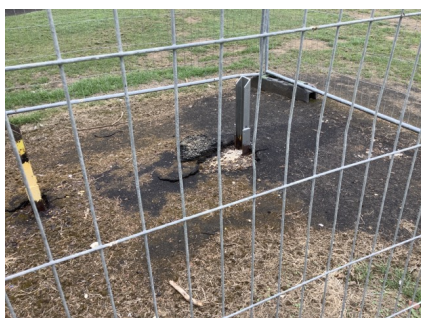
The wet pour surface is cracking.

Repair.

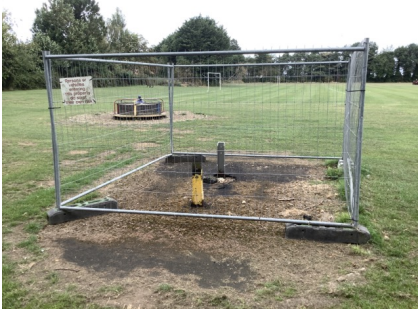
The item has been dismantled and fenced off.

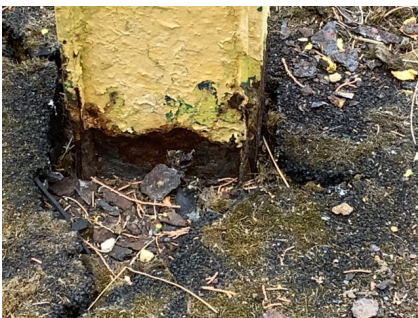
There is significant corrosion on this item.

De-scale back to good metal and coat with lead free paint, using appropriate precautions. Repairs may be necessary where corrosion is severe.

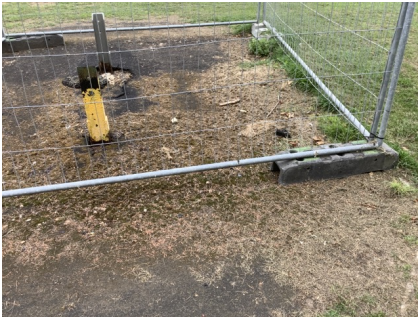
Moss is present.

Remove.

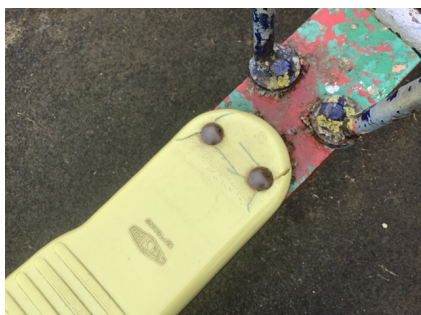
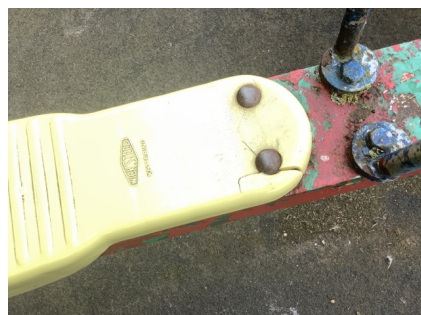
Item is damaged.

Both seats are cracked. Monitor.

No reasonably practicable action is identified., Read the notes for further action.

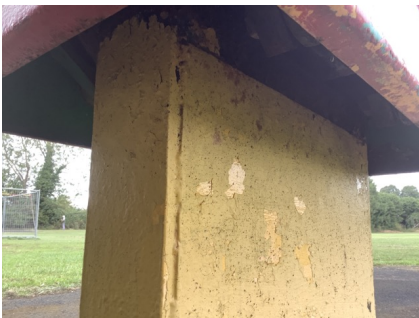
Item has some parts missing.

Mechanism cover missing. Replace.

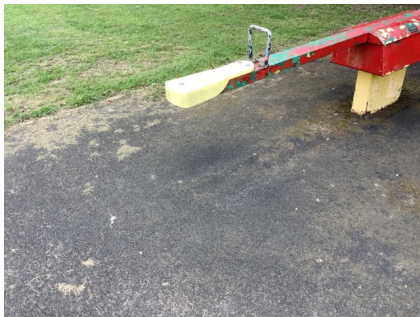
Sub-base collapsed. Monitor for holes and repair as necessary.

Monitor.

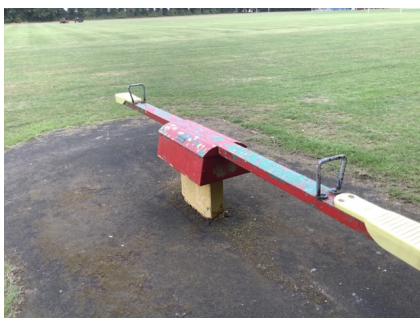
Paintwork is in poor condition.

De-scale back to good base material and coat with lead free paint, using appropriate precautions. Repairs may be necessary where corrosion is severe.

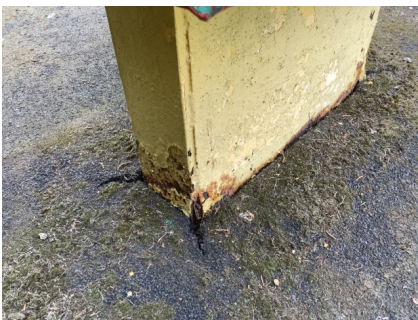
There is significant corrosion on this item.

Corrosion to the central housing at ground level.

De-scale back to good metal and coat with lead free paint, using appropriate precautions. Repairs may be necessary where corrosion is severe.

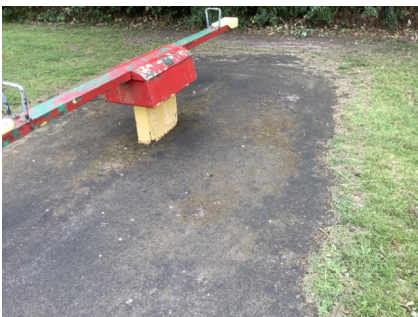
Moss is present.

Remove.

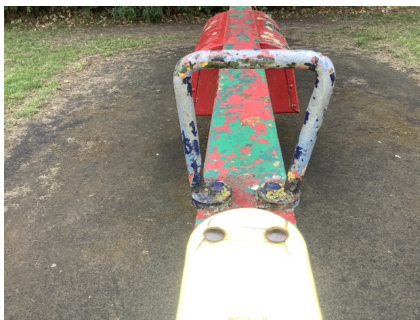
There is a head entrapment.

In the hand grip.

The unit was installed prior to the publication of the current standards. There is no requirement to make retrospective changes.

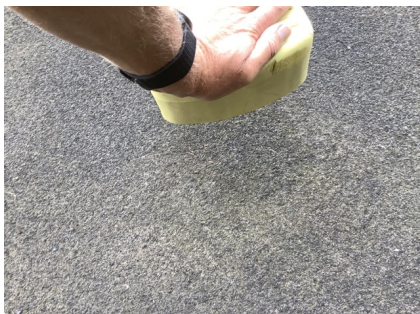
Clearance from seat assembly underside to ground less than 230 mm.

Modify.

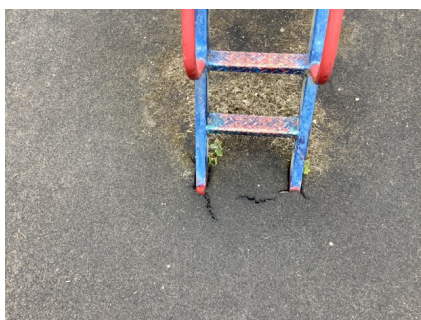
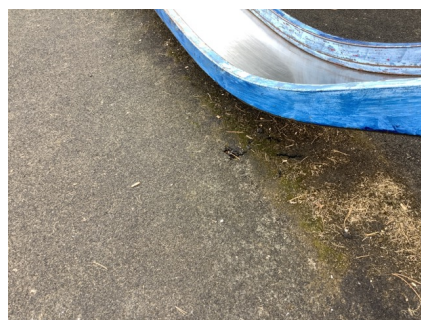
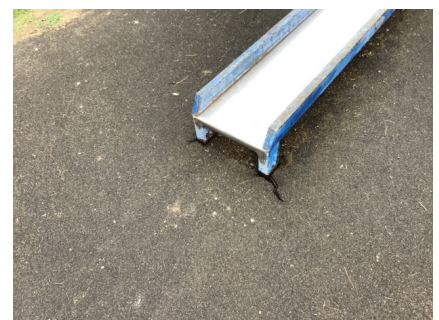
The wet pour surface is cracking.

Repair.

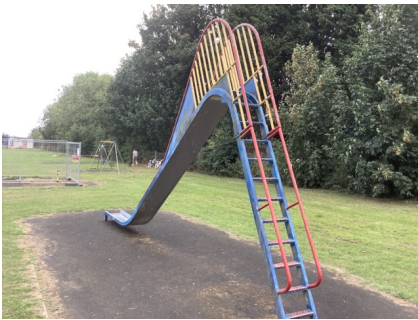
Paintwork is in poor condition.

De-scale back to good base material and coat with lead free paint, using appropriate precautions. Repairs may be necessary where corrosion is severe.

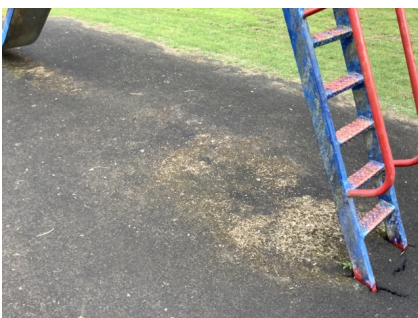
Moss is present.

Remove.

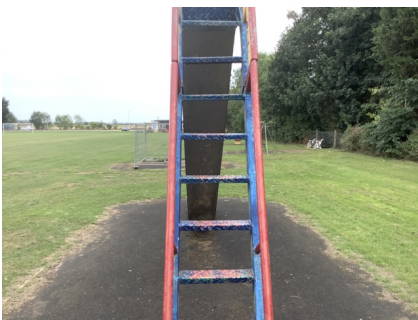
Access fails the entrapment requirements.

Entrapments between steps.

No reasonably practicable action is identified.

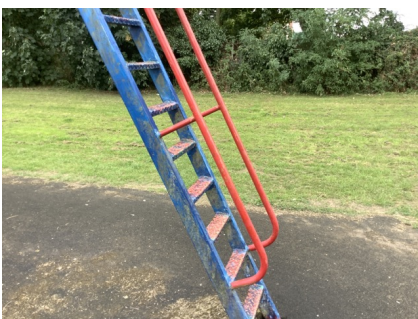
Guard rail height is below the minimum permitted of not less than 600 mm above the surface of the platform, step or ramp.

The unit was installed prior to the publication of the current standards. There is no requirement to make retrospective changes.

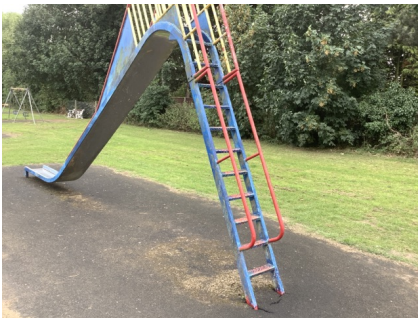
Stairs over 2000 mm must not be continuous. There must be appropriate intermediate platforms.

No reasonably practicable action is identified.

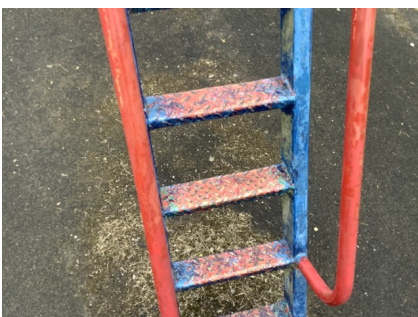
The depth of stair tread is either less than 110 mm or the projection is less than 140 mm, or both.

The unit was installed prior to the publication of the current standards. There is no requirement to make retrospective changes.

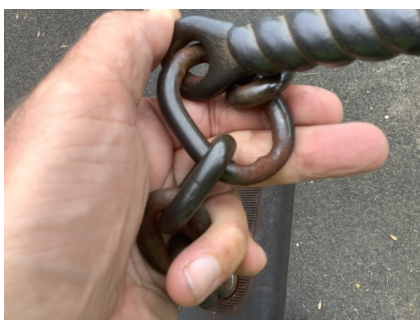
Some chain wear.

Monitor for further deterioration and replace before 40% wear.

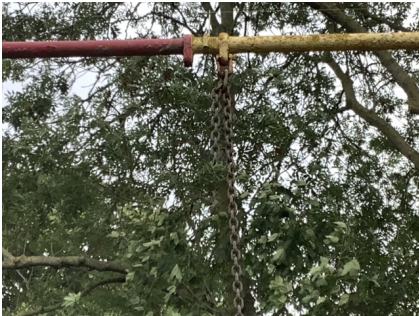
Chain has snagging hazard caused by surplus links.

Remove the excess links.

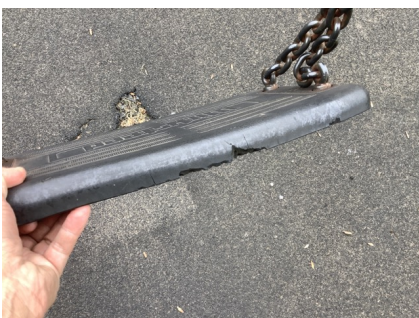
The swing seat has been damaged, but does not require immediate replacement.

Monitor and replace when hard material is exposed.

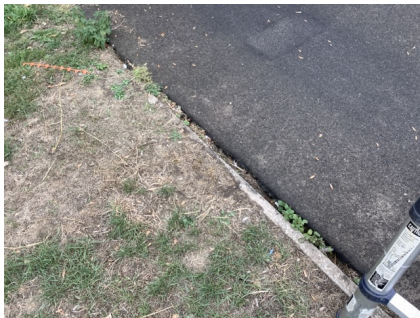
Shrinkage / separation of the surface. This may give a trip hazard.

Allow grass to establish in the gap, as this may prevent the wet pour from shrinking further.

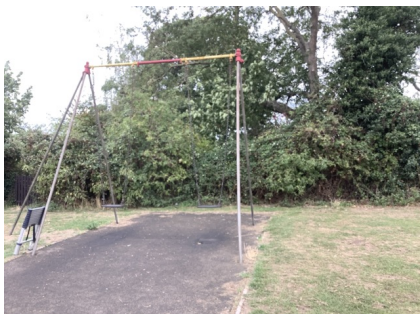
Item has some parts missing.

Loose arm support missing. Recommend it is removed / replaced due to the age of the frame.

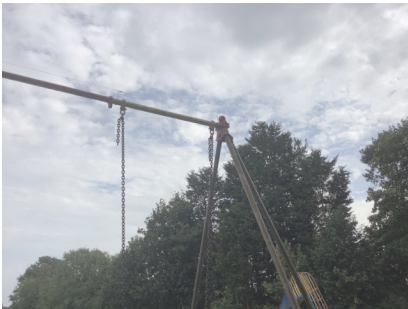
We are unable to gauge the structural integrity of this unit.

We advise an internal inspection of all parts or replacement.

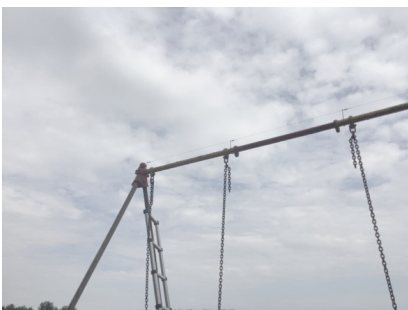
Paintwork is in poor condition.

The crossbar and header block rusting.

De-scale back to good base material and coat with lead free paint, using appropriate precautions. Repairs may be necessary where corrosion is severe.

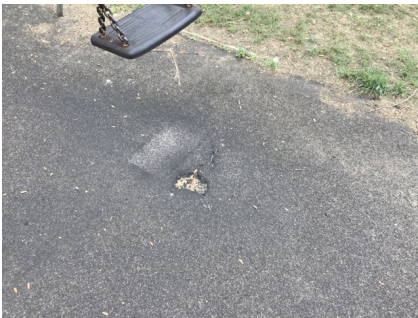
The surface is damaged.

Repair.

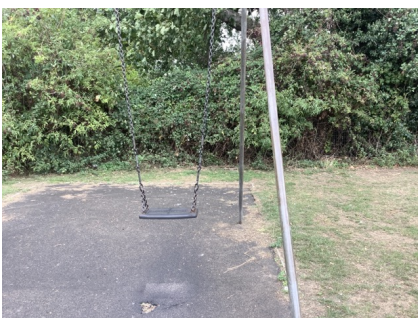
The distance between the seat side and the support is insufficient.

No reasonably practicable action is identified.

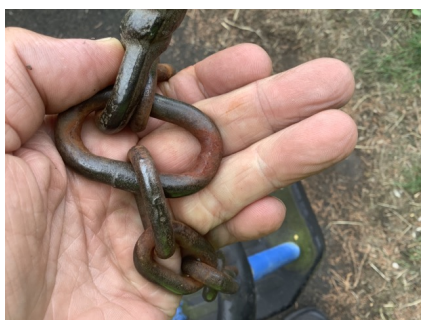
Some chain wear.

Monitor for further deterioration and replace before 40% wear.

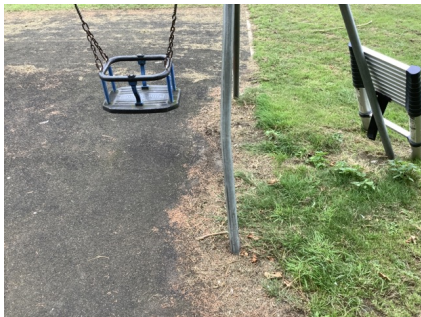
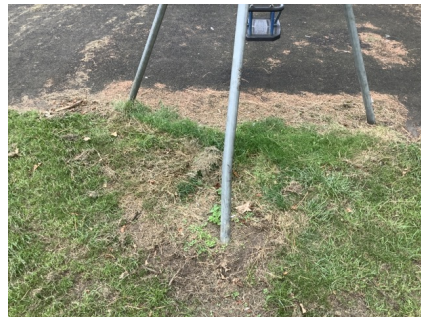
Item is bent.

Support posts x 2 bent.

No reasonably practicable action is identified.

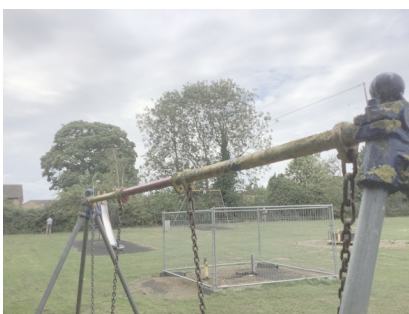
Paintwork is in poor condition.

De-scale back to good base material and coat with lead free paint, using appropriate precautions. Repairs may be necessary where corrosion is severe.

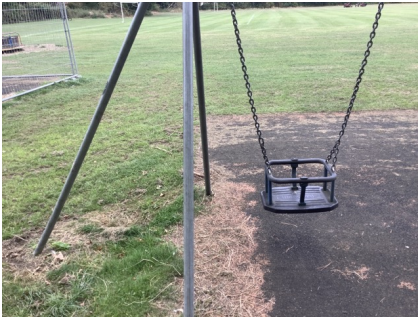
The distance between the seat side and the support is insufficient.

No reasonably practicable action is identified.
