the **play** inspection company

Annual Inspection

Pointon Parish Council

Pointon Playing Field

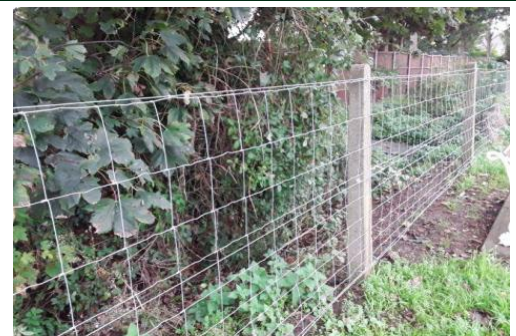
The adjacent foliage is overgrown - Cut back and maintain

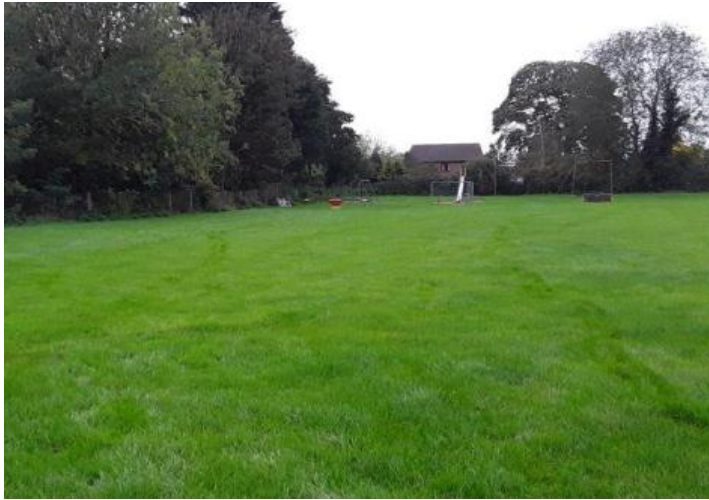
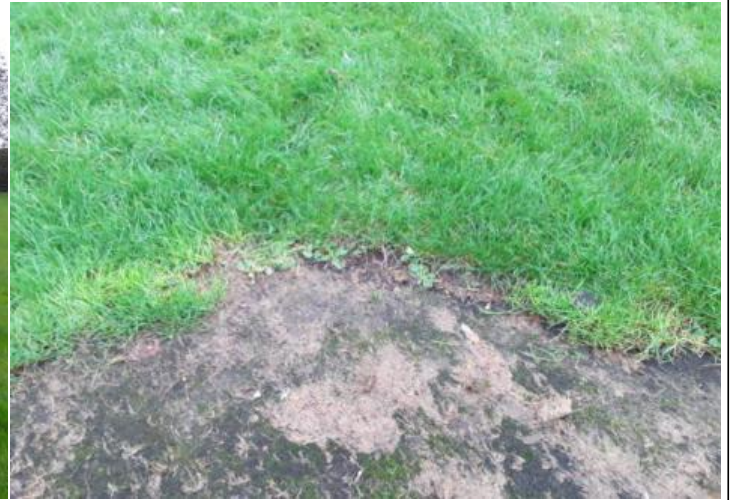
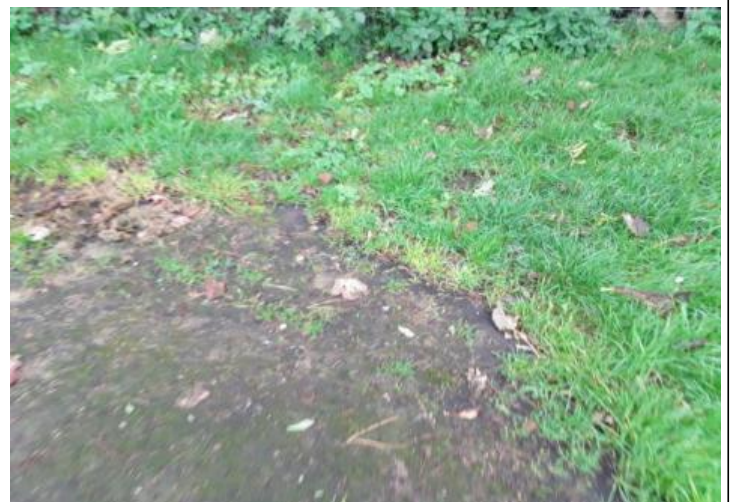
Finding: There is weed / vegetation growth on, between, or around the edges of the surfacing
Action: Remove weed / vegetation growth

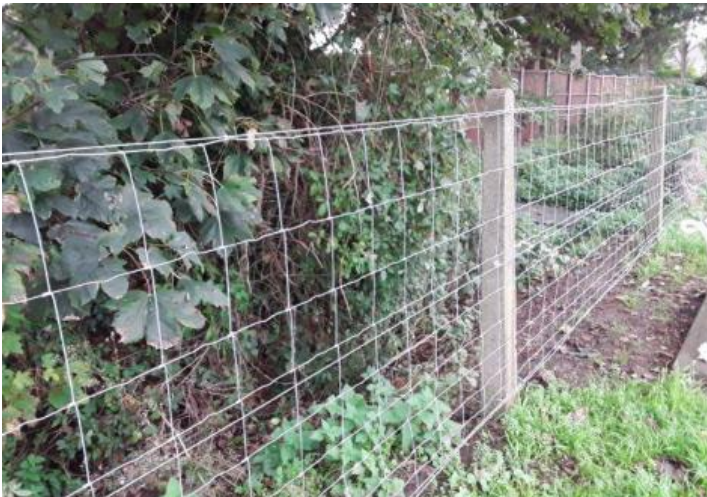
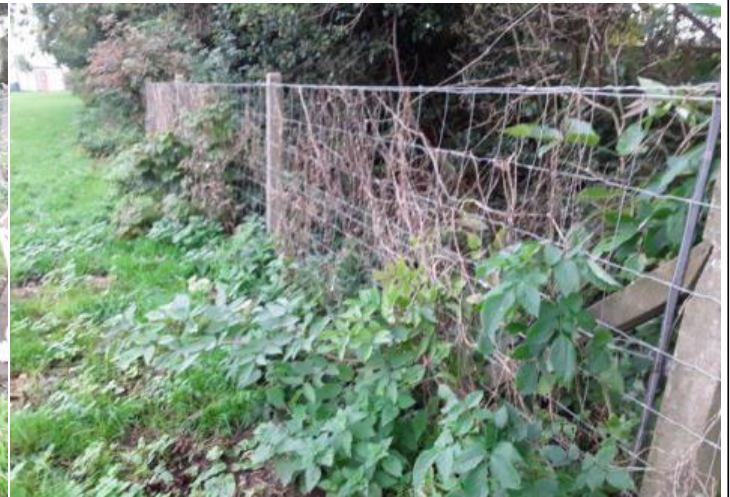
Finding: The adjacent foliage is overgrown

Action: Cut back and maintain

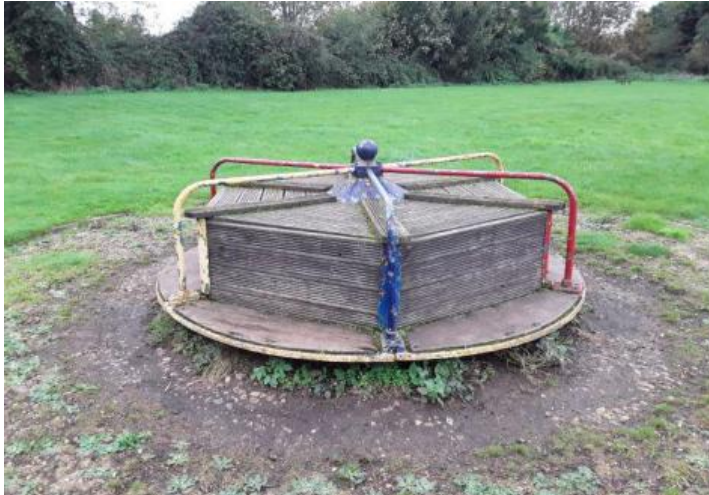
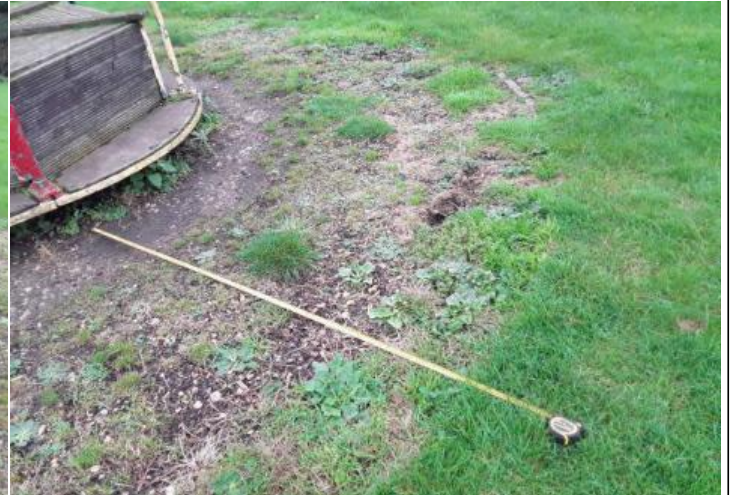
Finding: The safety surface has been removed, and in addition, the edge dimensions do not meet with the requirements of the current applicable standard (2.0m impact area required around the item - client notified)

Action: Provide an appropriate safety surface and extend edging dimensions to comply

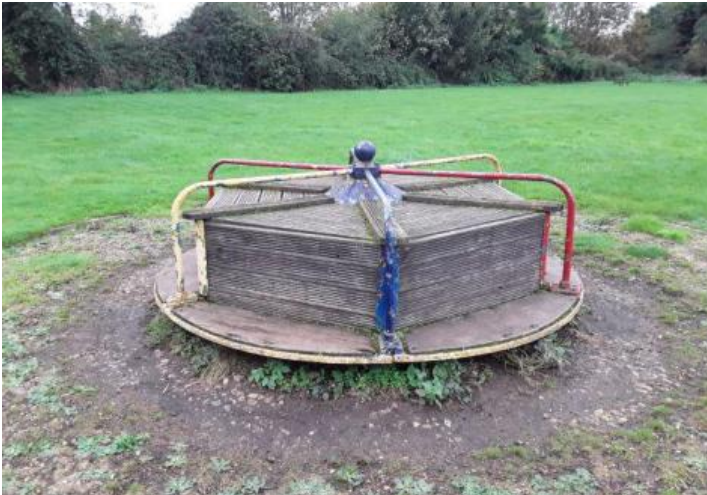
Finding: The distance between the underside of the roundabout platform and the playing surface is in excess of 110mm and contravenes the requirements of BS EN 1176 Part 5 which requires that the distance be maintained between 60mm-110mm - for the entire circumference of the roundabout

Action: Replace the missing surface

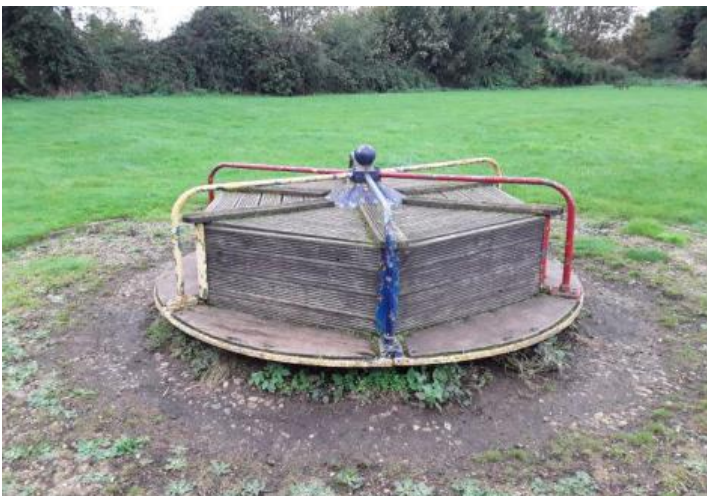
Finding: There is algae or moss on the surface of the equipment

Action: Clean and treat appropriately

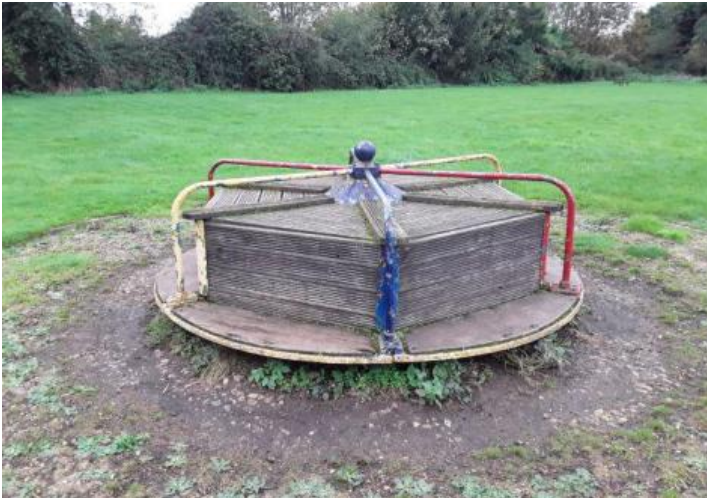
Finding: There are areas or parts of the timber on the structure that have rotted around fixing points

Action: Replace all affected timbers

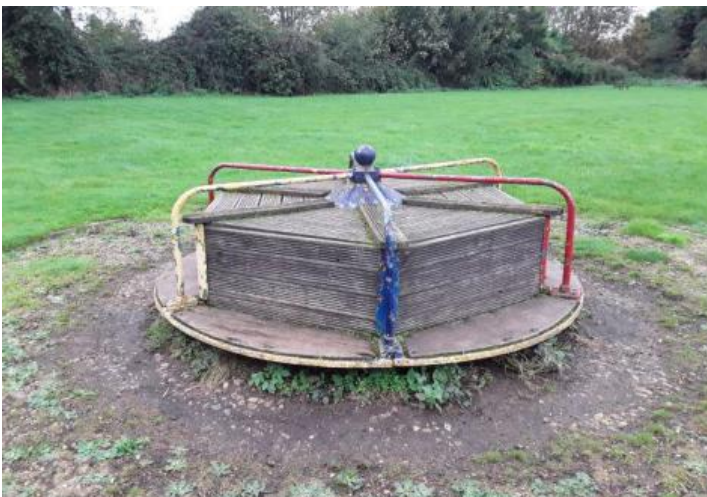
Finding: There is/are finger entrapment/s in the structure and the item fails to meet the requirements of BS EN 1176 Part 1 4.2.7.6 Entrapment of fingers

Action: Infill to remove the entrapments

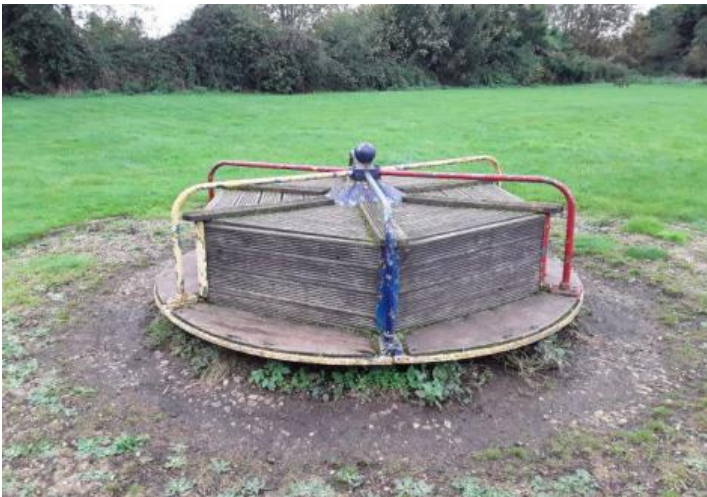
Finding: The bearing is showing signs of wear

Action: Monitor for any further deterioration and replace as required

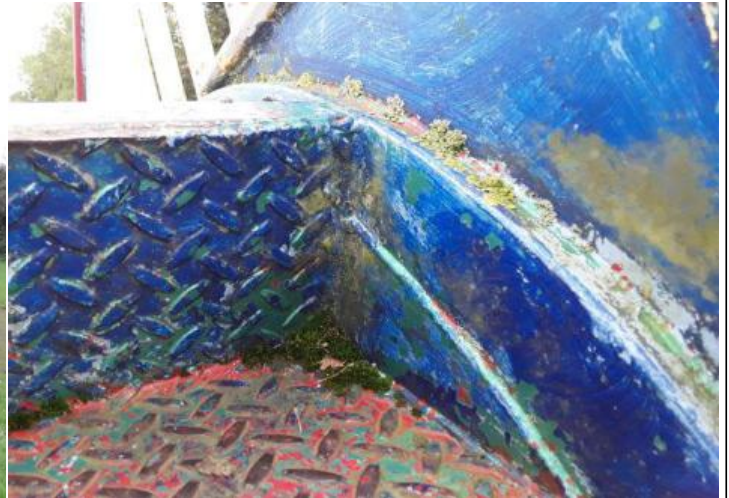
Finding: There is algae or moss on the surface of the equipment

Action: Clean and treat appropriately

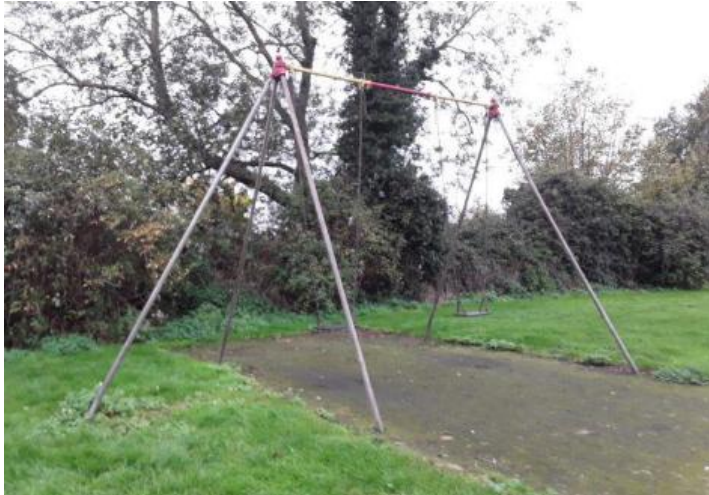
Finding: One of the lateral frame stabilisers is missing

Action: Replace the missing structural components

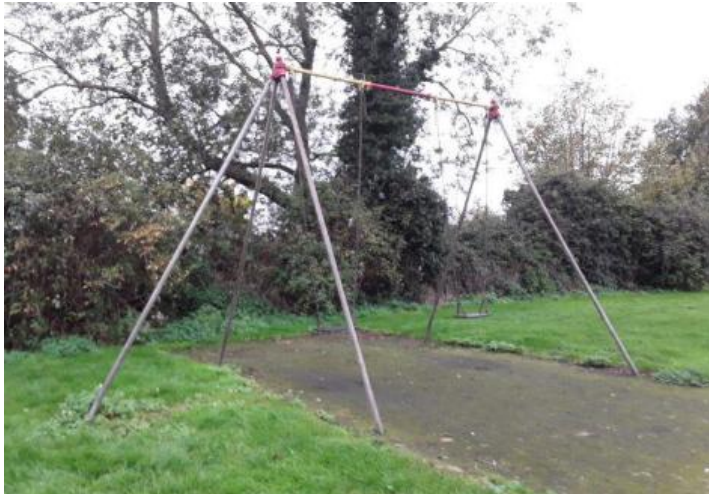
Finding: There are significant gaps (over 30mm) between the surface and the edging or between the joints in the surface; these are large enough for a small foot to enter

Action: Repair surfacing

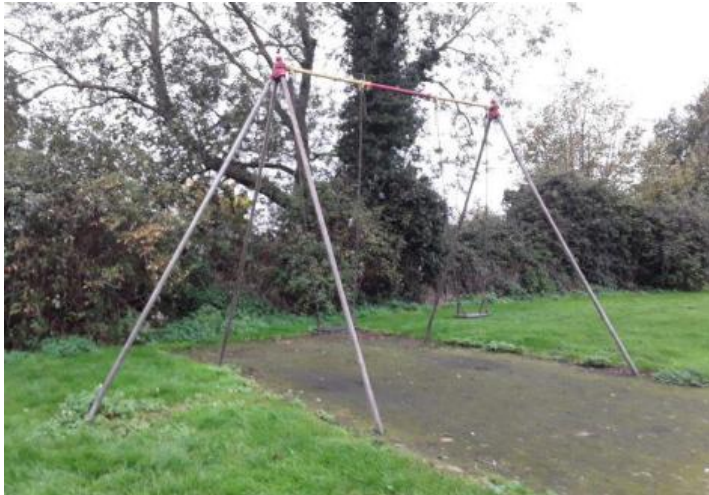
Finding: The seat has minor damage or wear

Action: Monitor for any further deterioration and replace as required

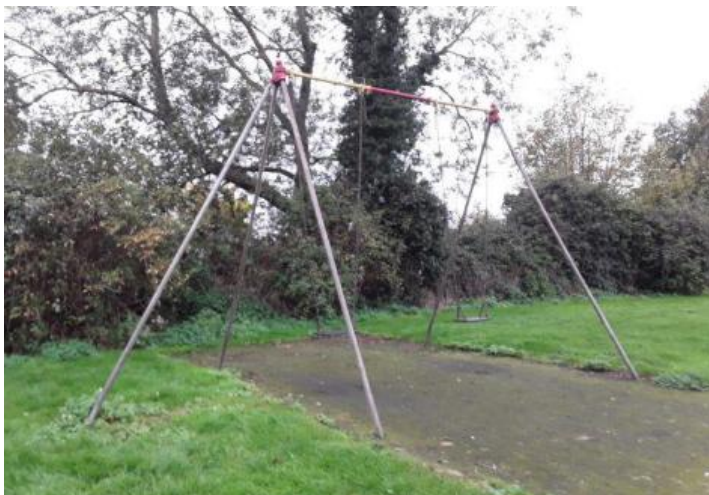
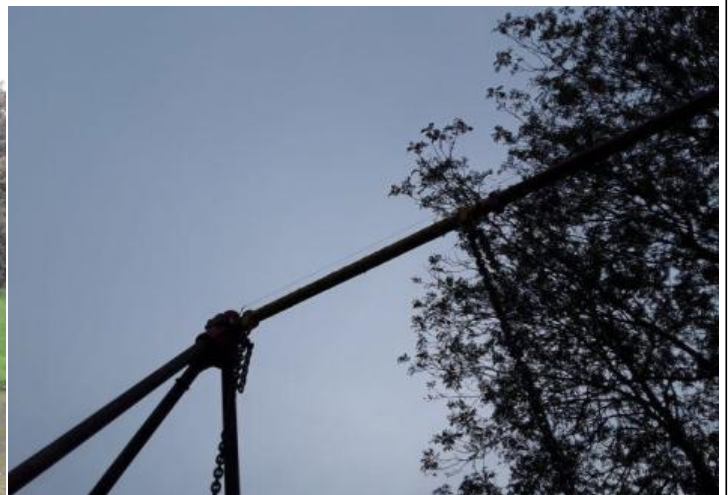
Finding: There are excessive chain tails provided, however a minimum of 2 additional links should always be provided with crucifix connectors

Action: Cut back excess chain tails but ensure a minimum of 2 additional links remain through the crucifix
